COMANDO DA AERONÁUTICA
CENTRO DE INVESTIGAÇÃO E PREVENÇÃO DE
ACIDENTES AERONÁUTICOS

FINAL REPORT
A - 128/CENIPA/2015

OCCURRENCE:	ACCIDENT
AIRCRAFT:	PP-ELA
MODEL:	206L-3
DATE:	23SEPT2015

This is the Final Report of the 23SEPT2015 accident with the BELL 206L-3 aircraft, registration PP-ELA. The accident was classified as “Loss of Control In-Flight”.

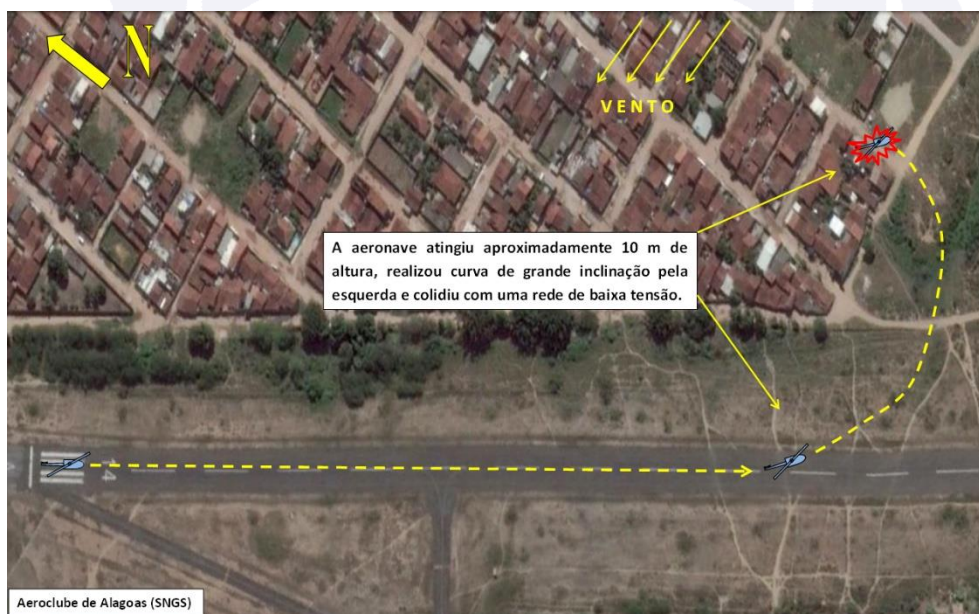
Figure 1 - Sketch of the accident.

The impact with the power grid launched the aircraft approximately 30 meters ahead. The total stop occurred with the helicopter lagged about 45° in relation to the runway axis (SNGS), according to Figure 1.

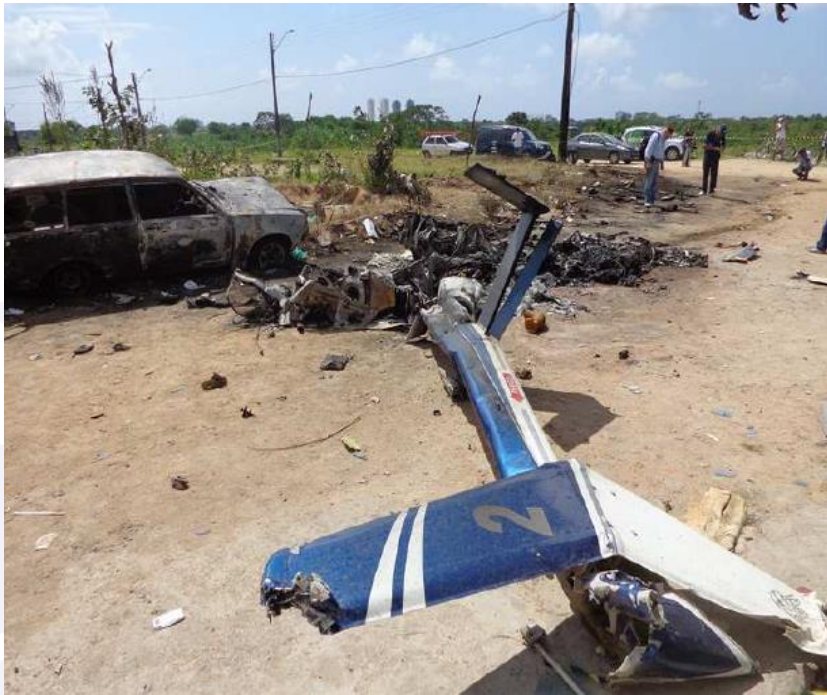
Figure 2 - Aircraft destroyed by fire.

The fire started immediately after the aircraft full stop. The combustion material was the fuel in the aircraft and the source of ignition was probably originated as a result of the strong friction of the helicopter parts with the ground (Figure 2).

The fire spread quickly. The situation was aggravated by the fact that the tanks were stocked with about 480 pounds of fuel.

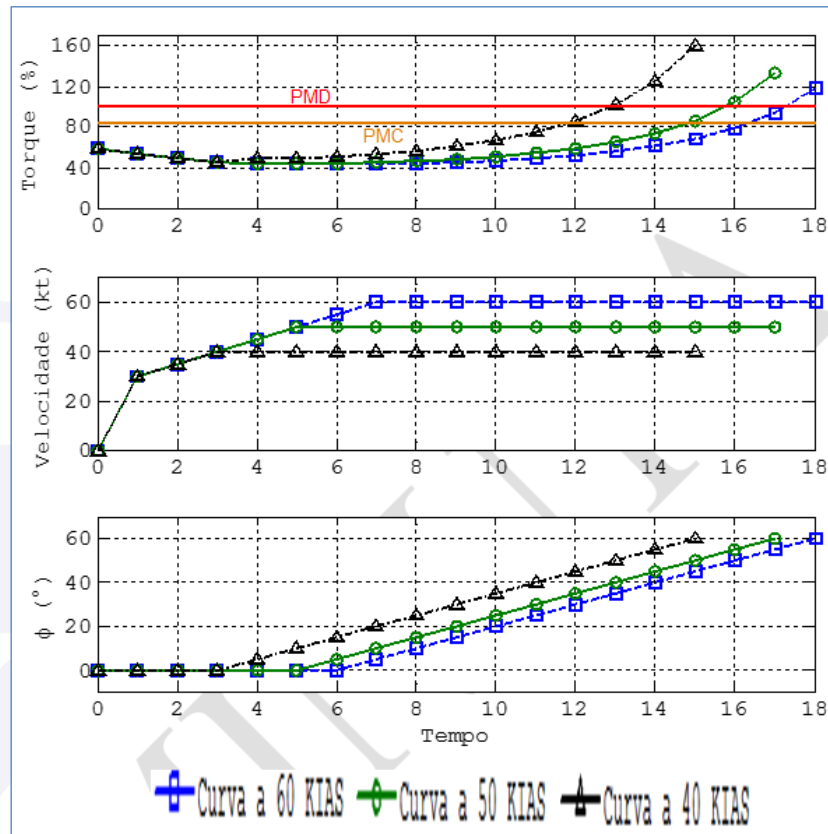
Figure 3 - Take off profiles with curve at 60KT, 50KT and 40KT.

In Figure 3, it is possible to verify the results of the performance related to several and possible takeoff profiles that the pilot could have adopted, depending on the speed ahead, applied torque (power) and bearing angle (Φ), considering the conditions of Weight of 1,520 kg, altitude of 387ft and temperature of 29 ° C. The first line of the graphic refers to the variation of torque over time. The second line represents the variation of speed ahead over time. The third line illustrates the variation of the aircraft's lateral slope according to the time. The red curve represents the Maximum Takeoff Power (PMD) and the orange curve represents the Maximum Continuous Power (PMC) of the helicopter.

For all the graphics shown in Figure 3, it can be observed that both the hover phase and the acceleration phase (takeoff) occur with a large extra margin of power. The smallest extra power margin reached during the flight is $\Delta TQ = 26\%$, relative to the maximum continuous power (PMC), which is $TQ = 85\%$. This condition is observed during the hover phase.

The graphics in Figure 3 show that the required torque increases as the lateral slope of the aircraft also increases. The required torque and PMC curves are found when the lateral slope of the helicopter reaches values of the order of 50° in relation to the horizon. The highest required power values are found on the 40KT curve (black).

Even in the most critical condition (40KT), with a high bearing angle (50°), the pilot could use an even higher power regime, maximum takeoff power (PMD, $TQ = 100\%$) without causing engine damage or decreases of rotation in the main rotor.

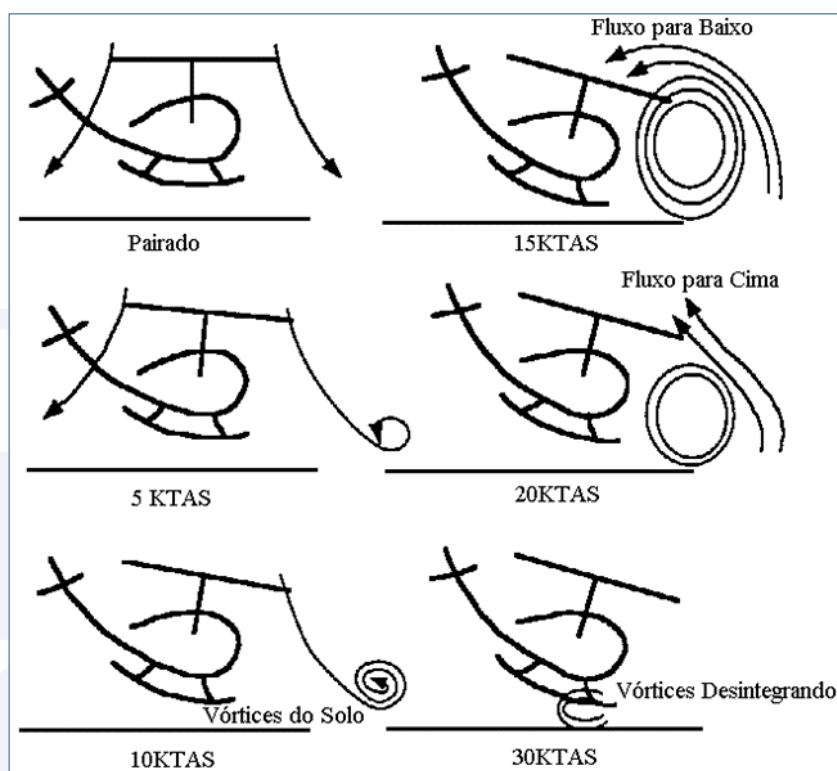
Figure 4 - Effect of ground vortices.

In low-speed forward flights within the ground effect, it is possible that the vortices produced by the main rotor are reflected by the ground, moving closer to the aircraft and inducing speeds with the rotor disk, as shown in Figure 4. So, the resulting loads on the blades affect stabilized longitudinal and lateral control conditions.

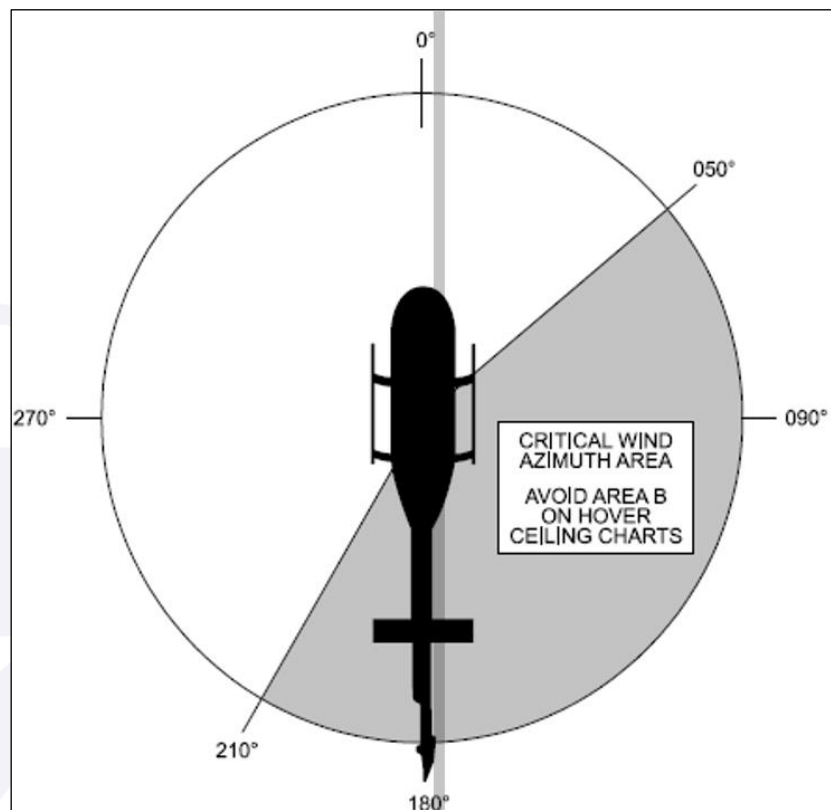
Figure 5 - Aircraft wind envelope.

This last envelope, reproduced in Figure 5, shows the relative wind limits at which the aircraft still presents satisfactory stability and control. For the case studied, this condition was demonstrated up to 26KT, under all weight conditions.

It was also considered that, at some point during the curve on the left, there might have been a relative wind incidence in the azimuths from 050 ° to 210 °, a sector considered as a critical azimuth area (Figure 5). However, the envelope reproduced in Figure 5 demonstrates that the aircraft had satisfactory conditions of stability and control for winds up to 26kt of intensity.

Since the wind at the site of the accident was 15kt, if the wind affected this sector, this occurred at intensities lower than those shown. In this way, it can be assumed that the possible relative wind incidence, in the azimuths considered critical, could cause the increase of the workload of the pilot in the control of the heading of the aircraft. However, it would not be enough for there to be total loss of yaw control.

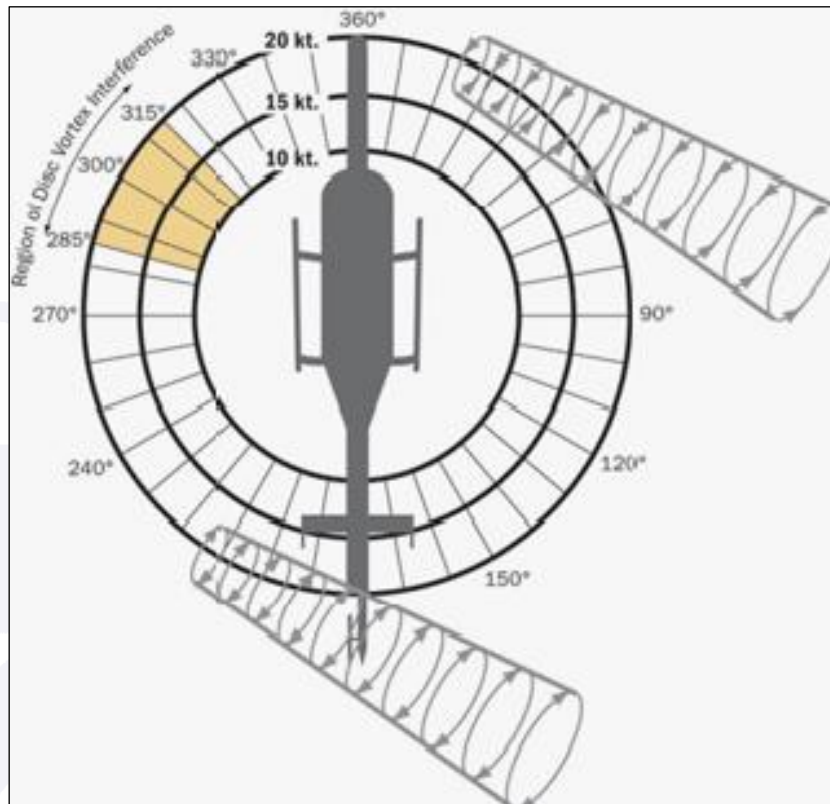
Figure 6 - Interference of the main rotor vortices on the tail rotor.

Also according to Advisory Circular (AC) 90-95, the incidence of relative wind at azimuths between 285° and 315° (Figure 6) can generate interference between the main rotor vortex and the tail rotor. With wind focusing on this region, it is possible that the tail rotor operates within the turbulence generated by the main rotor, causing a sudden reduction of the tail rotor traction, due to the change of air flow. The pilot, in this case, must apply left pedal to prevent the aircraft from guiding to the right.

Based on the wind direction / intensity information and on the flight profile described by the aircraft, it can be stated that there was no incidence of relative wind at azimuths of 285° to 315°, azimuths in which the wind incidence could cause loss of the rotor tail, due to the turbulence from the main rotor, according to Figure 6. Thus, it can also be stated that there was no incidence of relative wind in the azimuths from 210° to 330°, favorable condition to the appearance of vortex rings in the tail rotor, (Fig. 8). This way, it can be seen that these two effects did not contribute to the accident.

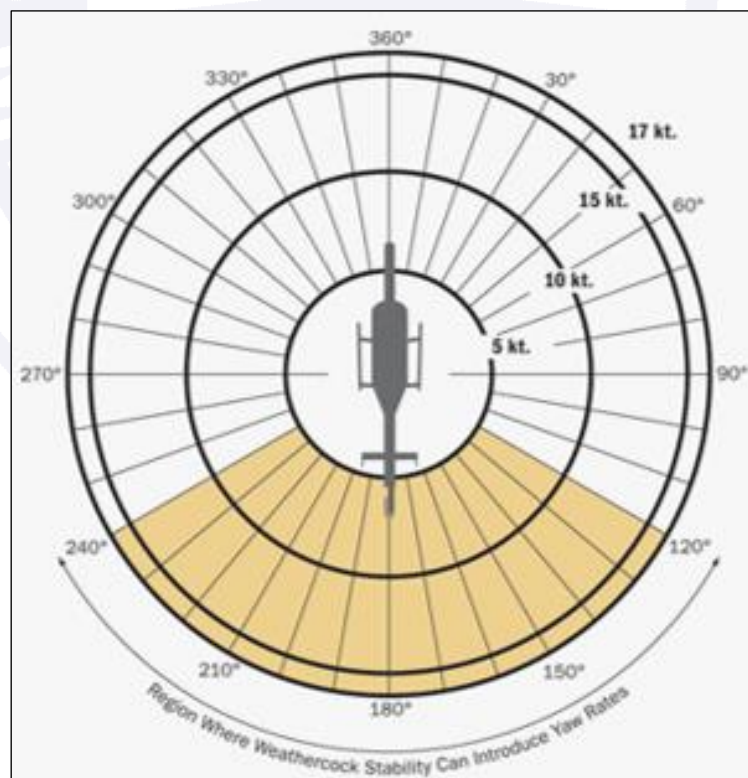
Figure 7 - Influential azimuth in the girouette effect.

Another azimuth that can lead to loss of the tail rotor effectiveness, according to the same reference, is the one between 120° and 240° due to the *girouette* effect, (Figure 7). At low speeds, tailwinds between 120° and 240° can increase the pilot's workload. The great contribution of the winds coming from this range of azimuths is in the increase of the yaw ratio of the aircraft, which, due to the *girouette* effect tends to be with head wind.

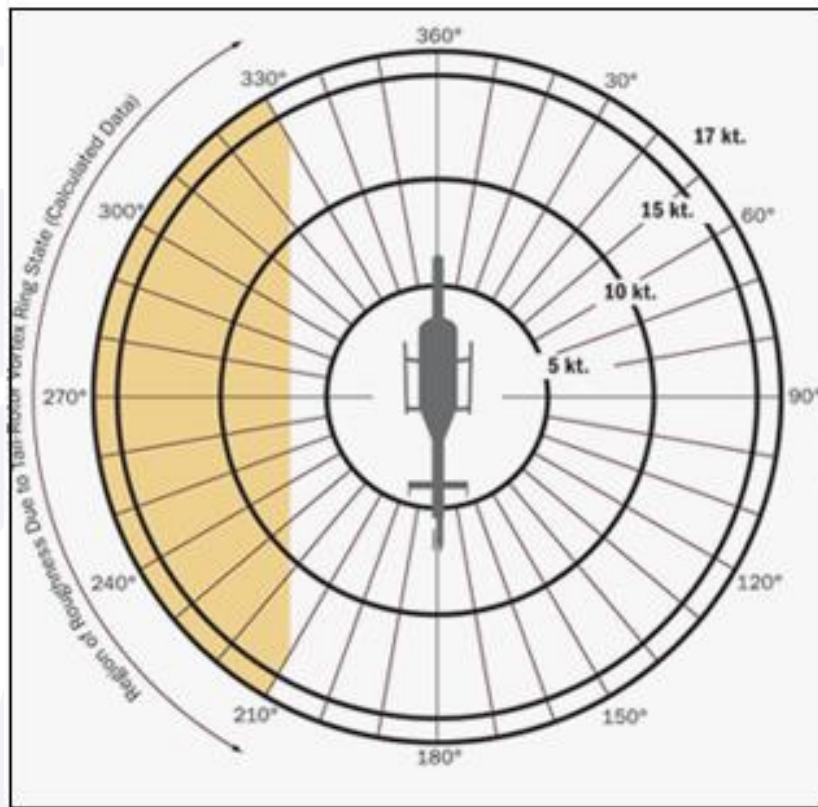
Figure 8 - State of vortex rings in the tail rotor.

A third influent azimuth in LTE is the one between 210° and 330° (Figure 8). In this situation, the velocity induced by the tail rotor has opposite direction to the relative flow incident on the left side of the aircraft, being able to develop the state of vortex rings in the tail rotor. As a result, it is assumed that the tail rotor flow will be non-stationary and non-uniform, causing oscillations in the traction produced, requiring rapid and continuous actuation of the aircraft pedals to maintain control of the flight.

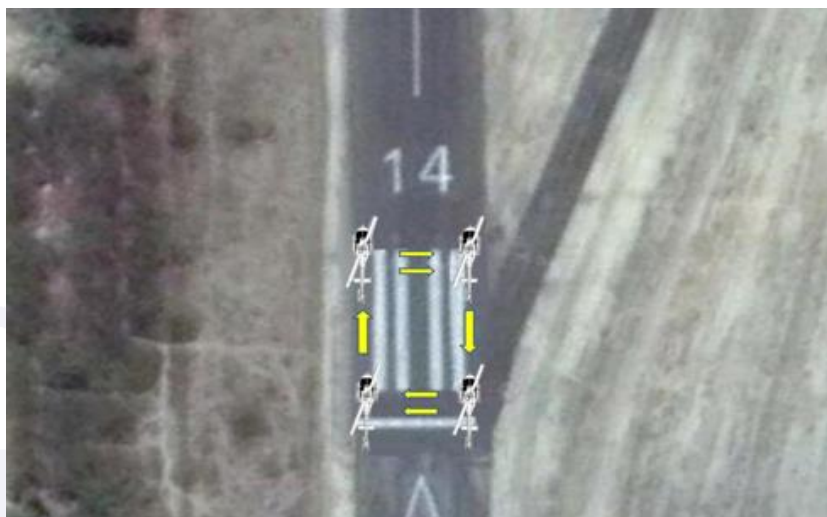
Figure 10 - Profile of the maneuver known as "square".

Training on SNGS threshold 14, usually performed by GOA crews, consisted of performing the maneuver known as "square", usually performed from the hovered flight (Figure 10).

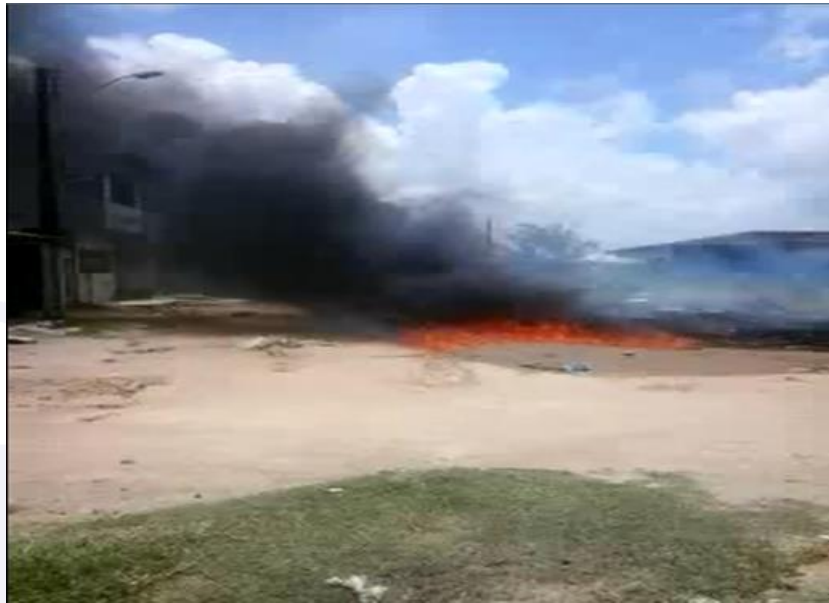
Figure 11 - Scene of the accident with the presence of fire

The video images showing the wreckage of the burning aircraft (Figure 11) demonstrated, through the smoke, that at the time of the accident the wind had a lateral component (left) in relation to the SNGS runway axis, whose characteristics (direction and intensity) were similar to those reported by METAR of SBM.
