COMANDO DA AERONÁUTICA
CENTRO DE INVESTIGAÇÃO E PREVENÇÃO DE
ACIDENTES AERONÁUTICOS

FINAL REPORT
A - 026/CENIPA/2016

OCCURRENCE:	ACCIDENT
AIRCRAFT:	PP-LIG
MODEL:	TBM700N
DATE:	01FEB2016

This is the Final Report of the 01FEB2016 accident with the TBM700N aircraft, registration PP-LIG. The accident was classified as "Undetermined".

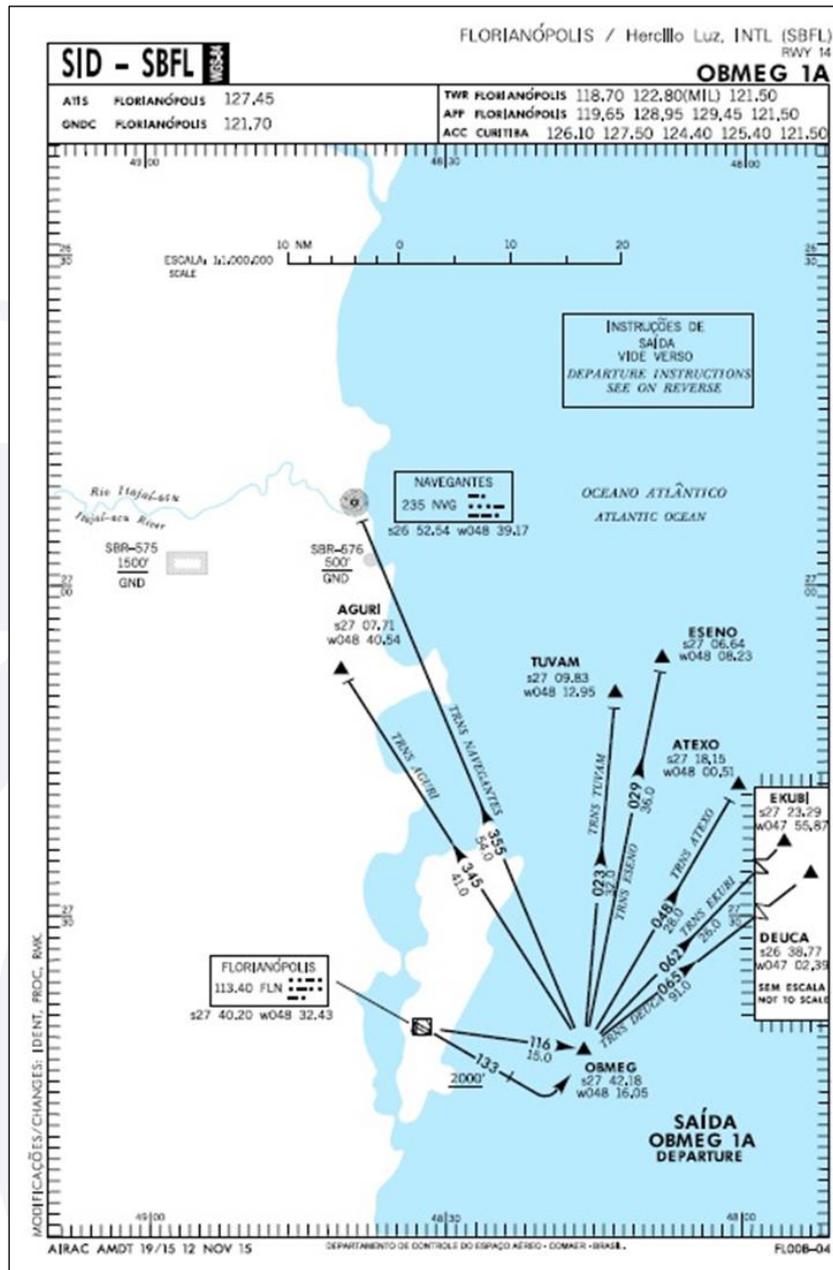
On the day of the accident, the communication took place normally. The flight plan was authorized using the OBMEG 1A Standard Instrument Departure (SID), AGURI transition procedure. (Figure 1)

Figure 1 - OBMEG 1A SID procedure.

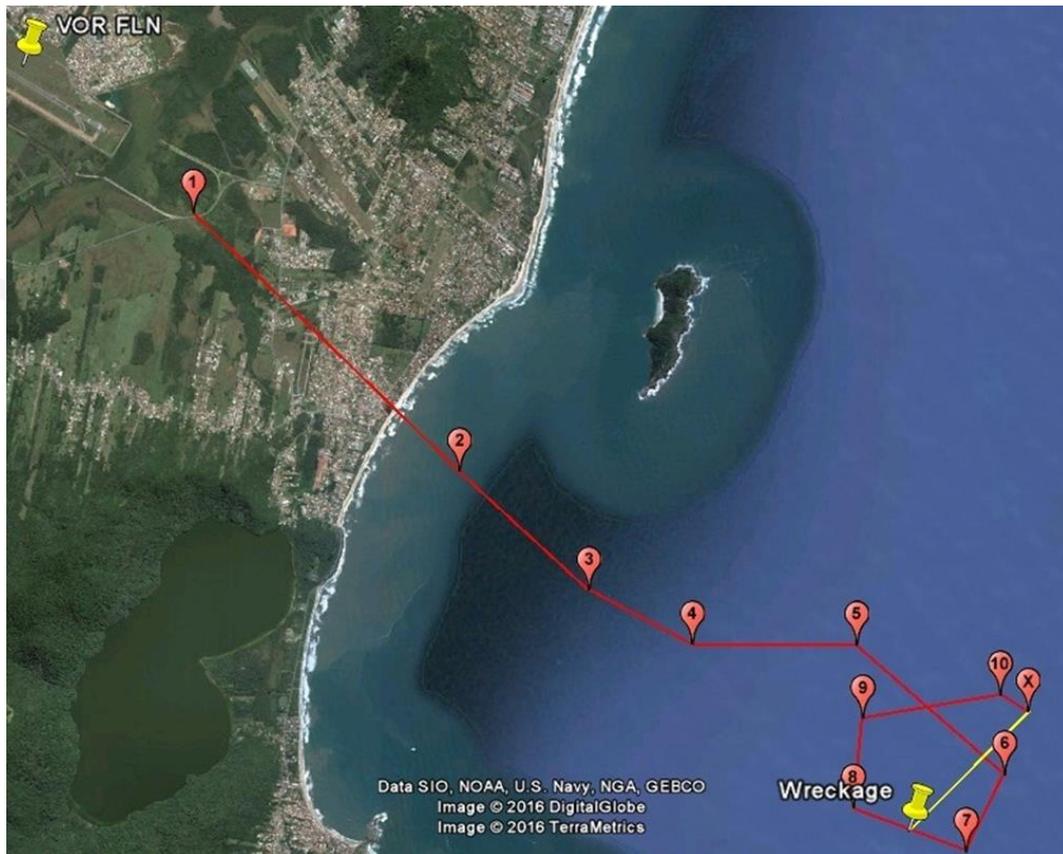
At 2,600ft, under instrument meteorological conditions, that is, below the established minimums to fly according to the rules of the visual flight, the aircraft started a small turn to the left. Shortly thereafter, the aircraft reversed the curve to the right, making a 360° turn to the right, while losing altitude and gaining speed, characterizing a downward spiral. (Figure 2).

Figure 2 - Trajectory performed by the aircraft.

Table 1, below, refers to the points indicated in figure 2, describing the data related to the UTC (UTC), distance and radial of the VOR FLN, altitude and speed of the aircraft:

The radar data showed that the flight trajectory exhibited variations of course and speed incompatible with the use of autopilot.
