COMANDO DA AERONÁUTICA
CENTRO DE INVESTIGAÇÃO E PREVENÇÃO DE
ACIDENTES AERONÁUTICOS

FINAL REPORT
A-050/CENIPA/2015

OCCURRENCE:	ACCIDENT
AIRCRAFT:	PP-LLS
MODEL:	EC155B1
DATE:	02APR2015

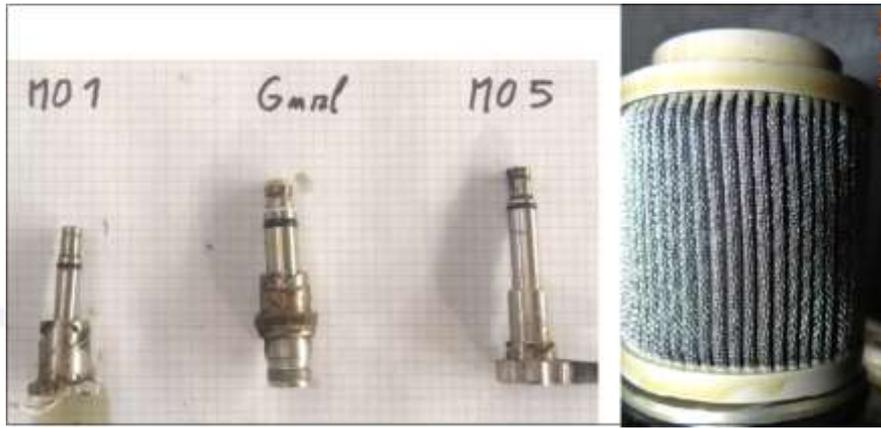
All the magnetic detectors in the lubrication system of the engines were inspected. No metal particles were observed in any of the magnetic detectors (module 1, module 5, and general detector of the system) (Figure 26).

Figure 26 - Detectors and oil filter of the engine SN 26194.

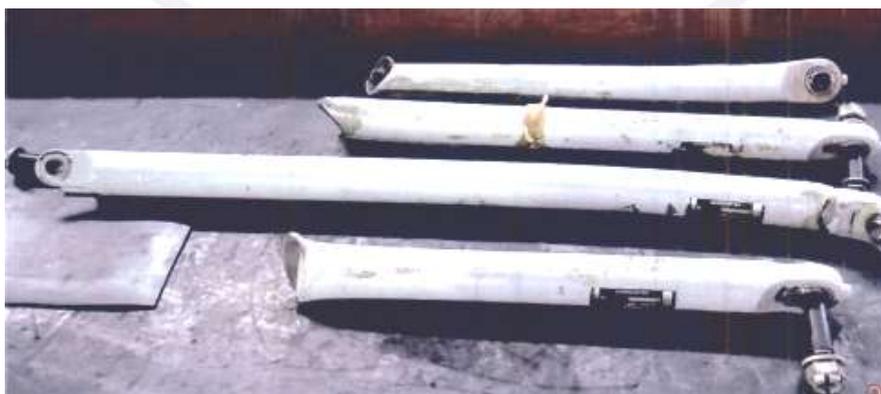
Fractures due to overload were observed in the bars for MGB attachment to the aircraft.

Figure 30 - MGB attachment bars.

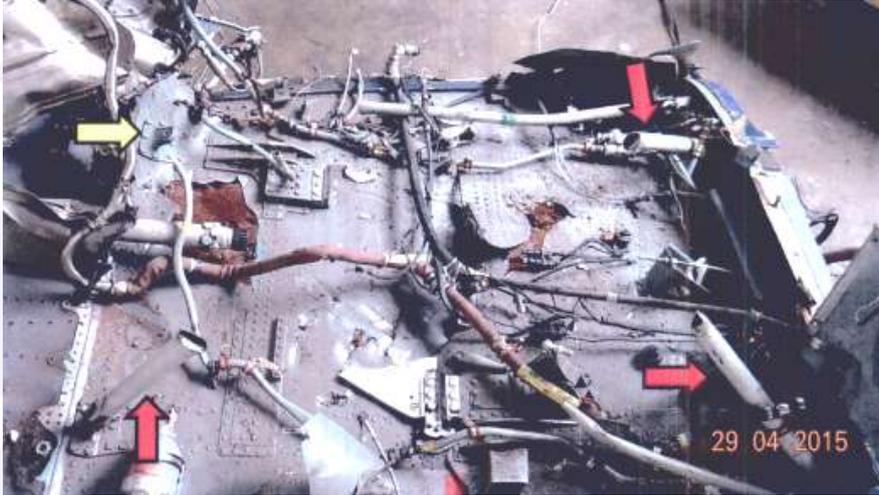
One of the bars was not connected to the attachment support (yellow arrow in Figure 31), but there was evidence of connection, and presence of the bolt at the moment of impact. This was characterized by the marks left by the bolt thread (Figure 32), and by the ovalization and deformation due to opening at the end of the attachment bar (Figure 33).

Figure 31 - Attachment bars (red arrows) and attachment support (yellow arrow).

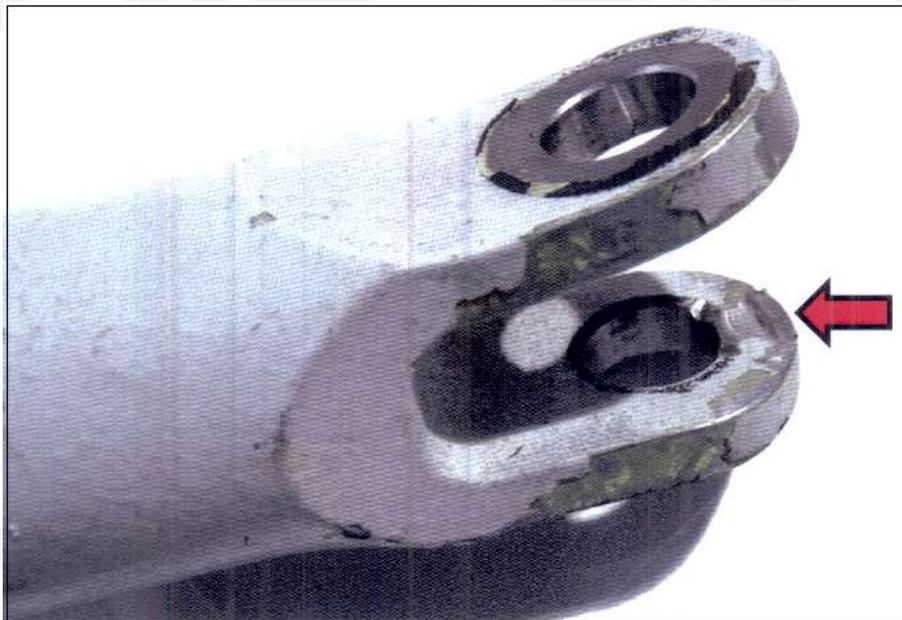
Figure 32 - Marks of impression due to contact with another body.

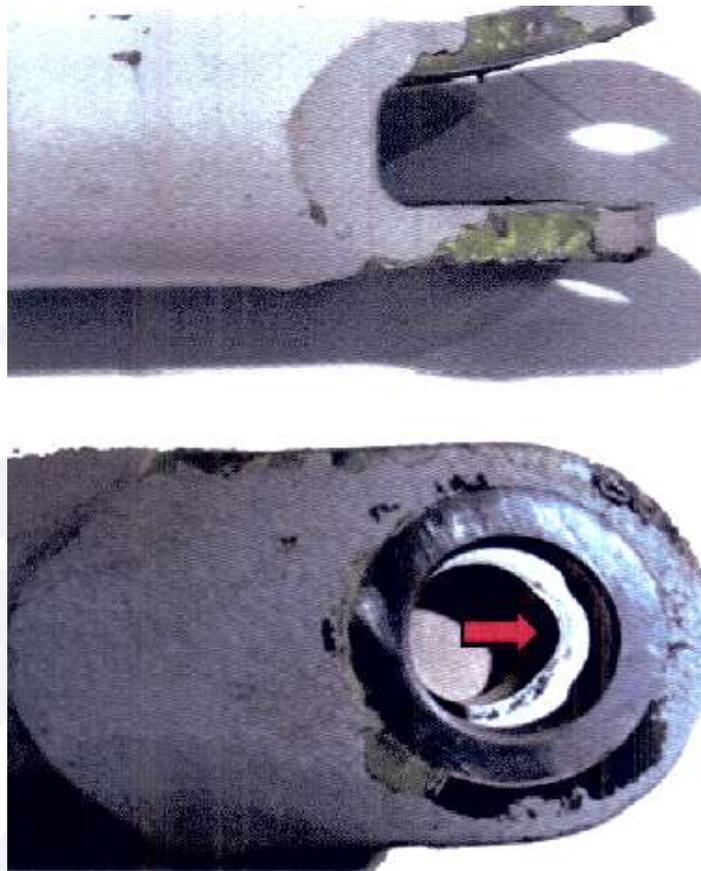
Figure 33 - Ovalization and deformation due to overload during opening effort at the end of the bar.

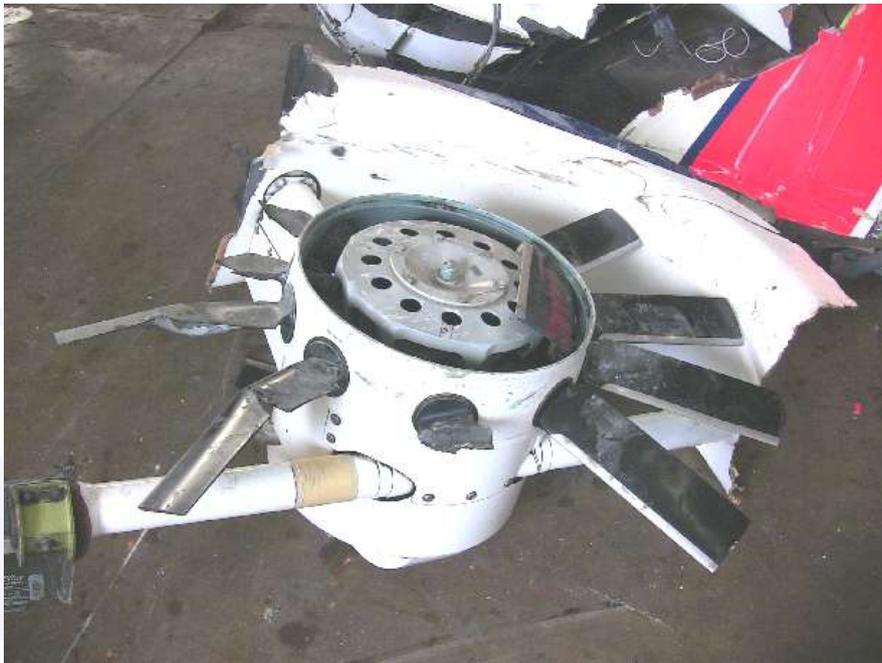
The broken blades presented folding in the normal direction of movement, with signs of bending on account of overload. The number of broken blades and the damage characteristics were an indication that there was little or no power in the tail rotor at the moment of impact (Figure 37).

Figure 37 - Fenestron damage and marks.

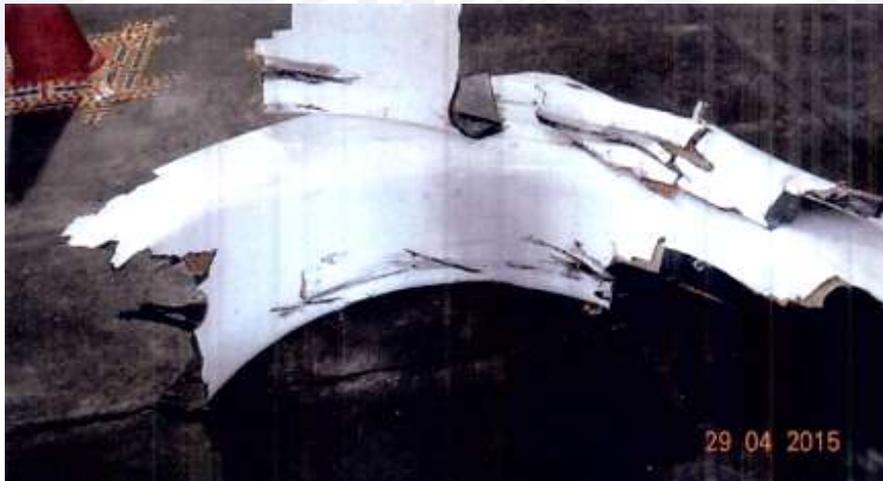
Figure 38 - Damage to the internal protection of the Fenestron.

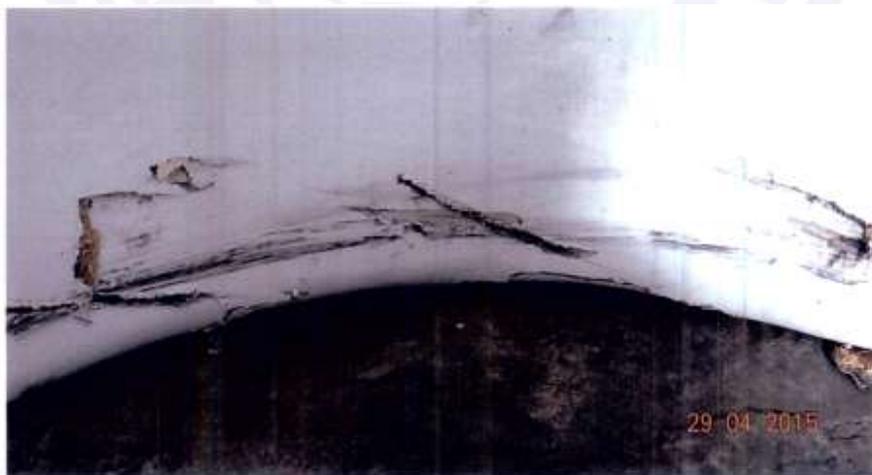
Figure 39 - Detail of penetration and cutting marks left by the tail rotor blades.

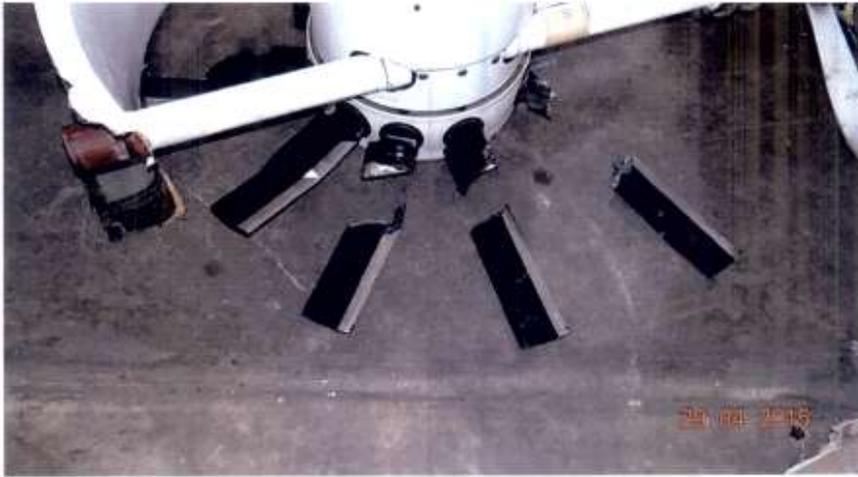
Figure 40 - Detail of the blades fractured by overload-induced flexion.

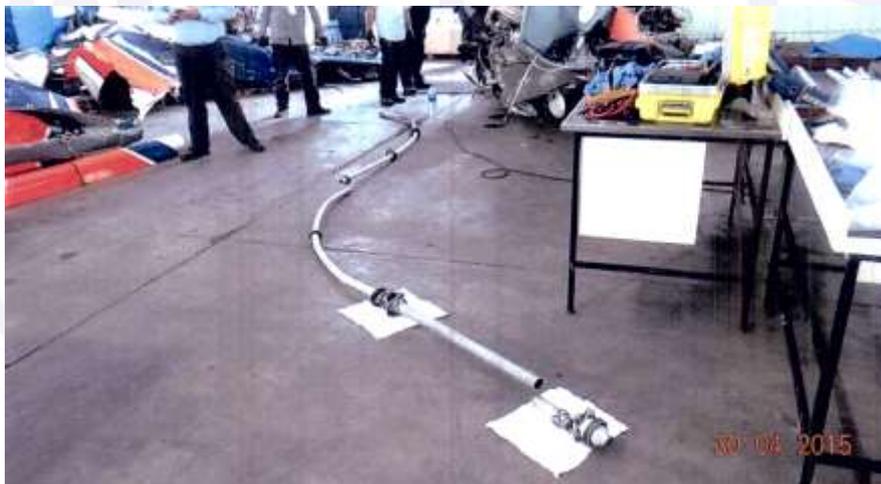
The analysis revealed buckling of the shaft due to compression efforts (Figure 43).

Figure 43 - Tail rotor driveshaft, showing details of the buckling.

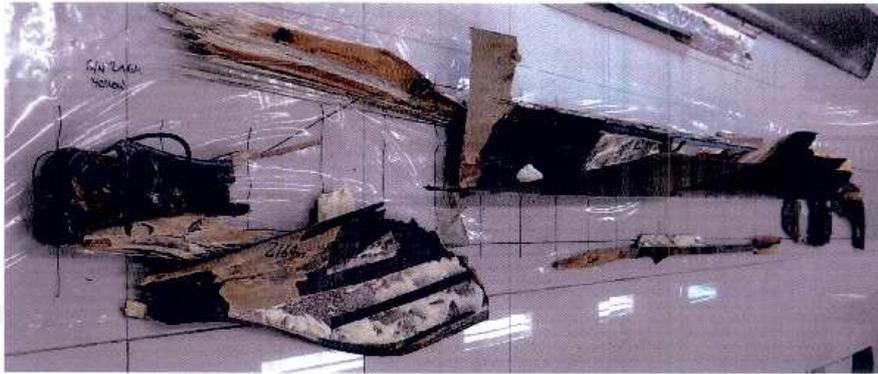
The exam of the yellow blade did not reveal the presence of bubbles on the surface that could have resulted from delamination or from detachment of the composite layers. No previous damage or a kind of damage that could have led to the accident was found, such as cracks, detachment, or delamination. The investigators observed that the leading edge of the blade remained composed, although showing signs of damage resulting from the crash. The damage to the yellow blade resulted from the accident, mostly due to impact and overload.

Figure 46 - Aspect of the yellow blade.

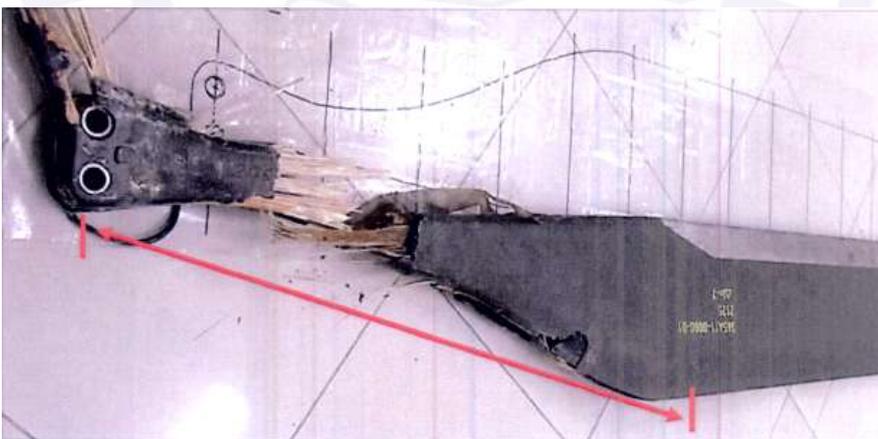
Figure 48 - Aspect of the damage to the trailing edge.

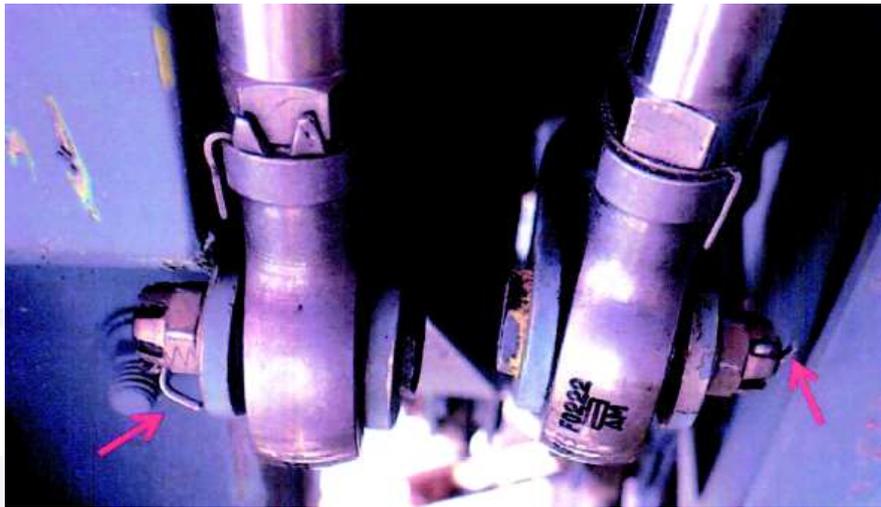
On the left side of the fuselage, investigators observed that the LH Ball-type flexible control roll (item 16 of Figure 49) and the Ball-type flexible control pitch (item 17 of Figure 49) were connected to the LH roll bellcrank (item 12 of Figure 49) and to the Pitch bellcrank (item 11 of Figure 49), respectively, by means of bolts, washers, nuts, and cotter pins. In other words, the fastening of these components was in accordance with the prescriptions of the manufacturer's manuals.

Figure 50 - LH Ball-Type flexible control roll and Ball-type flexible control pitch, LH roll bellcrank and Pitch bellcrank, as found in the wreckage. The red arrows indicate the cotter pins.

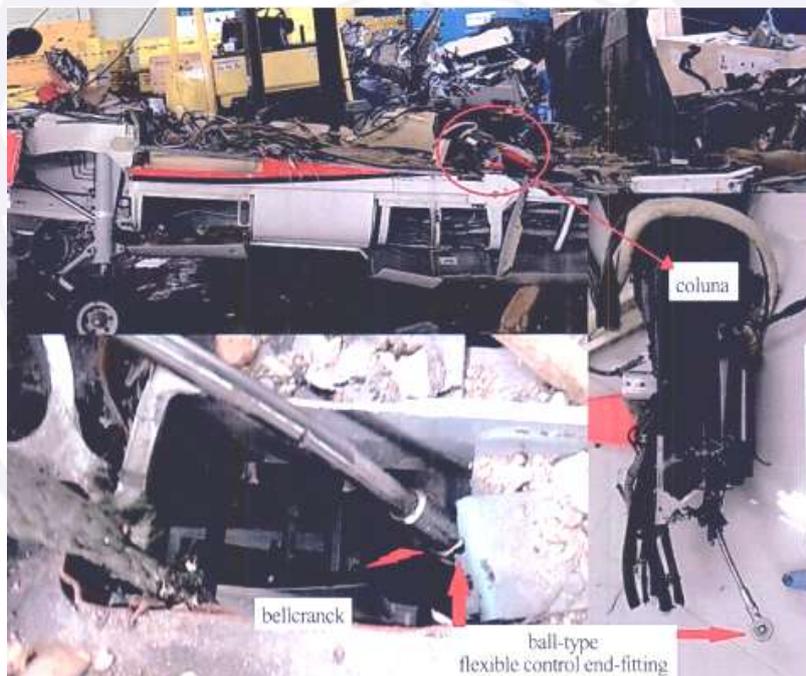
On the right hand side of the fuselage, the investigators observed that the RH roll ball-type flexible control (item 28 of Figure 49) was found not connected to the RH roll crank (item 14 of Figure 49). Figure 51 shows the general condition of this component, as observed during the analysis of the wreckage.

Figure 51 - Location and general condition of the RH roll ball-type flexible control and RH roll bellcrank.

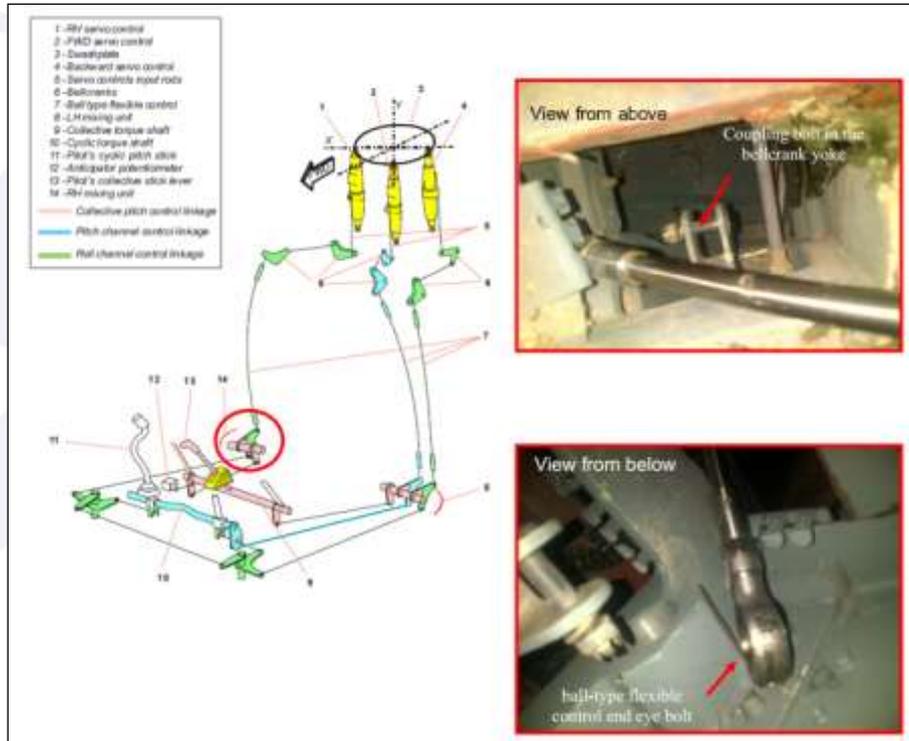
The bolt that was supposed to be fastening the right-hand side components was found intact, and lodged in the RH roll bellcrank, with its washer, and with the nut only partially screwed around the bolt thread, without application of torque, and without residues of anti-corrosion paste (CM 518 anti-corrosion agent). The bellcrank structure was intact. The RH roll ball-type flexible control was found not connected from the bolt - RH roll bellcrank assembly, as shown in pictures 52, 53, and 54. The cotter pin was not found.

Figure 52 - Location and detailed view of the RH roll ball-type flexible control disconnected from the RH roll bellcrank.

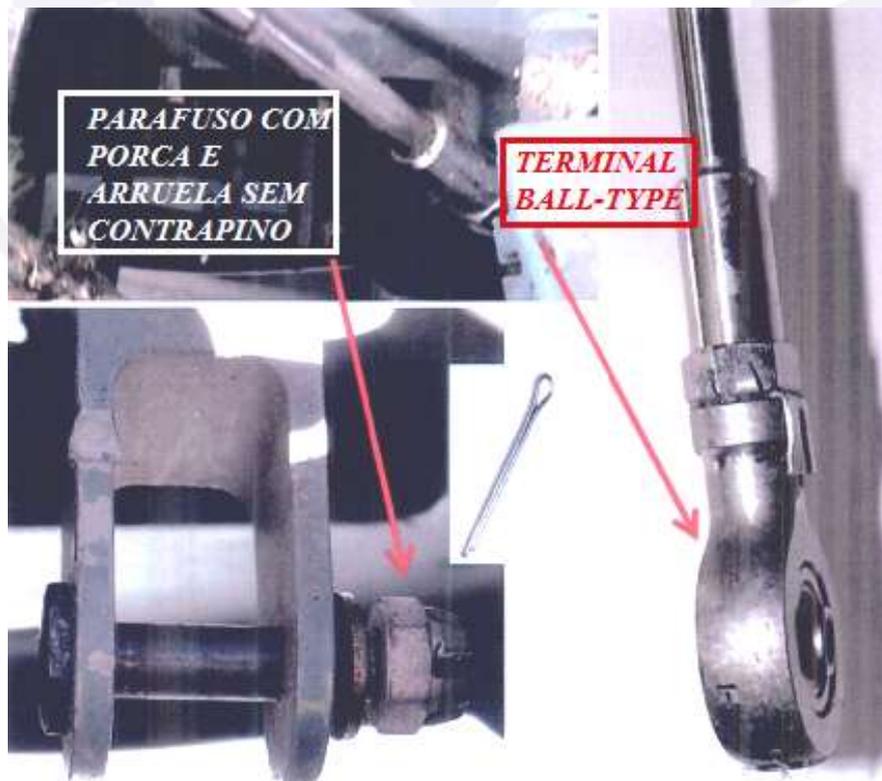
Figure 53 - RH roll ball-type flexible control and RH roll bellcrank as seen during the analysis of the wreckage.

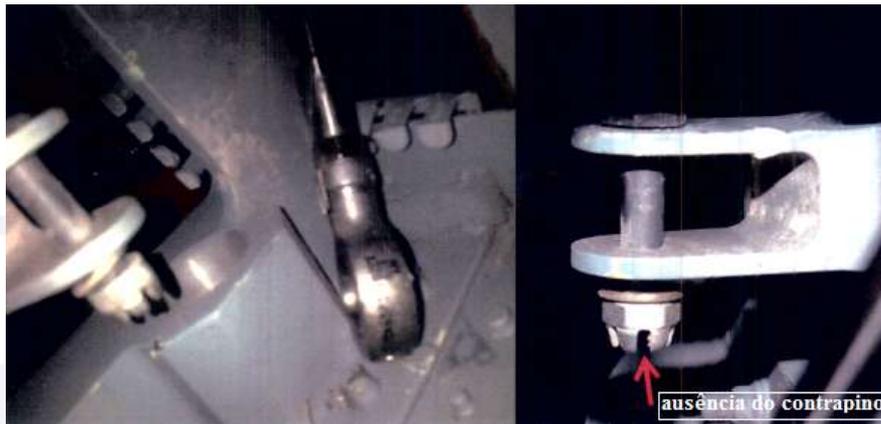
Figure 54 - RH roll ball-type flexible control and RH roll bellcrank found disconnected and without the cotter pin.

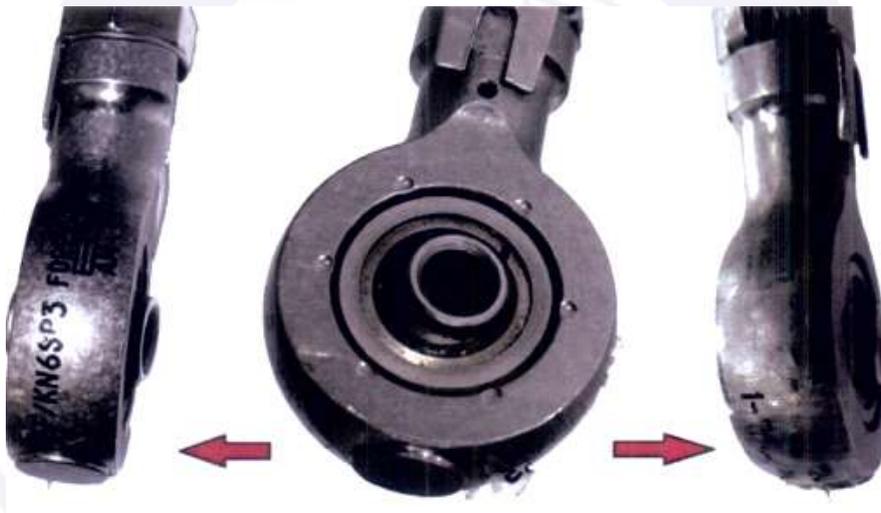
Figure 55 and Figure 56 show the wear of the polymeric tape on the end-fitting of the RH roll ball-type flexible control.

Figure 55 - End fitting of the RH roll ball-type flexible control. On the left, the arrow shows the part of the end-fitting without wear. On the right, the picture shows the part of the end-fitting with wear of the polymeric tape.

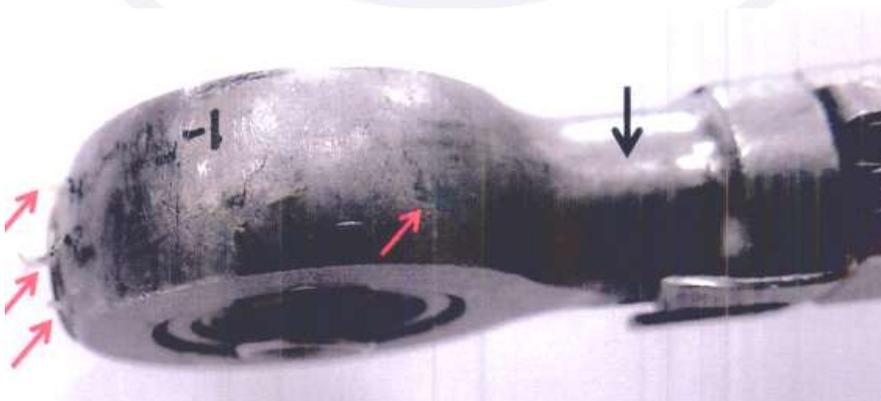
Figure 56 - Marks of friction on the end-fitting of the *RH roll ball-type flexible control*. Damaged polymeric layer is indicated by the red arrows, together with the area of strongest friction (black arrow).
