COMANDO DA AERONÁUTICA
CENTRO DE INVESTIGAÇÃO E PREVENÇÃO DE
ACIDENTES AERONÁUTICOS

FINAL REPORT
A - 001/CENIPA/2016

OCCURRENCE:	ACCIDENT
AIRCRAFT:	PP-LMM
MODEL:	C90GTI
DATE:	03JAN2016

This is the Final Report of the 03JAN2016 accident with the C90GTI aircraft, registration PP-LMM. The accident was classified as “Controlled Flight Into Terrain (CFIT)”.

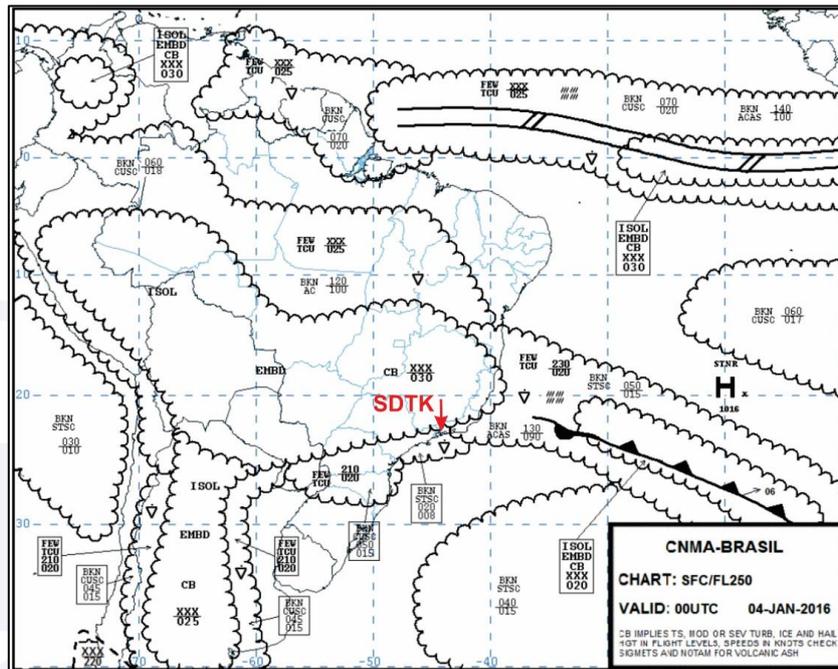
Figure 1 - 03JAN2016 SIGWX chart, valid until 04JAN2016, 00:00 (UTC).

The Significant Weather Chart (SIGWX) generated at 09:58 (UTC), valid until 00:00 (UTC), showed the presence of few Towering Cumulus (TCU) clouds based on 2,000ft and top in FL210. There was also the presence of Stratus (ST) and Stratocumulus (SC) clouds with base at 800ft and top at 2,000ft associated with rain showers (Figure 1).

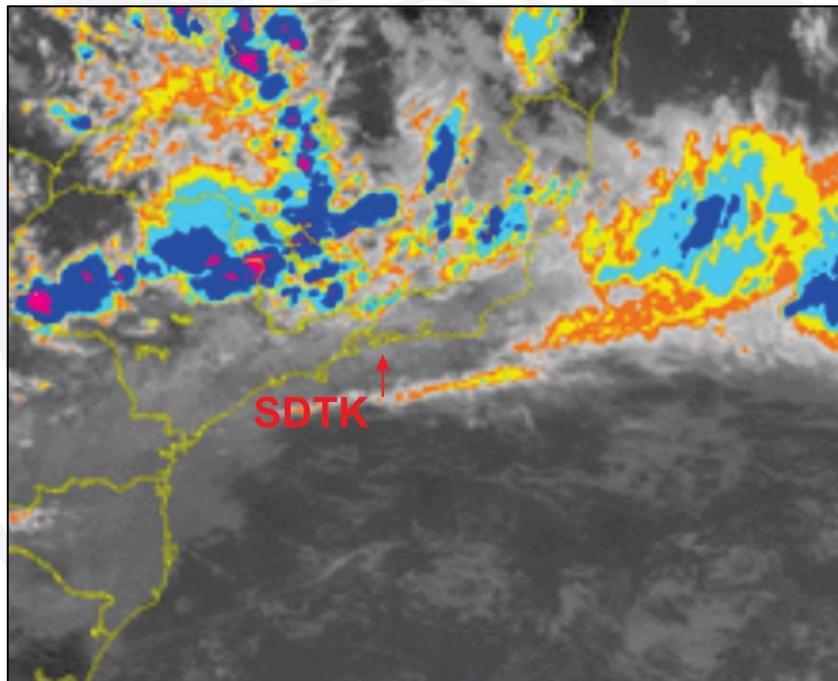
Figure 2 - Satellite image highlighted at 17:30 (UTC).

The satellite image of 17:30 (UTC) indicated the significant presence of cloudiness in the region of Paraty, RJ.

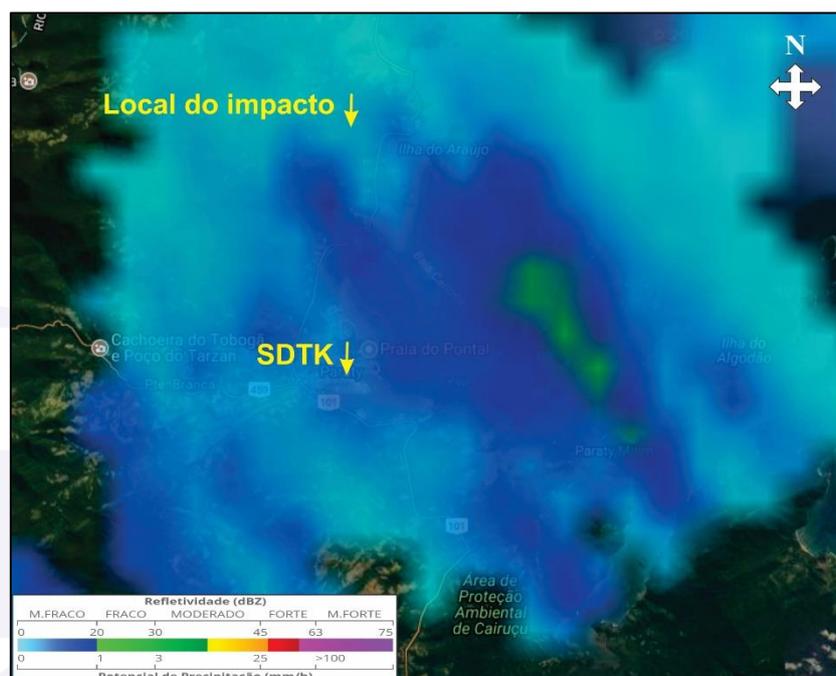
Figure 3 - Image of the meteorological RADAR of Pico do Couto, RJ at 17:20 (UTC).

Likewise, RADAR images from Pico do Couto, RJ, generated at 17:20 (UTC) showed the presence of precipitable water over the region of Paraty, RJ, especially on SDTK Aerodrome and the crash site of the PP-LMM aircraft (Figure 3).

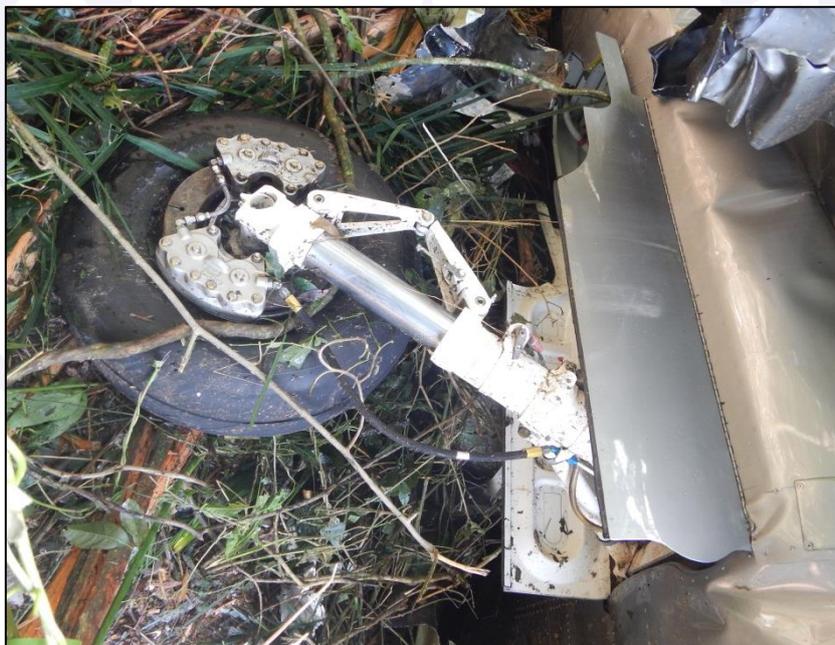
Evidence was found that, at the time of impact, the landing gear was not locked in up position.

Figure 4 - Landing gear outside its compartment.

Investigation data showed that the crew did not retract the landing gear during the second go-around procedure. This information was corroborated by the fact that the landing gear was found outside of its compartment at the point of impact, indicating that the crew forgot to perform this checklist item.

The fact that the landing gear was not retracted during the second go-around procedure indicated a failure, fostered by the possible forgetfulness of the crew, to perform the intended procedure.

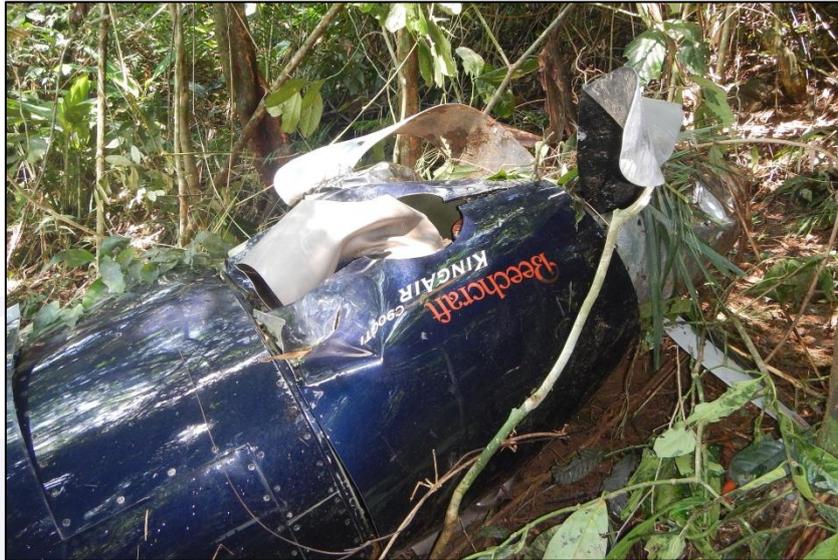
The left engine was found separated from the aircraft, upside down and with the propeller blades deformed. The right engine remained attached to the aircraft structure and also had significant deformations in the propeller. Both engines had evidences of high-speed collision.

Figure 5 - Left engine with deformation in the propeller.

The external damage on both engines indicated that the parts were developing power at the time of impact.

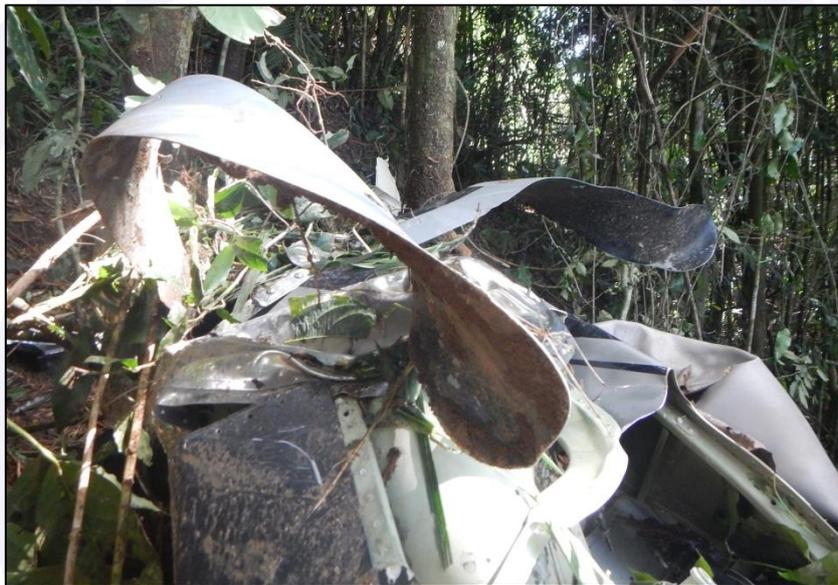
Figure 6 - Right engine with deformation in the propeller.
