COMANDO DA AERONÁUTICA
CENTRO DE INVESTIGAÇÃO E PREVENÇÃO DE
ACIDENTES AERONÁUTICOS

FINAL REPORT
A-060/CENIPA/2014

OCCURRENCE:	ACCIDENT
AIRCRAFT:	PP-SSP
MODEL:	R22 BETA
DATE:	23MAR2014

This is the Final Report of the 23MAR2014 accident with the R22 BETA aircraft, registration PP-SSP. It was classified as “[LOC-I] Loss of Control in Flight”.

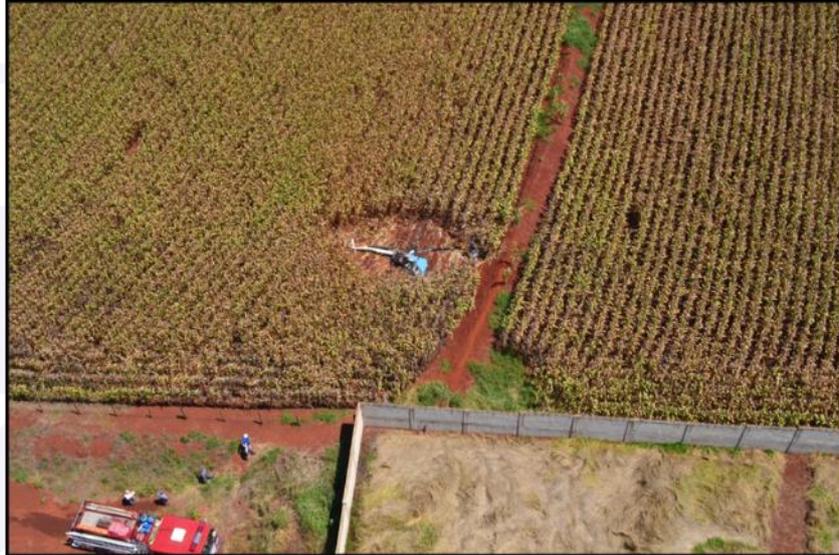
The aircraft was found in a cornfield and the marks on the vegetation indicated that the impact occurred in a wide-angle approach, with a high descent rate and practically no linear displacement.

The collision of the main rotor blades against the vegetation formed a circular area around the aircraft (Figure 1).

Figure 1 - Aerial photo of the accident site.

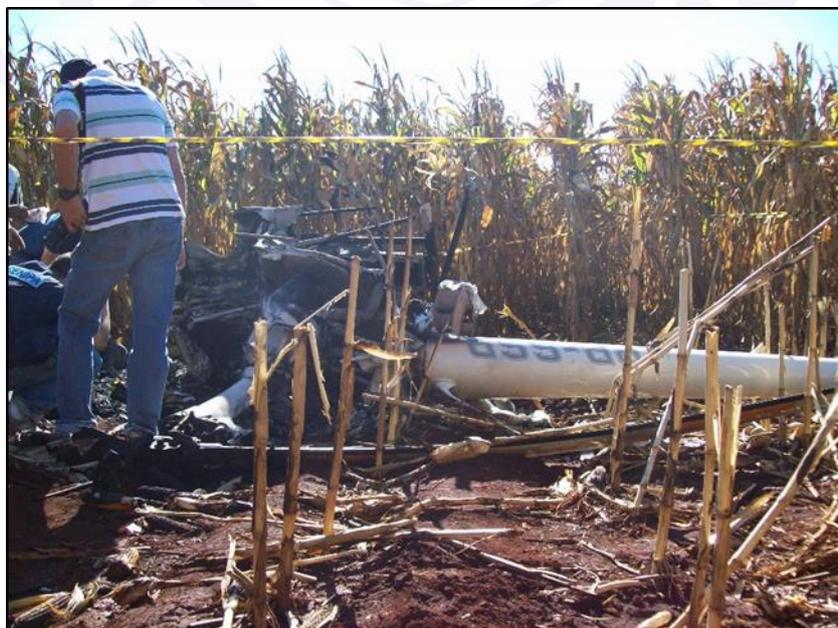
The skis were severely damaged, and even fractured and detached from the rest of the structure. The aircraft tipped over to the left side.

There was still a deflection in the main rotor blades but there was no impact marks at the leading edge, and the tail rotor blades were found to be quite twisted.

There was fire after the impact (Figures 2 and 3).

Figure 2 - Overview of the aircraft.

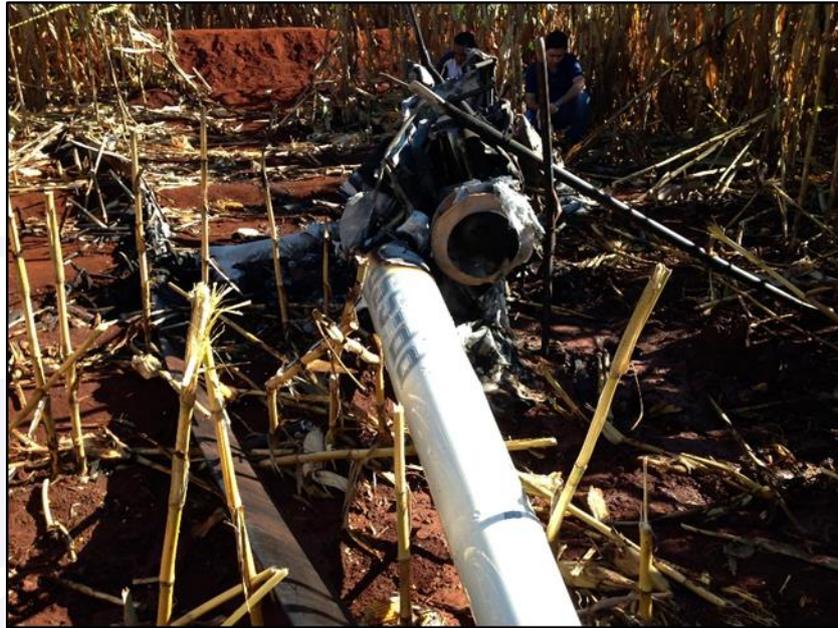
Figure 3 - View of the tail cone and cabin of the aircraft.

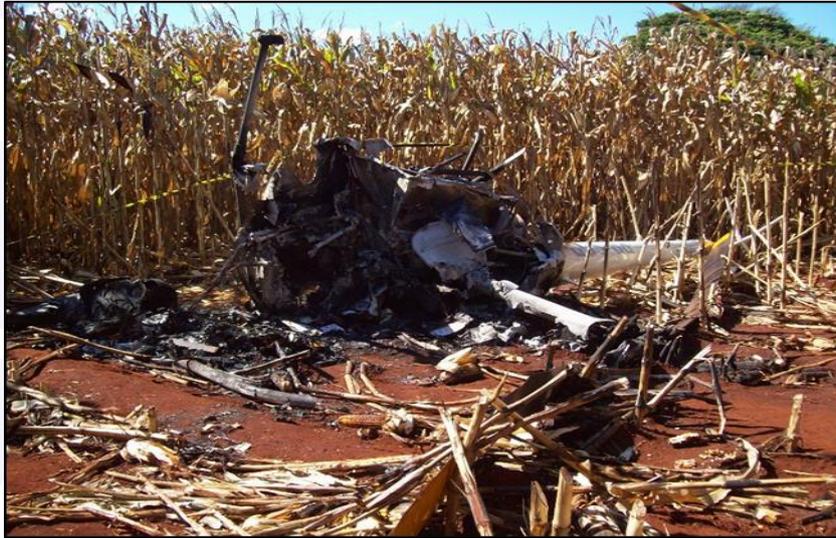
There was fire in the wreckage of the aircraft, focusing on the location corresponding to the fuel tank, which spread throughout the cabin area, reaching also part of the mast and the root of the main rotor blades.

The fire occurred after the impact, due to the rupture of the fuel tank.

Figure 4 - Destruction caused by fire.

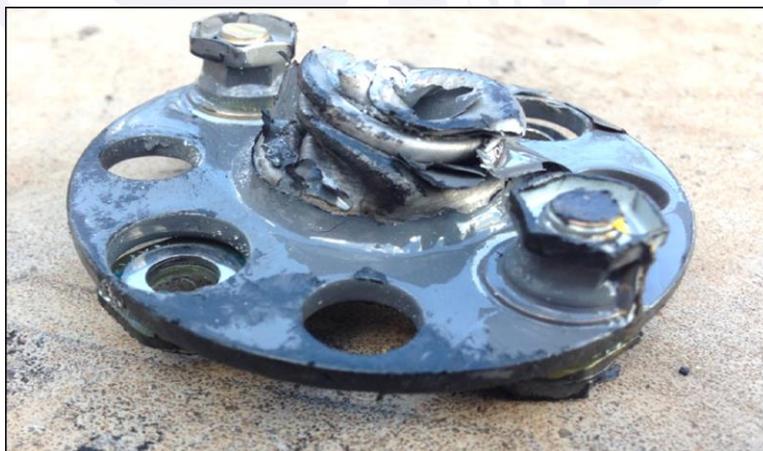
The engine had indications that it was operating normally. In the tail rotor drive shaft, it was evidenced that, at the moment of the collision against the ground, there was rotation and development of torque in the set.

The torsion of the shaft, along with the coupling flange with the engine, is the strongest evidence that there was no problem with the engine and the transmission assembly. In the reduction box, there was also no anomaly that could contribute to the occurrence.

Figure 5 - Shaft / flange assembly with torsion marks and cracks at break site.
