**COMANDO DA AERONÁUTICA**  
**CENTRO DE INVESTIGAÇÃO E PREVENÇÃO DE**  
**ACIDENTES AERONÁUTICOS**

**FINAL REPORT**  
**IG-105/CENIPA/2017**

<b>OCCURRENCE:</b>	<b>SERIOUS INCIDENT</b>
<b>AIRCRAFT:</b>	<b>PR-AVC</b>
<b>MODEL:</b>	<b>A319-115</b>
<b>DATE:</b>	<b>19JUL2017</b>

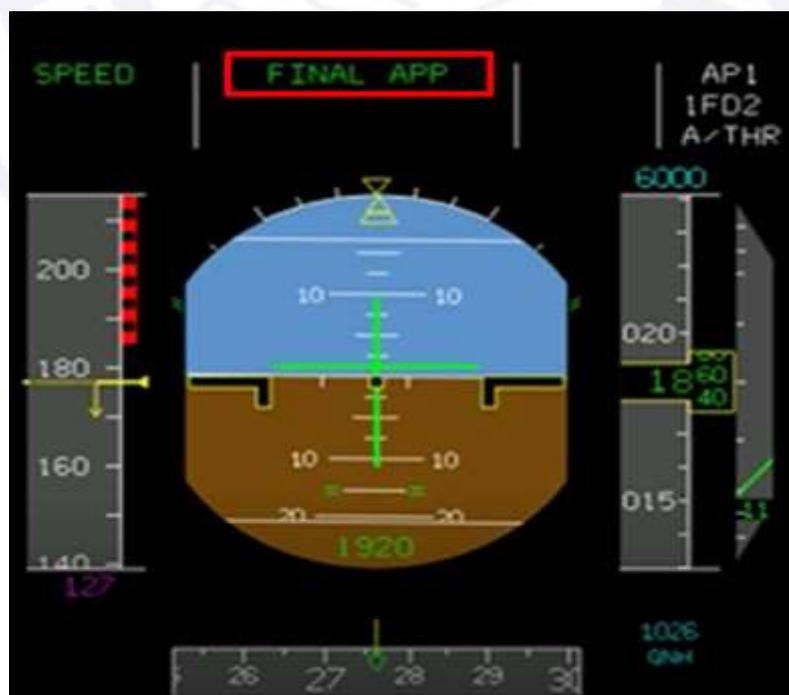
Figure 14 - Highlight in red for the "FINAL APP" mode engaged in the pilot's PFD.

According to data collected from QAR, it was observed that the approach was initiated in FINAL APP mode, as agreed in briefing, but, after passing the Final Approach Fix (FAF - position GL142 of the procedure), the commander selected the Vertical Speed (V/S) guiding mode and entered a descent rate of 1.400ft / min.

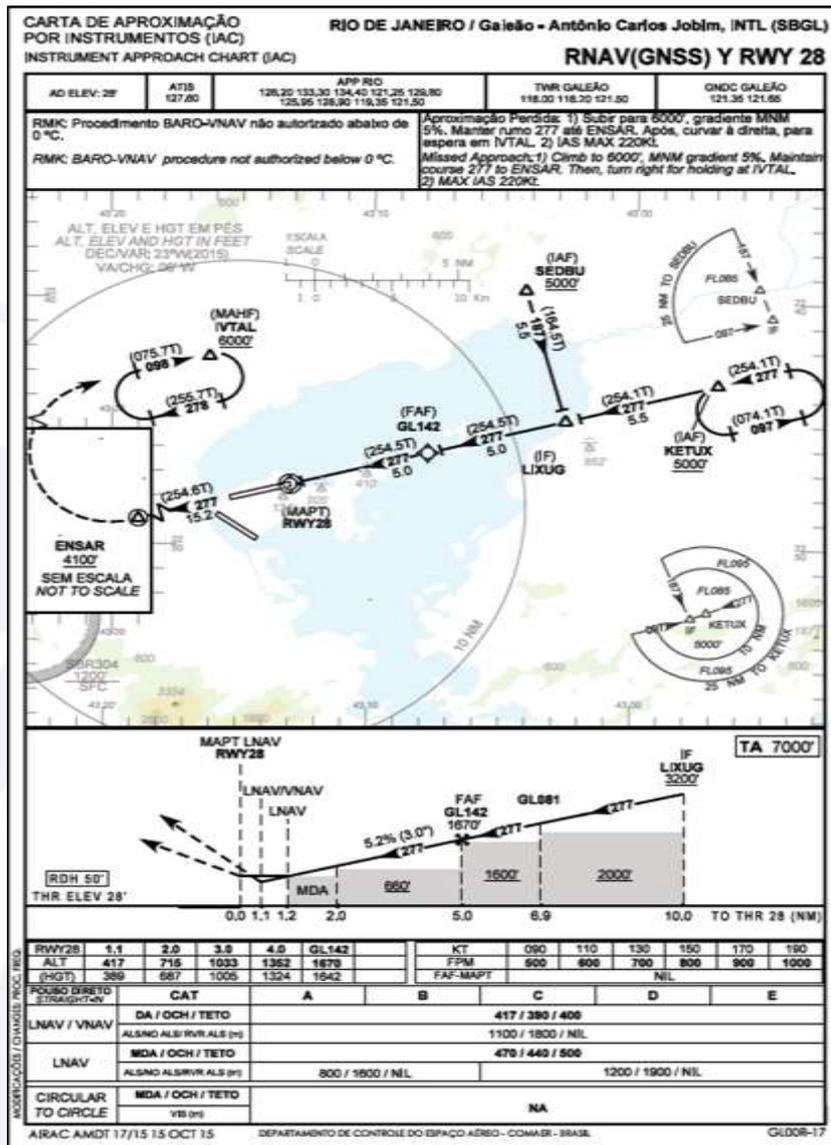
Figure 19 - DECEA chart without indication of the fix GL083 between FAF and MDA.

Unlike the Jeppesen chart (used by the crew), the DECEA chart, referring to the RNAV Y NWY 28 procedure of Galeão, did not include the indication of the fix GL083, despite presenting the restriction of descent in the predicted position, marked by the distance of 2 NM of threshold 28, as shown in Figure 19.

Although it did not contribute to the event, the Investigation Team noted that there was a slight difference between the Jeppesen chart (used by the crew) and the respective DECEA chart, regarding the indication of the Stepdown Fixes of RNAV Y RWY 28 of SBGL.

However, comparing with the respective DECEA chart (Figure 19), it was observed that point GL083 was not explicitly presented in the procedure.

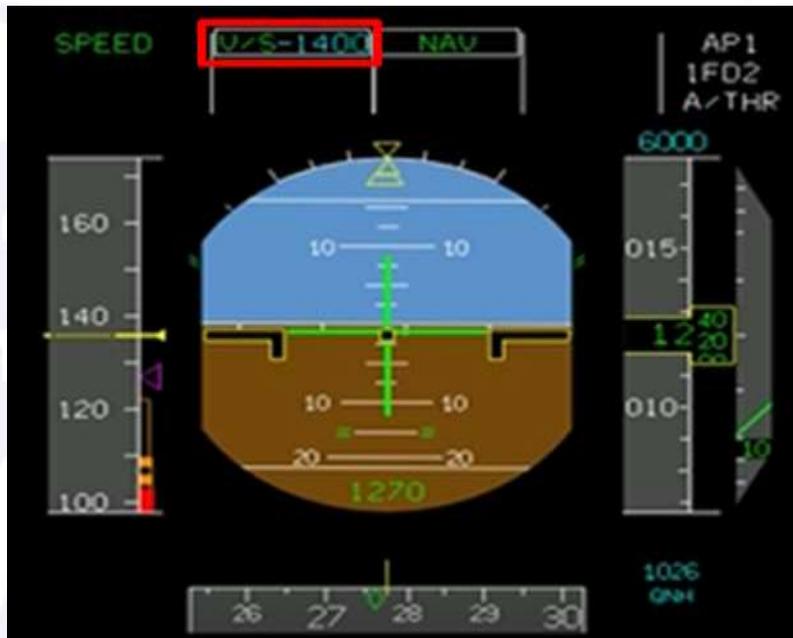
Figure 21 - Representation of the PFD with a red marking (our emphasis), highlighting the V/S (Vertical Speed) mode connected with a selected ratio of 1.400ft./min.

As already mentioned, the pilots had previously established, in briefing, that they would carry out the procedure in the FINAL APP mode. However, shortly after passing over the final approach FIX (FAF) of the procedure, the commander selected the Vertical Speed (V/S) mode, which caused the aircraft to exit the managed/managed FINAL APP condition and operate in the managed/selected condition (in this case, with V/S connected).

The use of V/S mode was not contemplated in the company's FCOM as one of the guidelines allowed in the execution of RNAV procedures. According to the cross-reference table shown in Figure 13, the guidance modes authorized using LNAV navigation were only the FINAL APP (recommended) or NAV FPA.

For purposes of illustration, Figure 21 represents the information contained in aircraft PFDs, based on data obtained from QAR, demonstrating a flight moment when the V/S mode is connected with a descent rate of 1,400 ft. / min selected by the crew.

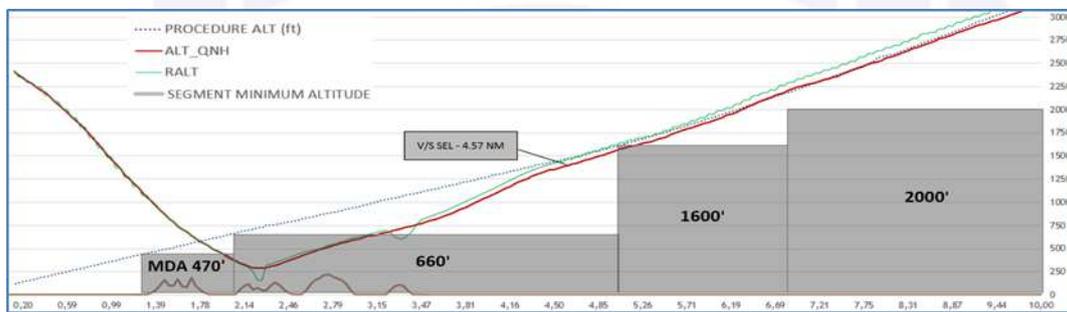
Figure 22 - Graphical representation of a constant slope prevised for an aircraft complying with the restrictions of the SBGL RNAV Y RWY 28 procedure, in contrast with the slope performed by the PR-AVC aircraft crew.

It is possible to identify in this Figure: a blue dotted line, representing the slope of the aircraft, if the FINAL APP mode was engaged; a red line, representing the slope performed by the crew; a green line representing the radio altimeter indication (RALT); the point at which the V/S mode was selected; the segment altitude constraints imposed by each Stepdown Fix and a relief reference, considering a cut of the topography on the approach axis, represented by a brown line.

Figure 22 clearly illustrates the points where the aircraft trajectory exceeded the GL083 and MDA constraints. It is possible to identify that the MDA was exceeded in a position previous to the one in which, there would be the limitation imposed by GL083.

At the lowest point of the trajectory, the position of the Too Low, Terrain alarm, the presence of elevations in the terrain resulted in a lower indication of altitude when compared to the barometric altitude. In any case, the radio altimeter information reflected the actual condition of the aircraft's proximity to the relief.
