FINAL REPORT
A-139/CENIPA/2015

OCCURRENCE:	ACCIDENT
AIRCRAFT:	PR-DMT
MODEL:	150H
DATE:	22OCT2015

This is the Final Report of the 22OCT2015 accident with the 150H aircraft, registration PR-DMT. It was classified as “Loss of Control in Flight”.

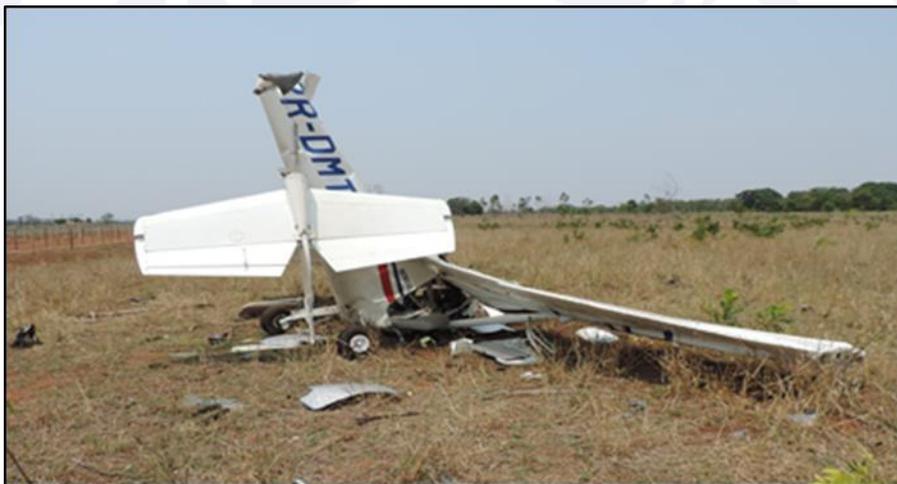
On the right side, in the middle portion of the runway, a reversal left curve with a high bank angle was commanded. There was loss of control of the aircraft in flight and consequent collision against the ground.

Figure 1- Overview of PR-DMT.

The aircraft crashed into the ground, in a practically vertical trajectory and with an angle of approximately 270° out of the direction of flight.

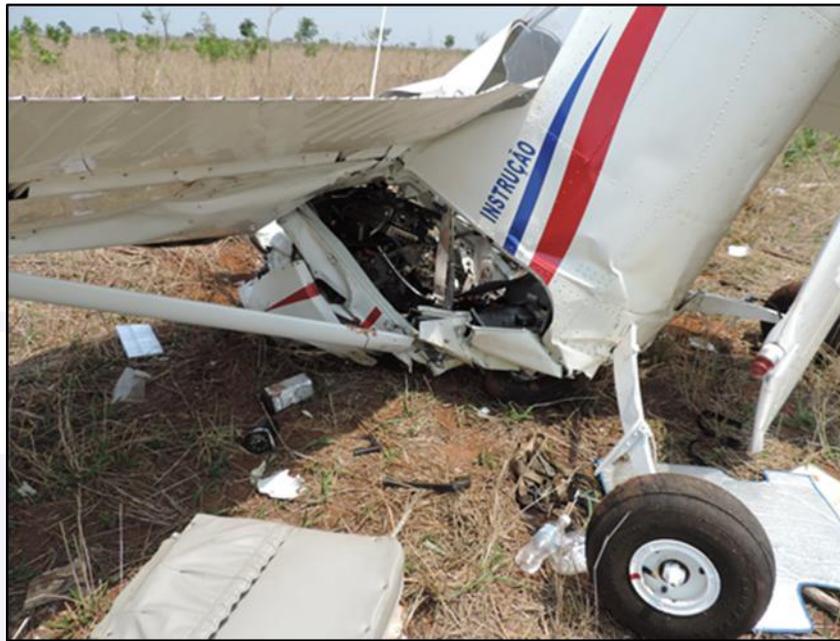
The aircraft had substantial damage to the engine and its entire structure (Figure 2).

Figure 2 - Damage to the engine and cabin of the aircraft.

The engine that equipped the aircraft was operational and showed evidence that it was in low rotation, probably idle, at the moment the aircraft collided against the ground. Due to the fact that no mechanical fault was detected in the engine analysis, the possibility of pilot-controlled action for "idle" should be considered in this case.
