**FINAL REPORT**  
**A - 125/CENIPA/2016**

<b>OCCURRENCE:</b>	<b>ACCIDENT</b>
<b>AIRCRAFT:</b>	<b>PR-DTA</b>
<b>MODEL:</b>	<b>E55</b>
<b>DATE:</b>	<b>22SEPT2016</b>

This is the Final Report of the 22SEPT2016 accident with the E55 aircraft, registration PR-DTA. The accident was classified as “[LOC-I] Loss of Control in-Flight”.

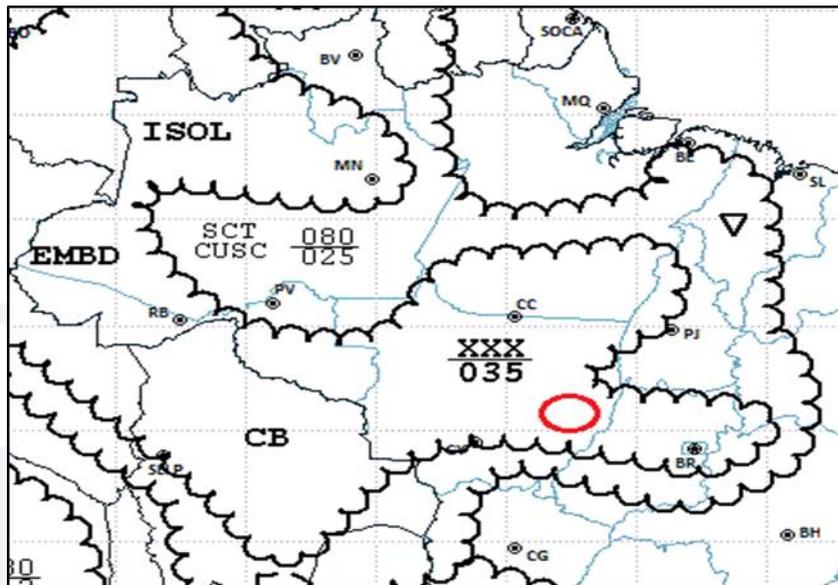
Figure 1 - Location of the occurrence highlighted in red.

This chart showed the probability of cloud formation of the Cumulonimbus type, embedded, based on 3,500ft to unlimited (XXX).

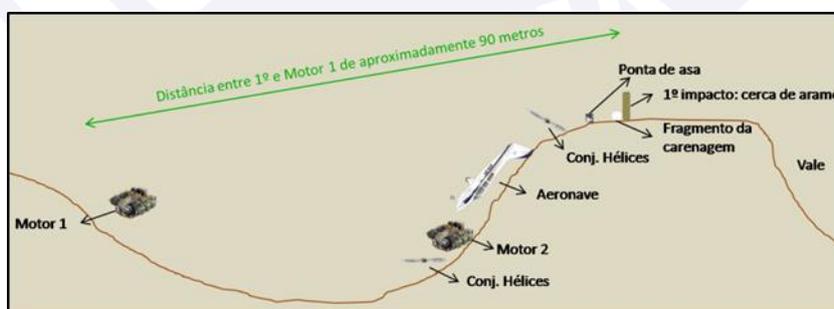
The accident occurred in a rural area, in the municipality of Campinápolis - MT. The accident area was in the shape of a depression, being flat in the vicinity of the first impact and downhill after a few meters. The distribution of the wreckage was of the linear type (Figure 2).

Figure 2 - Sketch of the accident dynamics (view of the relief cut).

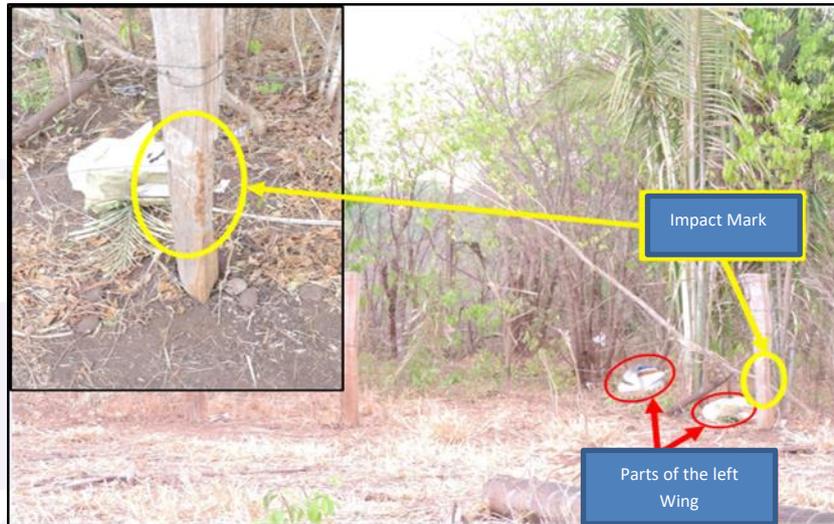
The first impact of the aircraft occurred on the fence that delimited a private property, breaking the barbed wire and leaving marks on the fence where it was fixed.

Parts of the left wing tip indicate that the impact occurred with this wing, suggesting that the plane was practically on the back, with a lateral slope of about 120° to the right, with a leveled nose (Figure 3).

Figure 3 - View of the first impact area and the trajectory of the aircraft.

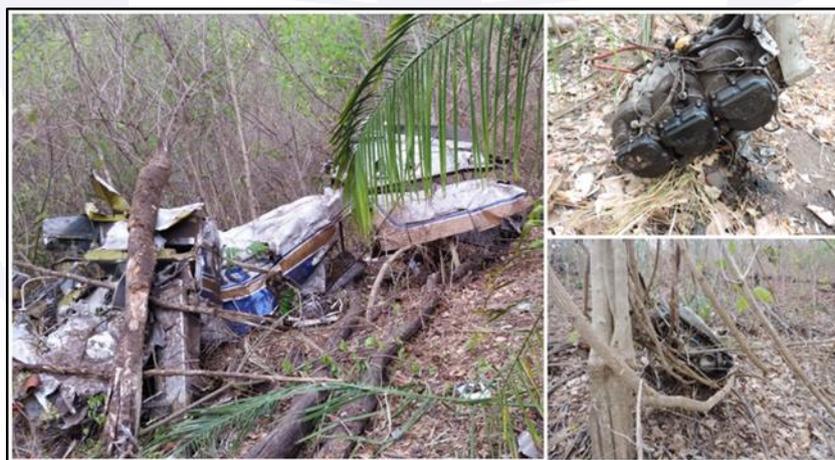
The fuselage was found in the back position, in the sloped area and separated from the engines (Figure 4).

Figure 4 - Fuselage resting on back and separate engines.
