**COMANDO DA AERONÁUTICA**  
**CENTRO DE INVESTIGAÇÃO E PREVENÇÃO DE**  
**ACIDENTES AERONÁUTICOS**

**FINAL REPORT**  
**A - 150/CENIPA/2015**

<b>OCCURRENCE:</b>	<b>ACCIDENT</b>
<b>AIRCRAFT:</b>	<b>PR-EDL</b>
<b>MODEL:</b>	<b>R66</b>
<b>DATE:</b>	<b>11NOV2015</b>

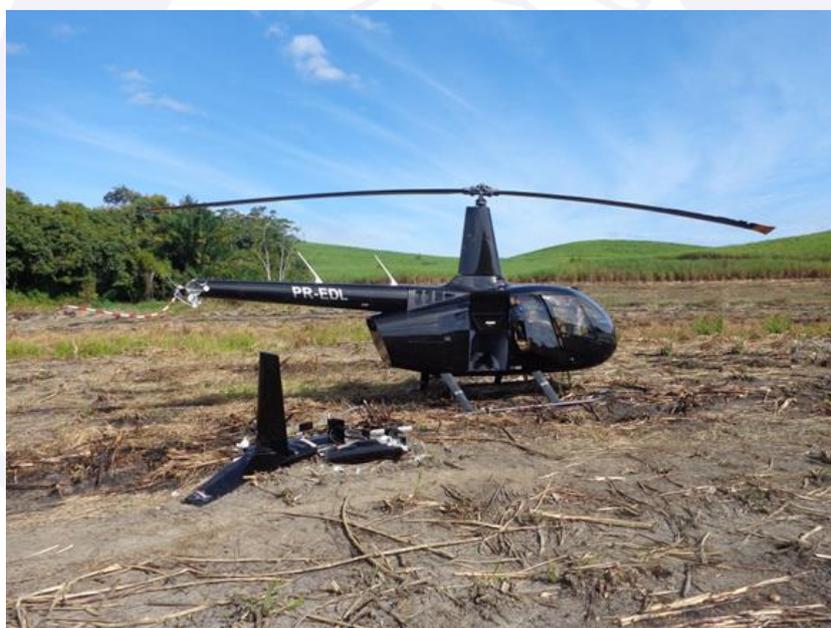
During the landing, the main rotor blade cut off the tail cone of the helicopter (Figure 1).

Figure 1 - Overview of the aircraft at the crash site.

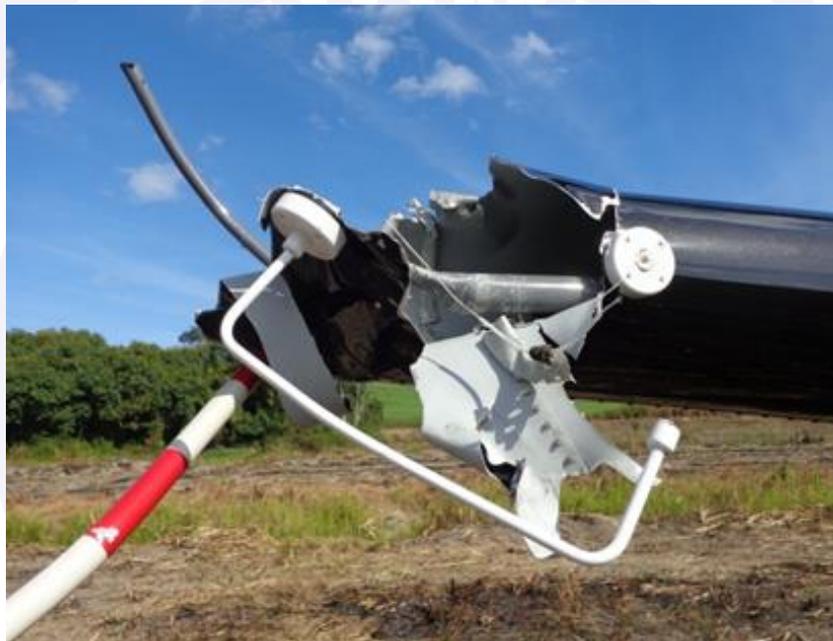
When performing the auto-rotation, when the aircraft touched the ground, the blades of the main rotor collided against the rear fuselage, resulting in the sectioning of the tail cone of the aircraft (Figure 2).

Figure 2 - View of the sectioned tail cone.

The sudden application of the cyclic control backwards during the emergency landing was decisive for the shock between the main rotor blades and the tail cone of the aircraft.

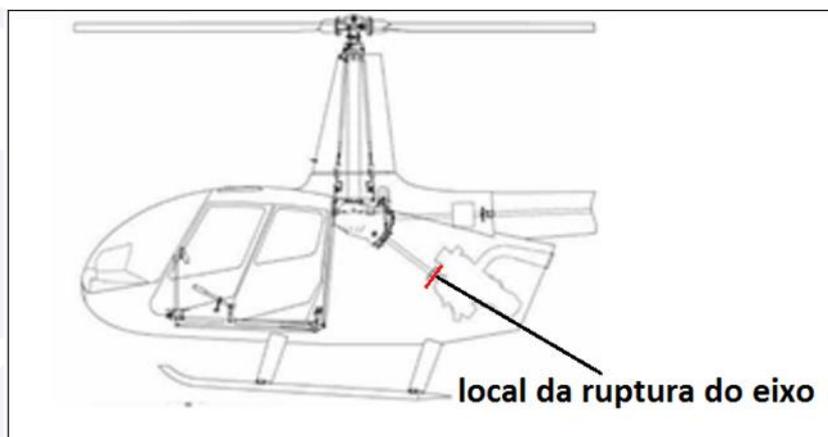
At the site of the accident, researchers from the Aeronautical Accident Investigation and Prevention System (SIPAER) identified a rupture in the shaft weldment, which presented corrosion aspects (Figures 3 and 4).

Figure 3 - Shaft Weldment shown in the set.

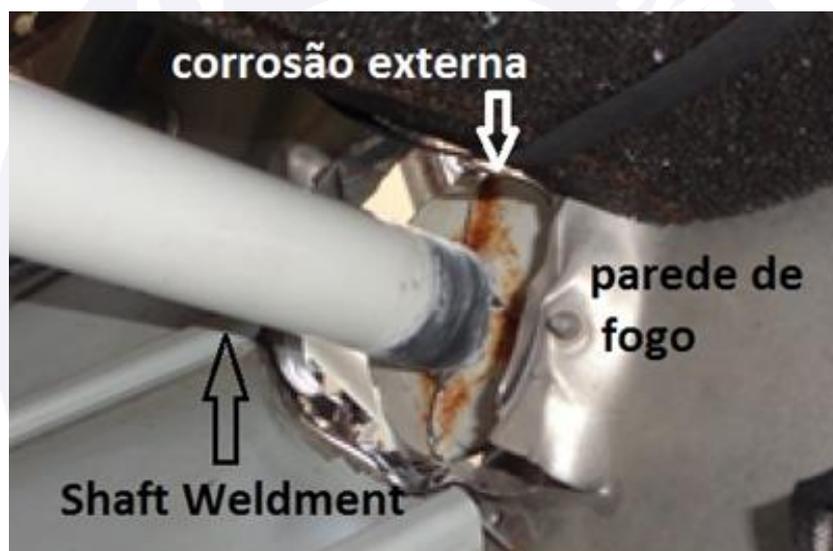
Figure 4 - View of the damaged component.

"The fracture of the analyzed power axis occurred by a mechanism of fatigue under twist, probably initiated in the region of the weld next to the deflector. The exact initiation of the fatigue process could not be determined due to the damage suffered after the shaft rupture. Despite this, there is evidence of corrosion in regions close to the fracture, which indicates that pites of corrosion may have facilitated the initiation of the fatigue process. Corrosion observed in the deflector region, both externally and internally, indicates that this region must undergo periodic inspections to verify and remove corrosion. It is also necessary to verify the need to apply protective paint on the inside of the tube of the power shaft".

The analyzes performed by the IAE / DCTA showed that there was a shaft weldment due to a torsional fatigue mechanism probably started in the region of the weld near the baffle. There were also signs of corrosion in the regions close to the fracture, which indicated that pites of corrosion could have contributed to the initiation of the fatigue process.

Acting with the manufacturer of the aircraft, seeking a better detailing of the weldment inspection criteria, on the 100-hour inspection card of the R66 aircraft, notably with regard to the identification of corrosion points in the weldment shaft in the front and back parts of the firewall.

Acting with the aircraft maintainer to ensure proper compliance with the shaft weldment inspection procedures established on the R66 model aircraft inspection card, specifically with regard to the identification of corrosion points on the weldment shaft, in the front and back parts of the firewall.

Analyze the feasibility of issuing an Airworthiness Directive based on the procedures described in R66 SERVICE BULLETIN SB-16 and R66 SERVICE BULLETIN SB 17 from the Robinson Helicopter Company.

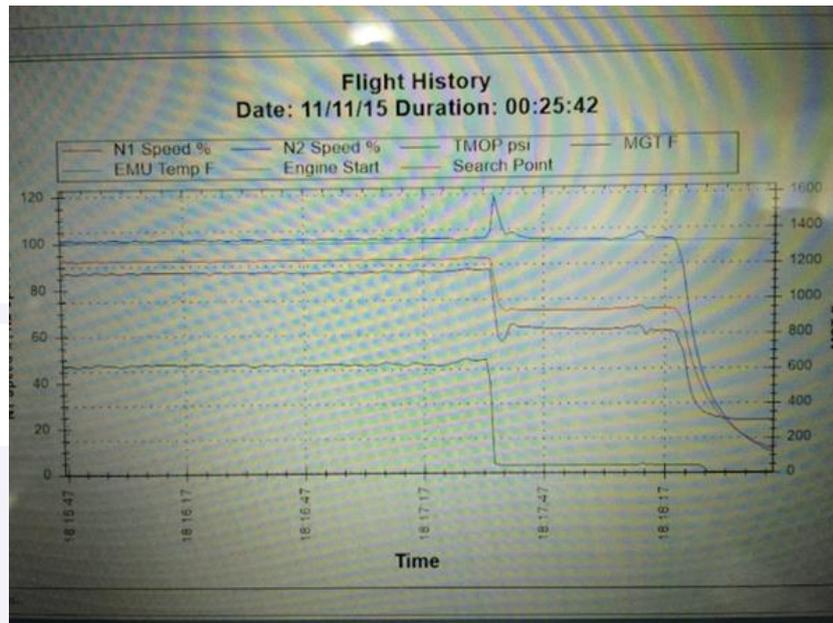
The analysis of the data extracted from the Engine Monitoring Unit (EMU) indicated that, at the beginning of the occurrence, the stable parameters characteristic of the cruise flight were interrupted by a sudden increase in N2. The decrease of the other engine parameters was also evidenced, as shown below in Figure 5.

Figure 5 -Variation of the engine parameters moments before the accident.

The data extracted from the EMU indicated that there was a sudden increase in the value of N2 and the decrease of the other parameters, evidencing that, during the cruise flight, a sudden decrease occurred in the workload that the engine performed, being possible to associate this fact to the sudden collapse of the shaft weldment.

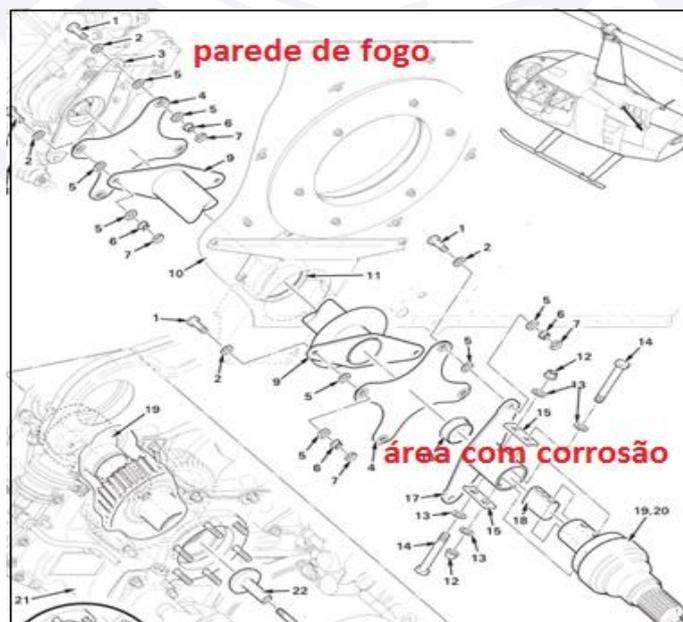
Subsequently, some R66 model aircraft operators, who were not subject to compliance with R66 SERVICE BULLETIN SB-16, identified that the weldment shaft had corrosion points on the back of the aft. weldment area, as identified in Figure 6 below.

Figure 6 - Engine shaft weldment.

These facts led to the issuance of DIVOP No. 01/2016, on 03FEB2016, of CENIPA, which dealt with the inspection of component parts (shaft weldment). DIVOP recommended that helicopter maintainers, model R-66, should adopt judicious procedures to perform the inspection of the critical parts of the shaft weldment, before and after the firewall, in order to comply with the recommendation of the 100-hour inspection card.
