FINAL REPORT
IG-187/CENIPA/2013

OCCURRENCE:	SERIOUS INCIDENT
AIRCRAFT:	PR-EKN
MODEL:	BK 117 C-2
DATE:	15OCT2013

This is the Final Report of the 15OCT2013 serious incident with the BK 117 C – 2 aircraft, registration PR-EKN. It was classified as “Others”.

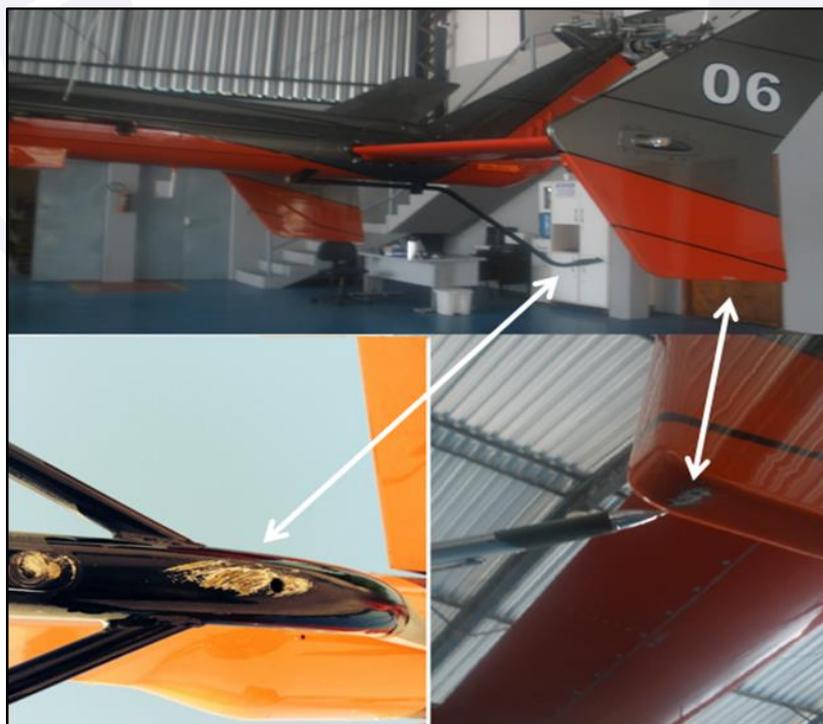
After the engine shutdown, it was observed that the aircraft had minor damage in the tail guard and left vertical stabilizer.

The aircraft had minor damage in the tail guard and in the left vertical stabilizer.

Figure 1 - Damage caused in the vertical stabilizer and tail guard.

It was observed that the touch of the tail guard and left vertical stabilizer of the helicopter against the ground was the result of the momentary loss of the view of the terrain by the pilot, after the appearance of a dense cloud of dust, characteristic of the brownout.

The occurrence of brownout during the landing decreased the situational awareness of the pilot, influencing his performance, making it difficult to control the aircraft, which caused the collision of the vertical stabilizer and the tail guard against the ground.

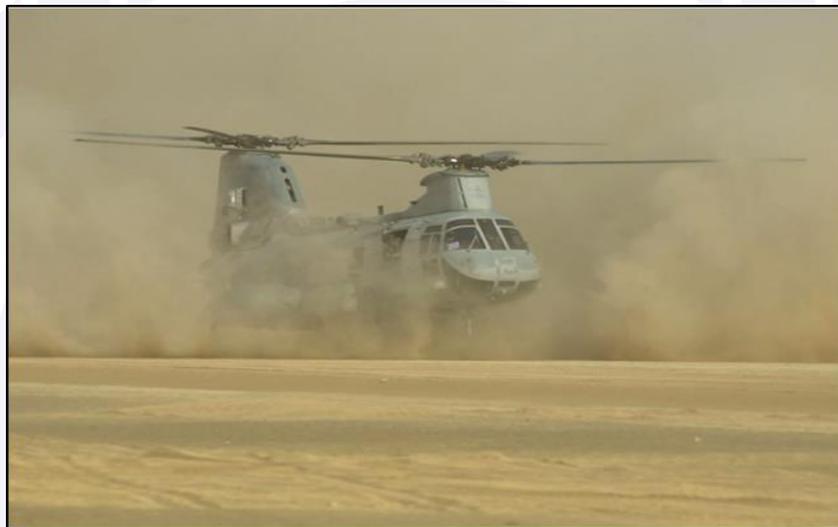
The landing and takeoff of a helicopter on a sand or dusty terrain may produce a dense cloud and lead to the pilots' disorientation. This phenomenon is known as brownout and can cause an aeronautical occurrence.

Figure 2 - Occurrence of brownout at takeoff (illustrative image).

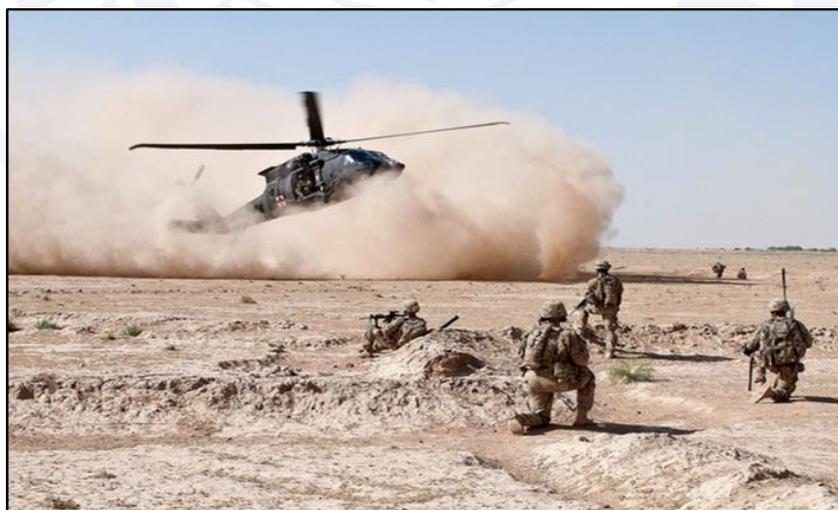
During the occurrence of brownout, air recirculation and flat surface runoff produced by the rotating wings (main rotor) cause clouds of dust to appear, making it difficult to see the external references by the pilot.

Figure 3 - Occurrence of brownout in the landing (illustrative image).
