**FINAL REPORT**  
**A-191/CENIPA/2013**

<b>OCCURRENCE:</b>	<b>ACCIDENT</b>
<b>AIRCRAFT:</b>	<b>PR-GPM</b>
<b>MODEL:</b>	<b>AS 350 B2</b>
<b>DATE:</b>	<b>22OCT2013</b>

This is the Final Report of the 22OCT2013 accident with the AS 350-B2 aircraft, registration PR-GPM. The accident was classified as "Engine Failure In-Flight".

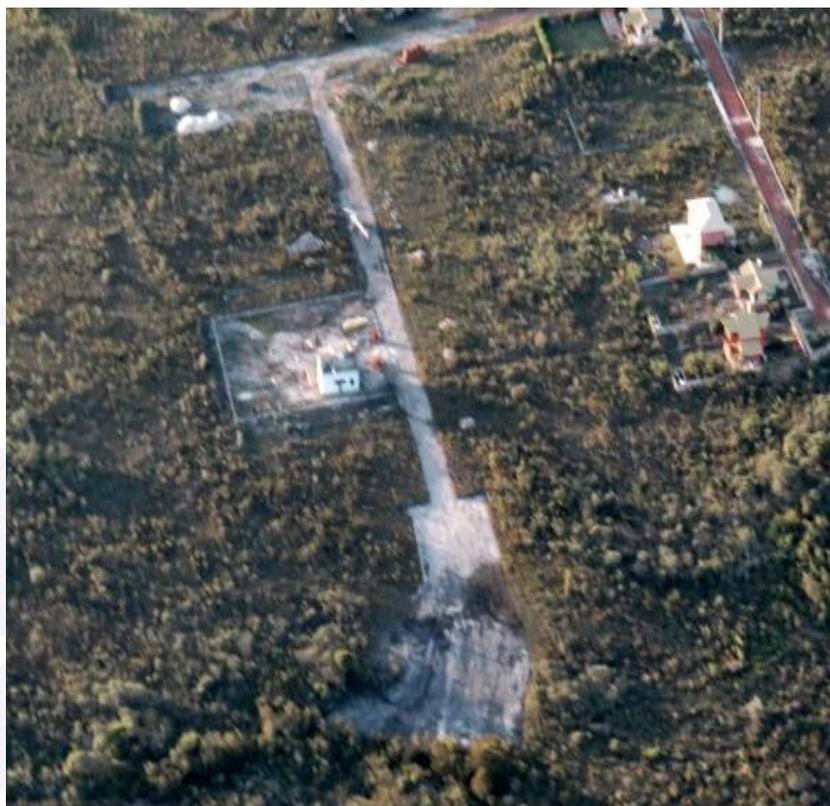
After the impact on the ground, the aircraft moved approximately five meters ahead, dragging itself, leaning on the front of the skis until full stop (Figures 1 and 2)

Figure 1 - Overview of the accident site.

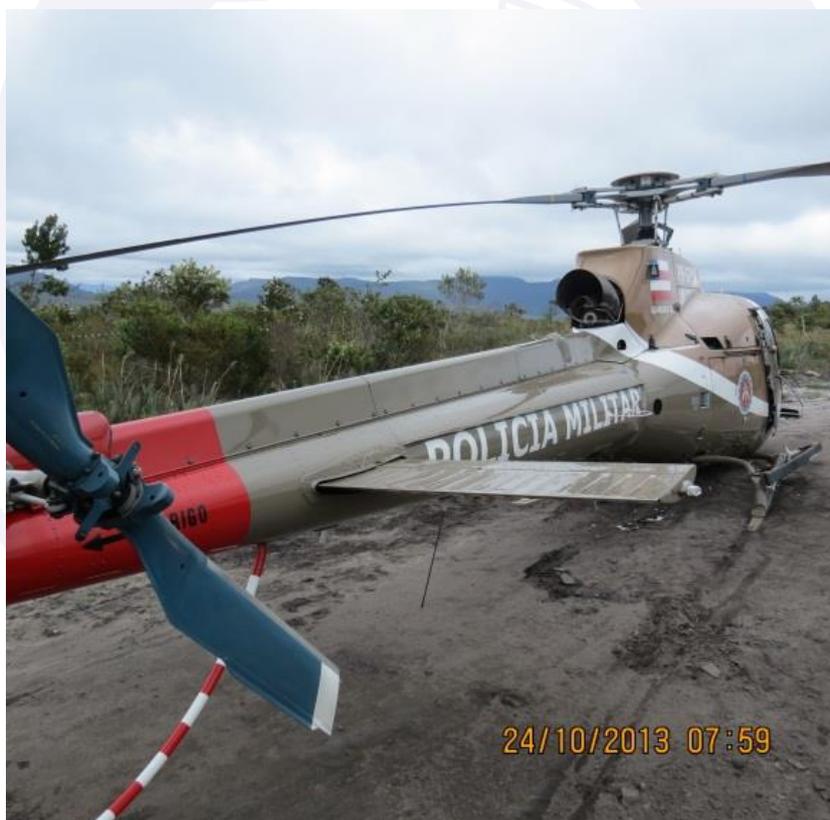
Figure 2 - View of the aircraft marks on the ground.

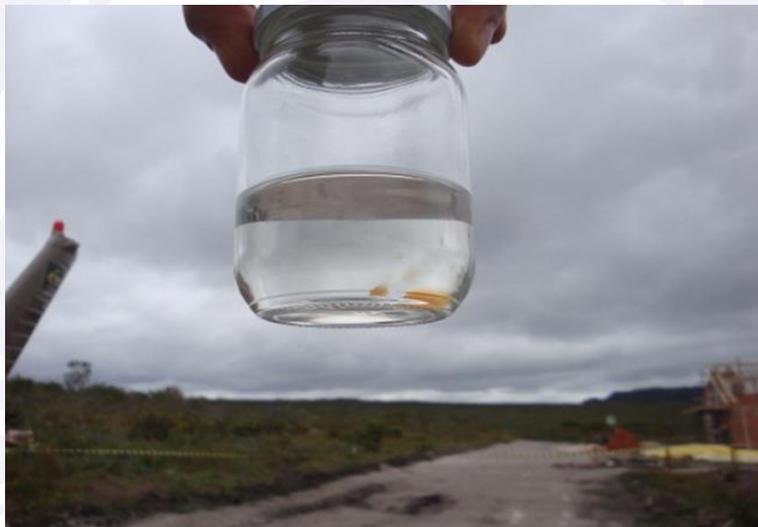
Fuel samples were collected from the aircraft and the tanker truck (CTA). In both cases, it was observed the presence of a light brown substance in the collected fuel, as well as the presence of an analogous substance inside the CTA filters (Figures 3 and 4).

Figure 3 - Sample of fuel collected from the aircraft at the accident site.

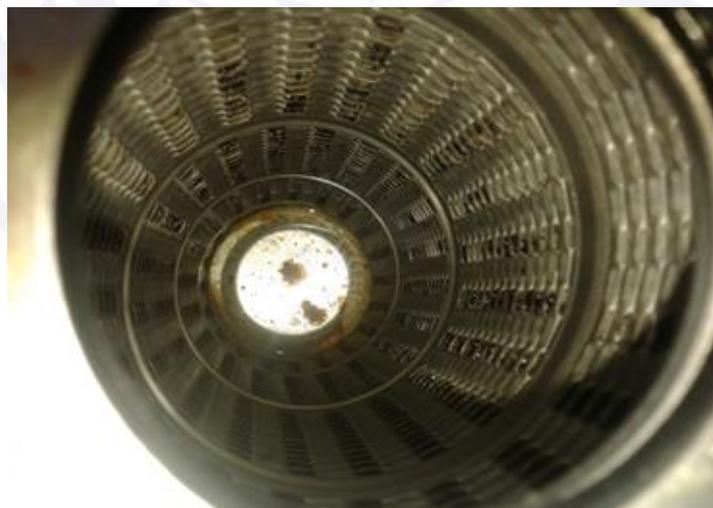
Figure 4 - Aspect of the internal part of the CTA filter body.

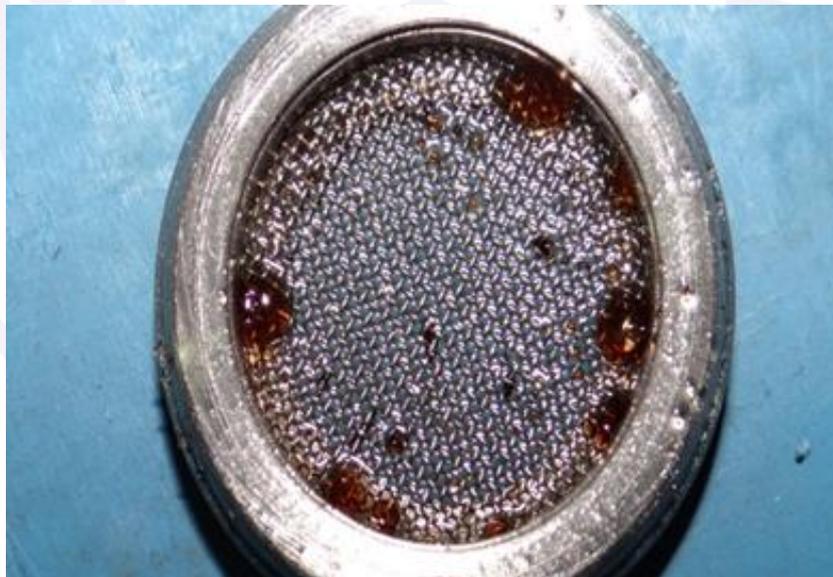
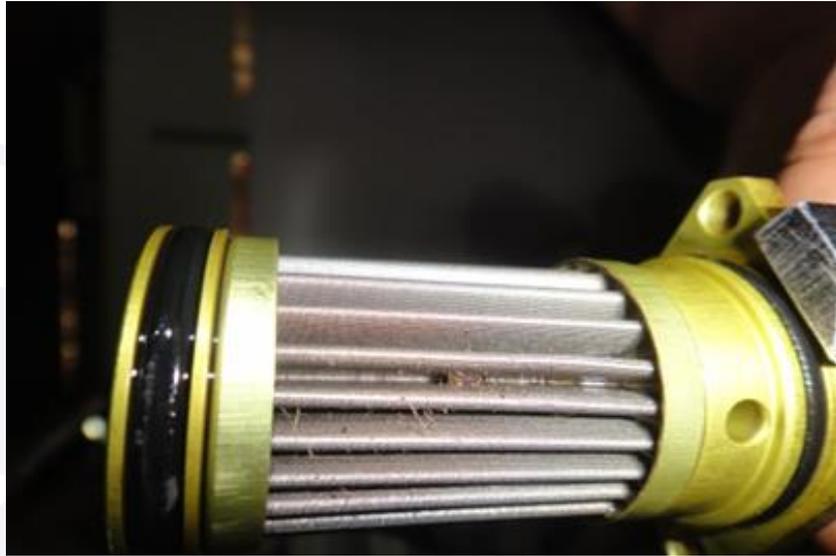
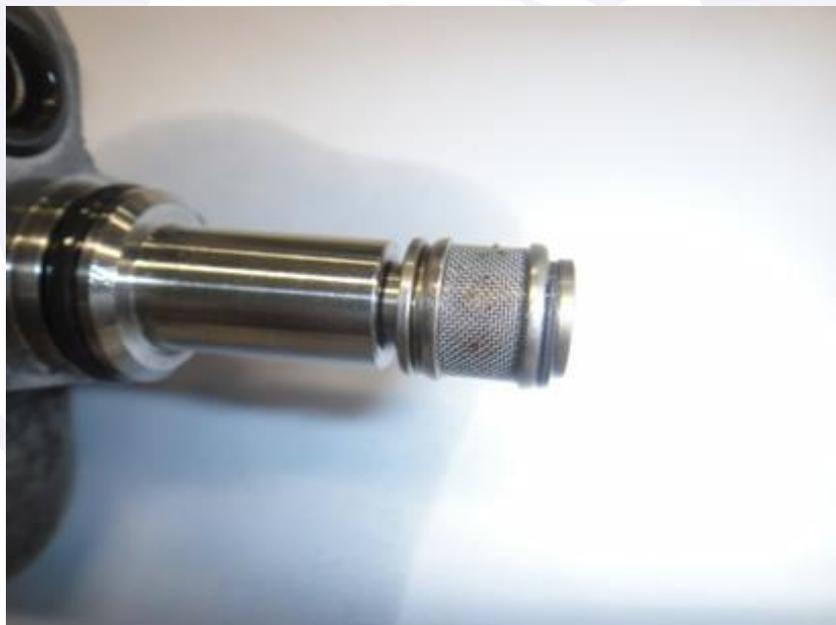
- the intake filter, the main filter and the filter of the amplifier piston of the FCU presented contamination with a characteristic similar to that found at the accident site;
- The metering valve was inoperative and locked in the closed position. The valve was driven to the open position by its drive lever, but no success was achieved; and
- the free turbine shaft started to rotate normally, without friction, at the time of the uncoupling between the high pump / FCU and the gearbox.

Figure 5 – FCU's input filter, netting type.

Figure 6 - FCU main filter.

Figure 7 – FCU's filter of the amplifier piston.

After the visual identification of this contamination (Figures 5, 6, 7, 8, 9, 10, 11 and 12), contaminant samples were collected and analyzed in the laboratory. The analyzes found that the residue found was polyacrylic acid salt (sodium polyacrylate)

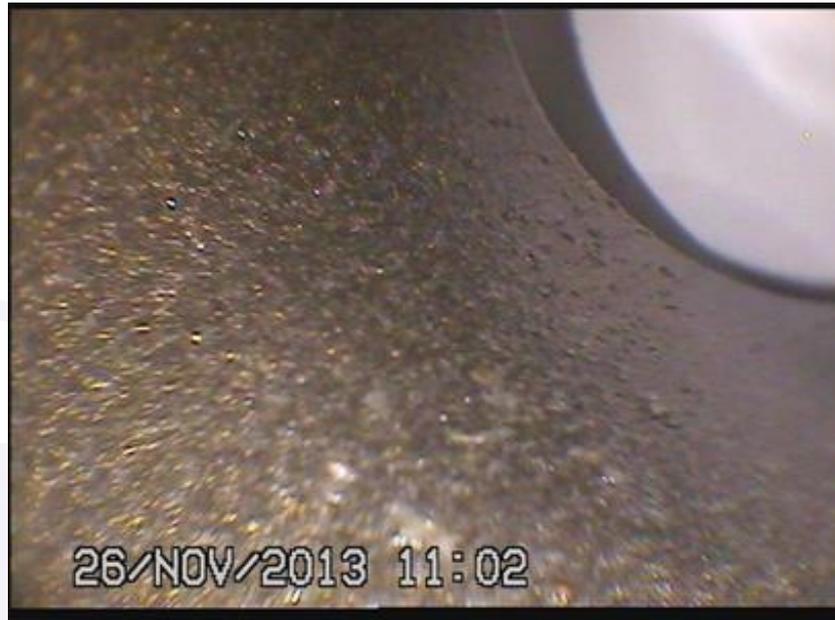
Figure 8 - FCU inner chamber.

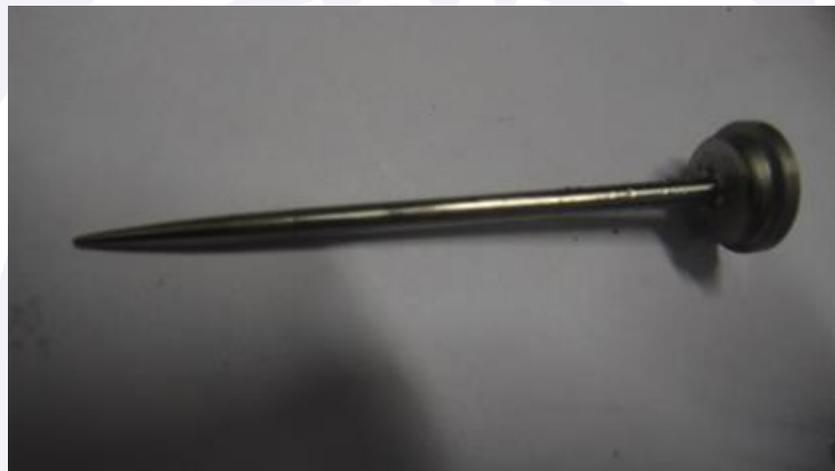
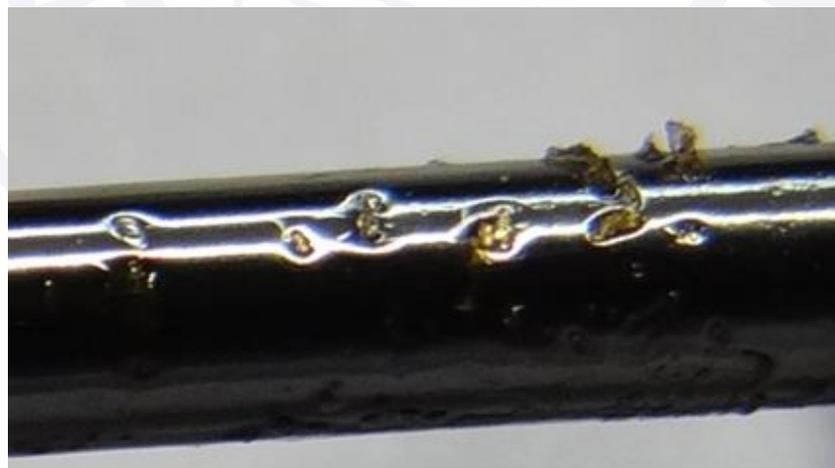
Figure 9 - FCU metering valve needle.

Figure 10 - Enlarged image of the metering valve needle.

contamination of the fuel system of the aircraft, the locking of the metering valve in the "closed" position and the consequent loss of power observed.

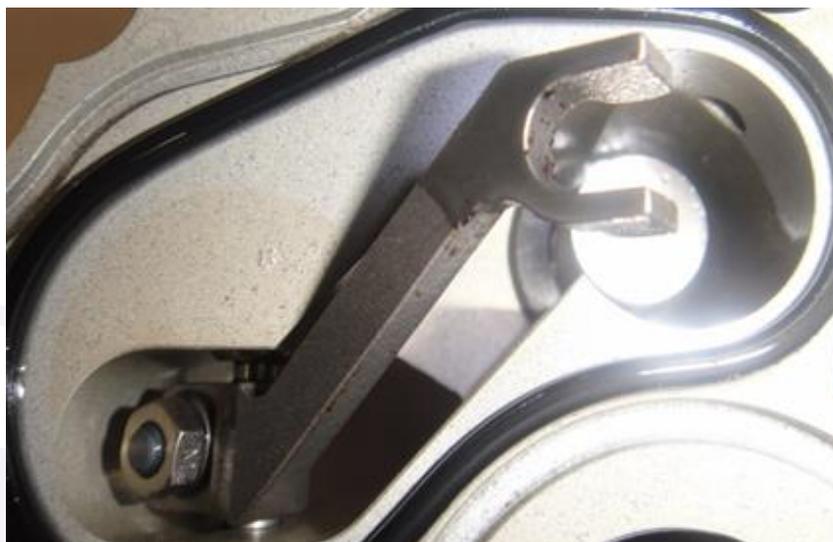
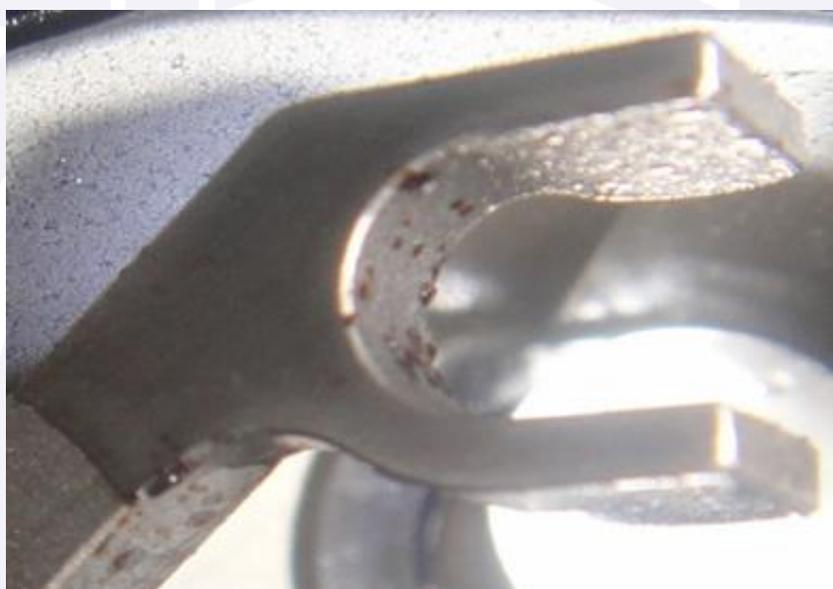
Figure 11 – Actuating rod of the FCU metering valve.

Figure 12 - Enlarged image of the Actuating rod of the FCU metering valve.

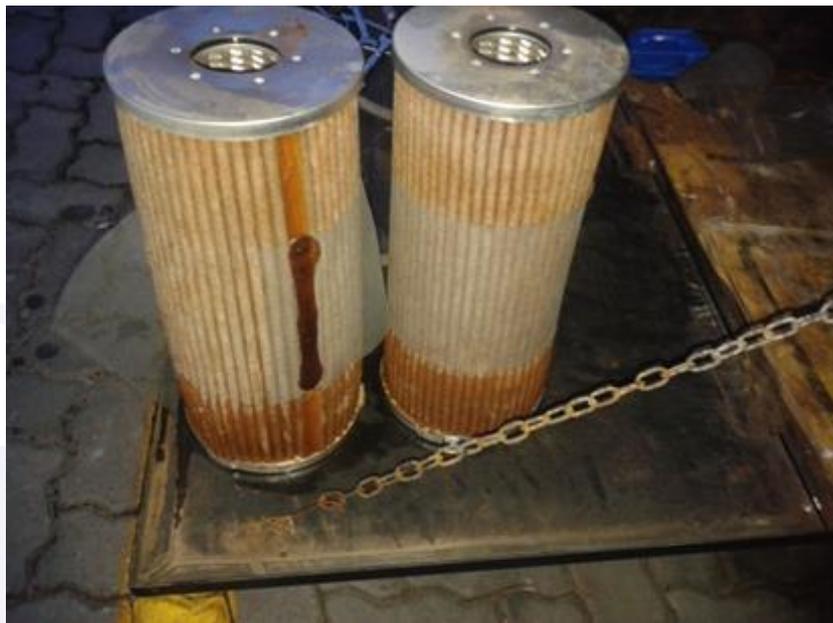
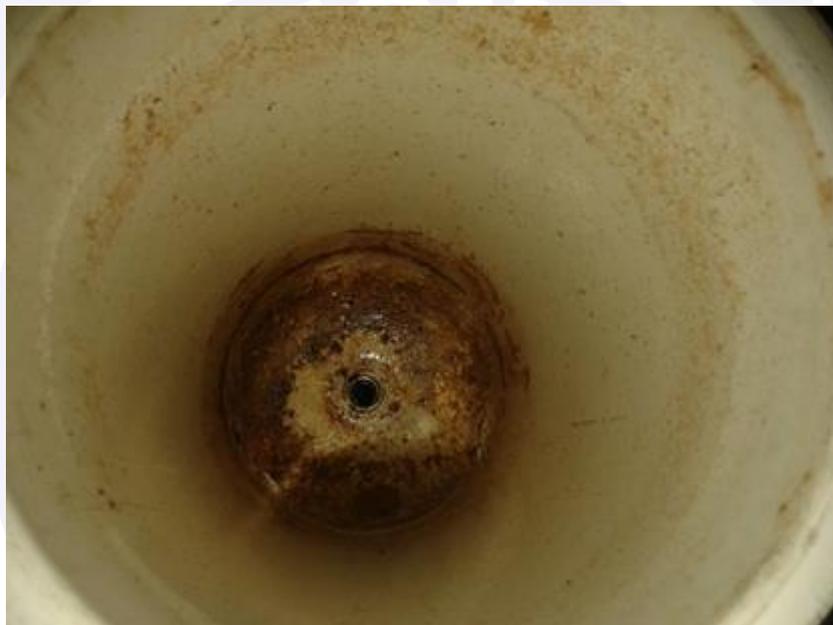
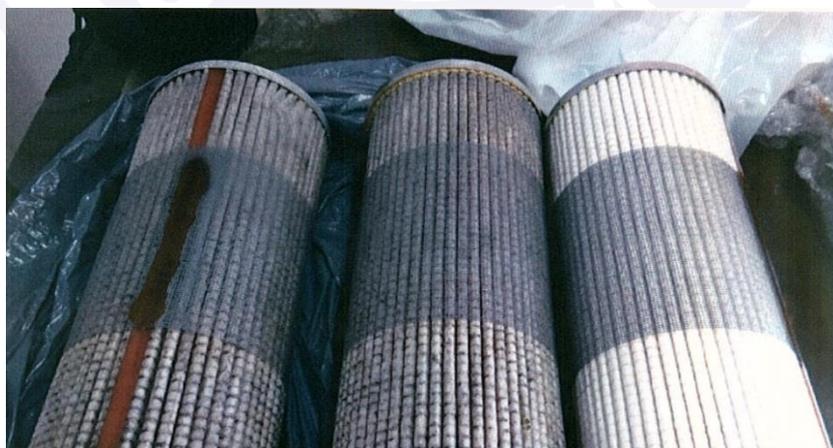
The truck's fuel filters were also collected for analysis. Two filters were analyzed from the truck that fuelled the aircraft and a new filter, which had not yet been used (Figures 13, 14, 15, 16 and 17).

Figure 13 - Filters taken from the fuel tanker truck (CTA).

Figure 14 - Storage of one of the CTA filters.

Figure 15 - Two filters taken from the CTA (left) and a new filter (right).

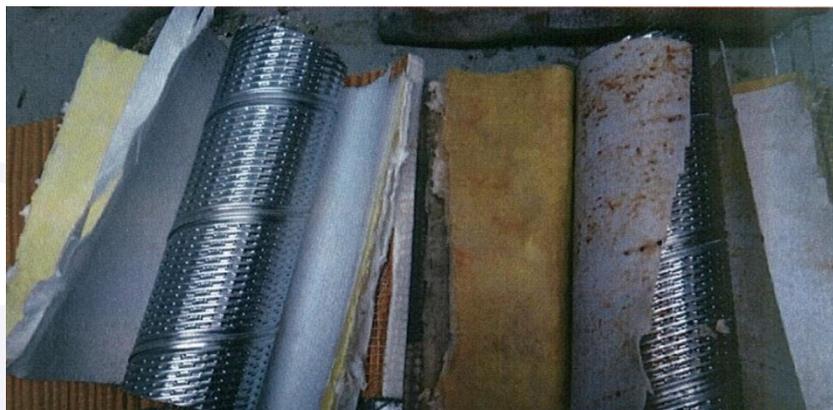
In the filters removed from the fuel tanker truck the same contamination described previously was found in considerable volume. The analyzes indicated that it was the same chemical found in aircraft tanks, that is polyacrylic acid salt (sodium polyacrylate).

Figure 16 - New filter (left) without contamination and filter removed from CTA (right) with contamination.

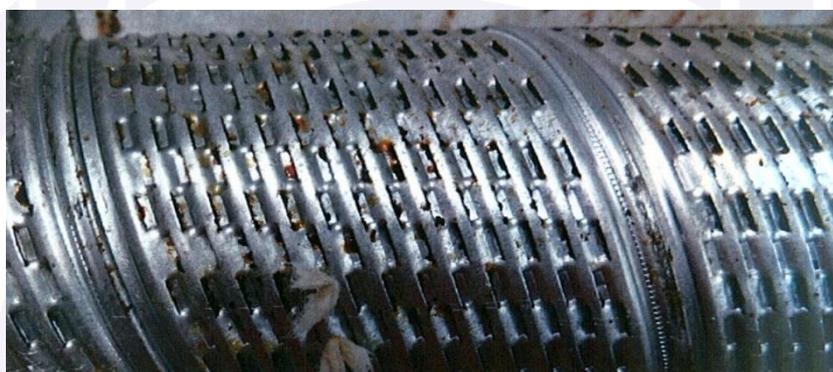
Figure 17 - Detail of the contamination in the internal structure of one of the filters removed from the CTA.
