**FINAL REPORT**  
**IG-085/CENIPA/2014**

<b>OCCURRENCE:</b>	<b>SERIOUS INCIDENT</b>
<b>AIRCRAFT:</b>	<b>PR-HFC</b>
<b>MODEL:</b>	<b>AS-355N</b>
<b>DATE:</b>	<b>26APR2014</b>

This is the Final Report of the 26APR2014 serious incident with the AS-355N aircraft, registration PR-HFC. The serious incident was classified as “Collision with Obstacle In-Flight”.

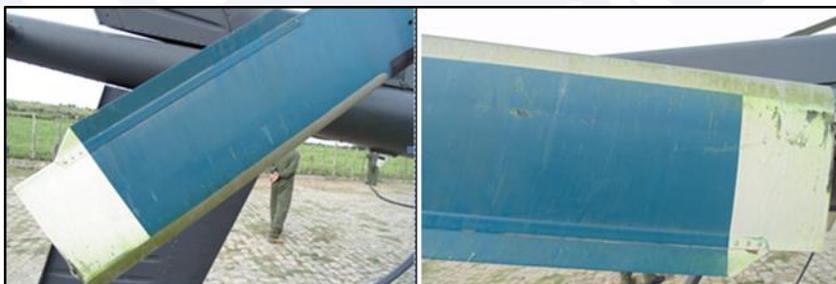
The aircraft had damage in the tail rotor blades (Figure 1).

Figure 1 - Damage in the tail rotor blades.

After a visual inspection by the co-pilot, there was a new takeoff to the municipality of Orocó - PE, where, through a technical inspection performed by mechanics, it was identified the presence of scratches on the tail rotor blades and kneading in the respective impact fingers (Figure 1).

- l) It was identified the presence of scratches on the tail rotor blades and kneading on the respective impact fingers;
- m) the aircraft suffered minor damage; and
