FINAL REPORT
IG - 076/CENIPA/2015

OCCURRENCE:	SERIOUS INCIDENT
AIRCRAFT:	PR-POL
MODEL:	AS-350 B2
DATE:	20MAY2015

This is the Final Report of the 20MAY2015 serious incident with the AS-350 B2 aircraft, registration PR-POL. The serious incident was classified as "Collision In-Flight with Obstacle".

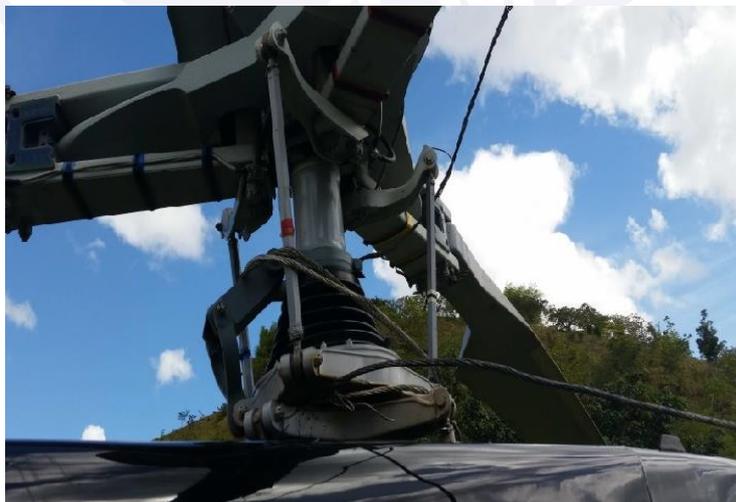
Figure 1- Damage in the main rotor assembly.

As a consequence of the impact, the power cable ruptured and collided with the aircraft structure, wrapping into the space between the fixed and rotating plateaus and the main rotor pitch changing links (Figure 1).

The HELIBRAS Report concluded that the aircraft was in conditions to be repaired and that the cards related to the impact of the main rotor and tail rotor should be complied.

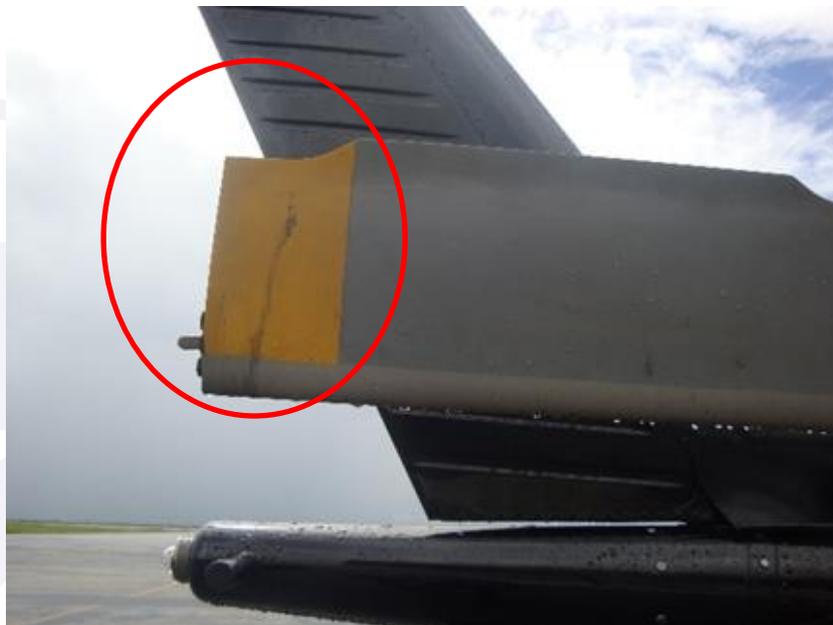
The aircraft had damages in the main rotor pitch changing links, in one of the tail rotor blades (Figure 2), in the engine exhaust (Figure 3), in the horizontal stabilizer (Figure 4), in the pilot instrument panel, on the right upper "plexiglass" and the VHF radio antenna.

Figure 2 - Damage to one of the tail rotor blades.

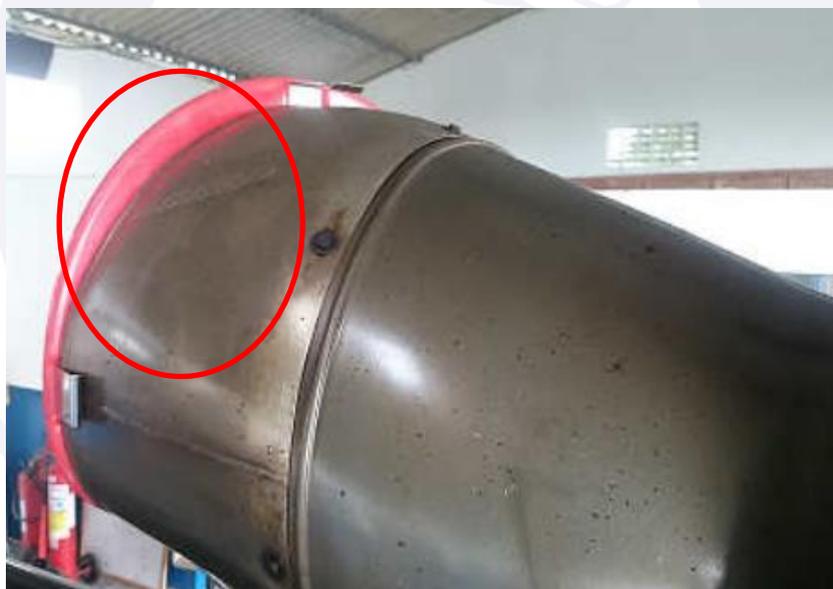
Figure 3 - Damage to engine exhaust.

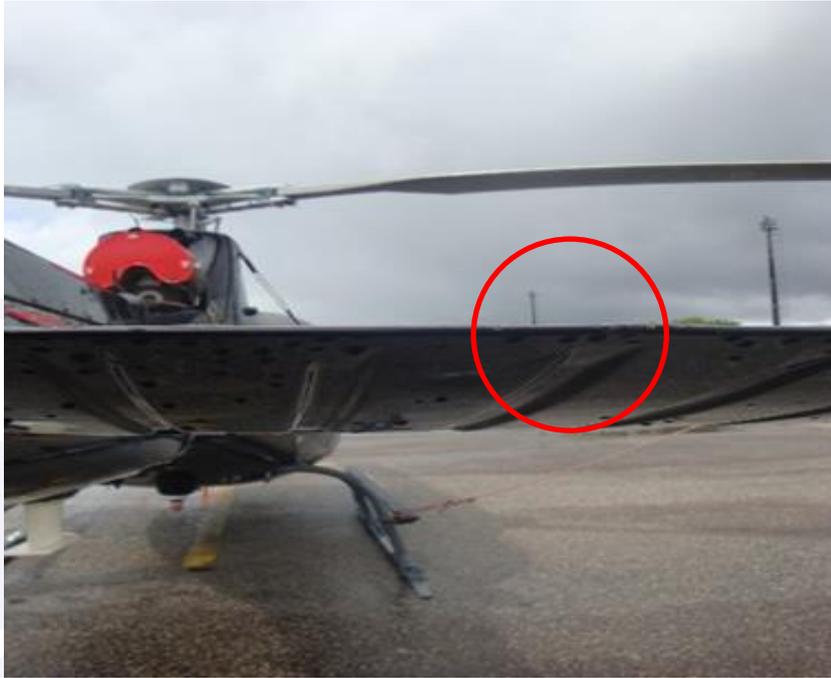
Figure 4 - Damage to the horizontal stabilizer.

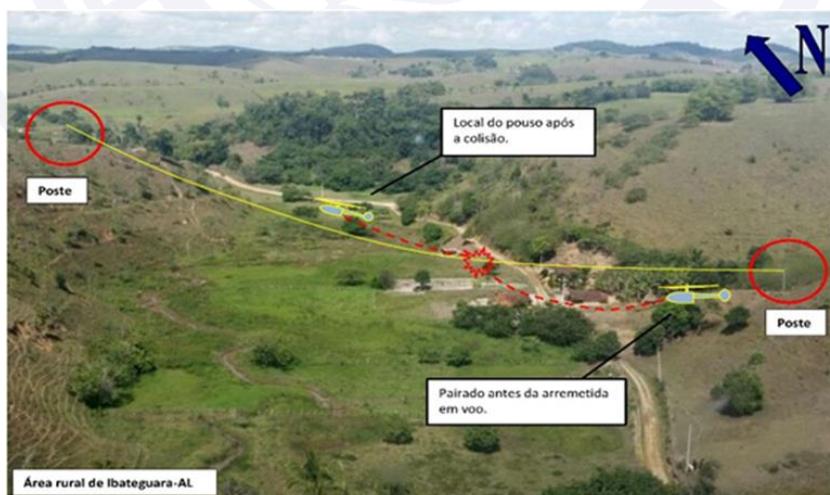
After a hovering flight, during a go-around procedure, the helicopter collided with a low-voltage rural electrification network cable. (Figure 5)

Figure 5 - Sketch of the accident site.

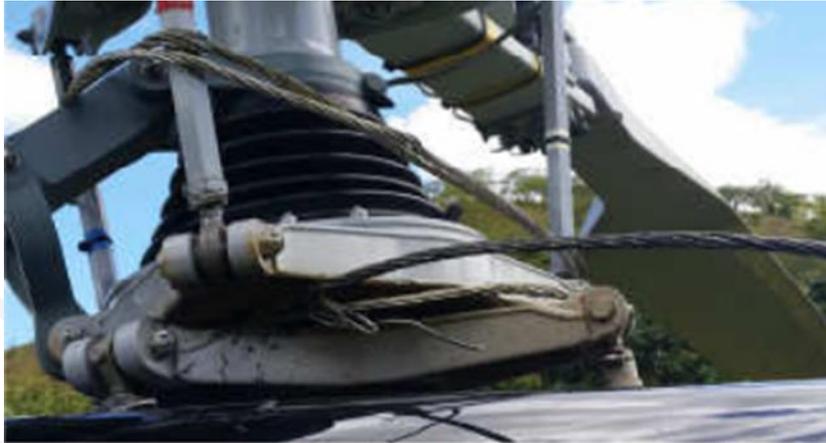
After removing the electric cable from the main rotor assembly (Figure 6), the crew evaluated the technical conditions of the aircraft and performed a new takeoff to Maceió.

Figure 6 - Electrical cable attached to the main rotor components.
