FINAL REPORT
A - 147/CENIPA/2015

OCCURRENCE:	ACCIDENT
AIRCRAFT:	PR-RSA
MODEL:	AT-502B
DATE:	09NOV2015

This is the final report of the accident with the AT-502B aircraft, registration PR-RSA, on 09NOV2015. The event was classified as “Loss of Control - Inflight” (LOC-I).

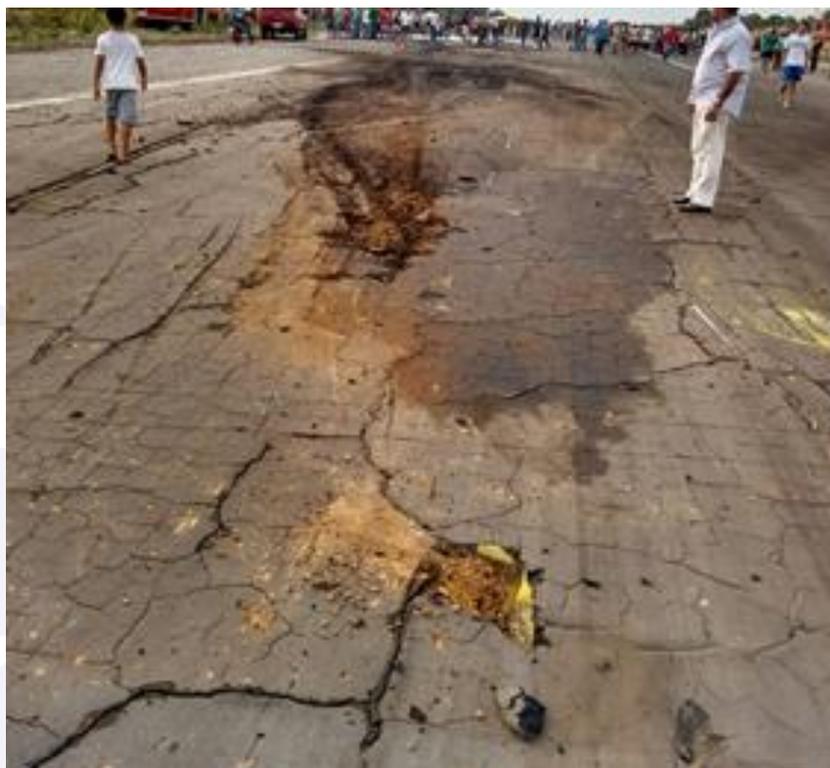
Figure 1 - Impact marks.

The aircraft right wing was the first part to hit the ground, followed by the propeller blades, engine, and then the other parts (Figures 1 and 2).

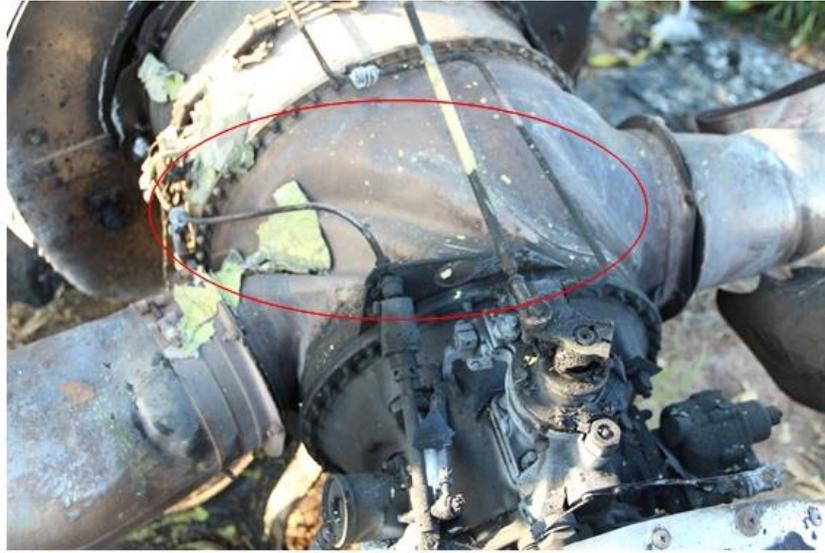
Figure 3 - C flange twisted by the impact.

The right wing exploded in the impact, and the fire consumed the entire aircraft. One of the propeller blades was cut, and the other propeller blades were distorted. The right landing gear was separated from the fuselage, and the engine twisted at “C” flange (Figure 3).

However, the damage observed on the propeller and on C flange was consistent with engine power development, what shows that the aircraft impacted the ground with operating engines. This fact was confirmed by interviewing the accident witnesses.

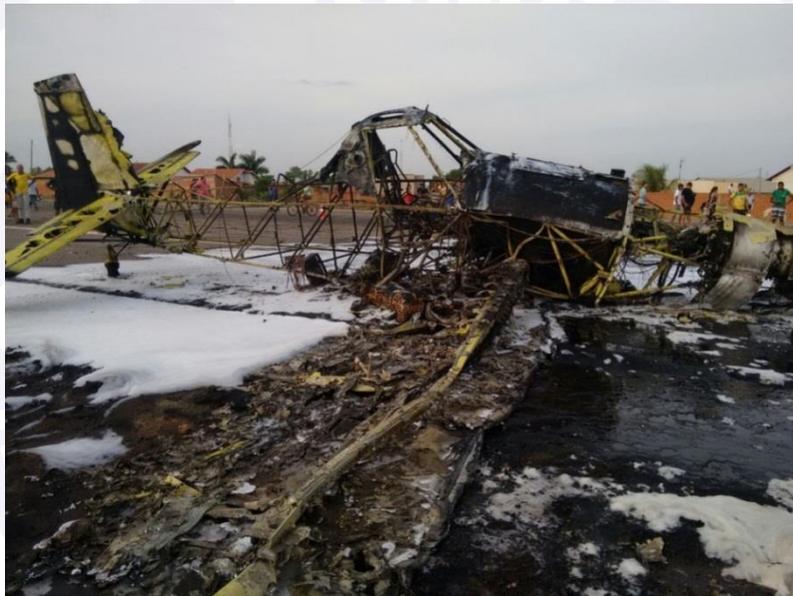
Figure 4 - Aircraft final position.

The aircraft came to rest 60 meters of the initial impact, on a heading of about 150° magnetic (180° of the takeoff run direction) (Figure 4).

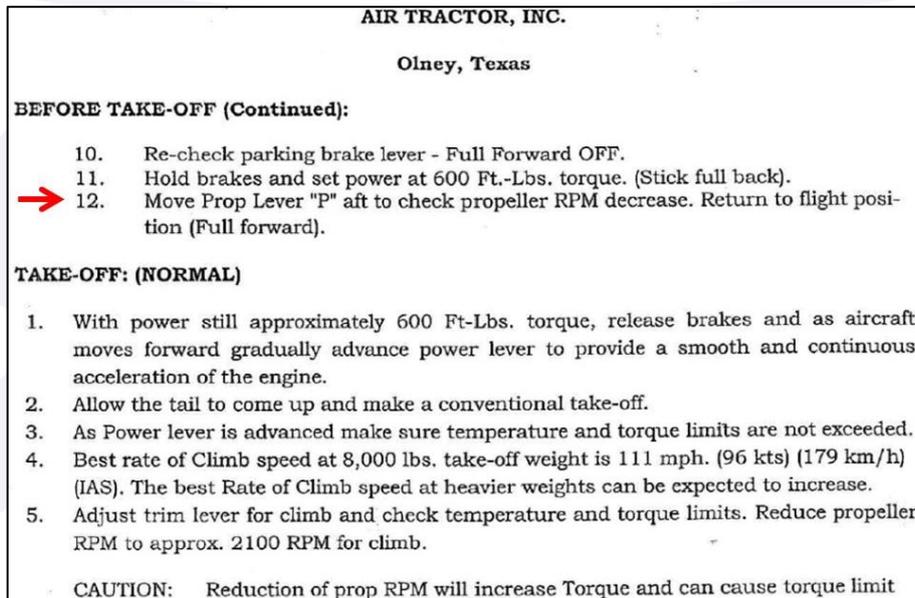
Figure 5 - Propeller lever position for takeoff according to AT-502B flight manual.

While preparing for takeoff, the pilot accelerated the engine with propeller lever aft (wrong position). As prescribed in the flight manual, the propeller lever should be in the flight position (fully forward) for takeoff. (Figure 5).

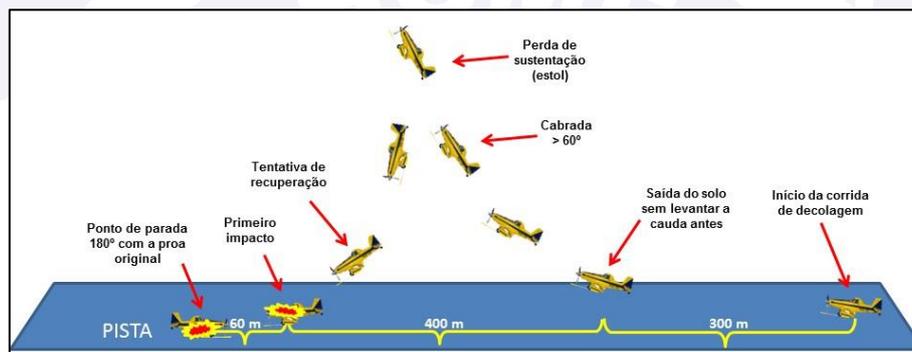
Figure 7 - Airplane trajectory in the vertical plane

It was not possible to allege the exactly climb angle the aircraft reached. Based on several reports and on the dynamics of the flight, it is likely that the aircraft exceeded 60° climb angle.

In such situation, the aircraft climbed for a while, but then entered a stall. The aircraft was observed in a steep nose down attitude, followed by the changing attitude consistent with recovering to a normal attitude. However, the aircraft collided with the ground about 400 meters from the departing point.

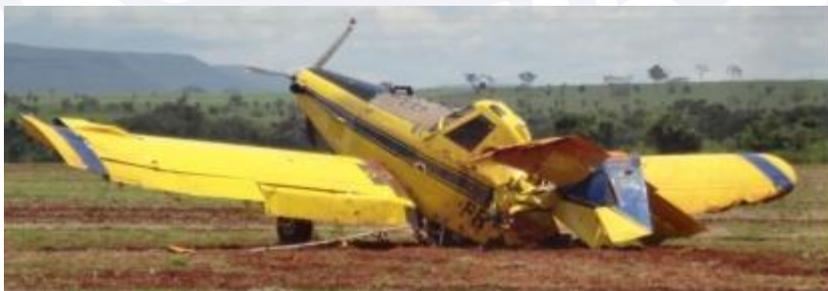
Figure 8 - PR-TPL after crash.

The aircraft became airborne about three meters before the departure end, lost height, and collided with two fences (86m and 98m of the departure end), followed by the impact with the ground. The aircraft came to rest about 140m of the departure end, and with operating engine.

The aircraft was substantially damaged, and the pilot was uninjured.

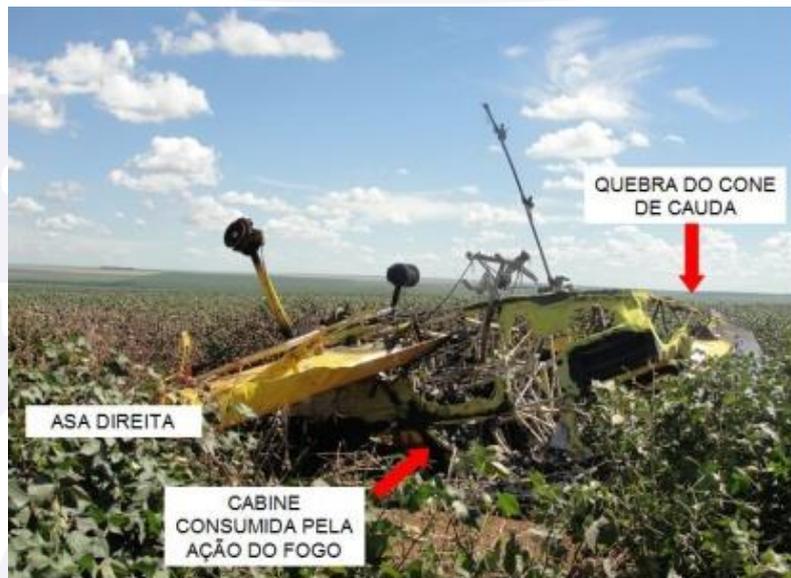
Figure 9 - PT-SUL after crash.

During takeoff roll, the pilot started to jettison the hopper load. Then, it entered a cotton crop beyond the departure end, flipped over, and came to rest up-side-down.

A left wing fire ensued. An agricultural assistant helped the pilot to exit the aircraft.
