COMANDO DA AERONÁUTICA
CENTRO DE INVESTIGAÇÃO E PREVENÇÃO DE
ACIDENTES AERONÁUTICOS

FINAL REPORT
IG-512/CENIPA/2017

OCCURRENCE:	SERIOUS INCIDENT
AIRCRAFT:	PR-SEC
MODEL:	S-76C
DATE:	26AUG2011

This is the Final Report of the 26AUG2011 serious incident with the S-76C aircraft, registration PR-SEC. It was classified as “Abrupt Landing”.

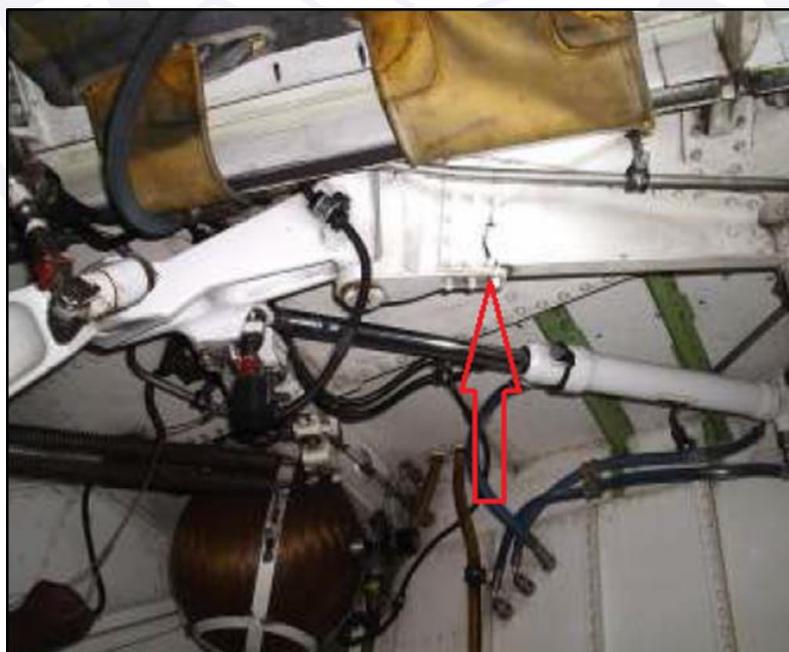
The aircraft had damage in the landing gear and in the landing gear attachment structure (Figure 1).

Figure 1- Damage in the landing gear attachment structure.

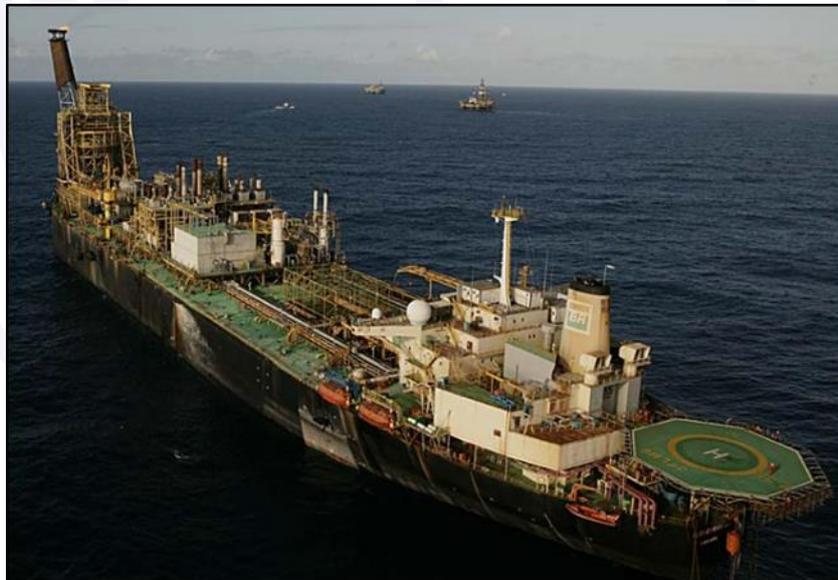
Figure 1 - View of the FPSO P-35, with emphasis on the helideck at the rear of the ship.

The P-35 had a helideck located in the rear of the ship, and in an inferior position to the structures of the boat. This positioning did not meet all the parameters recommended in NORMAM 27, regarding the position of the Final Approach and Takeoff Area (AAFD).

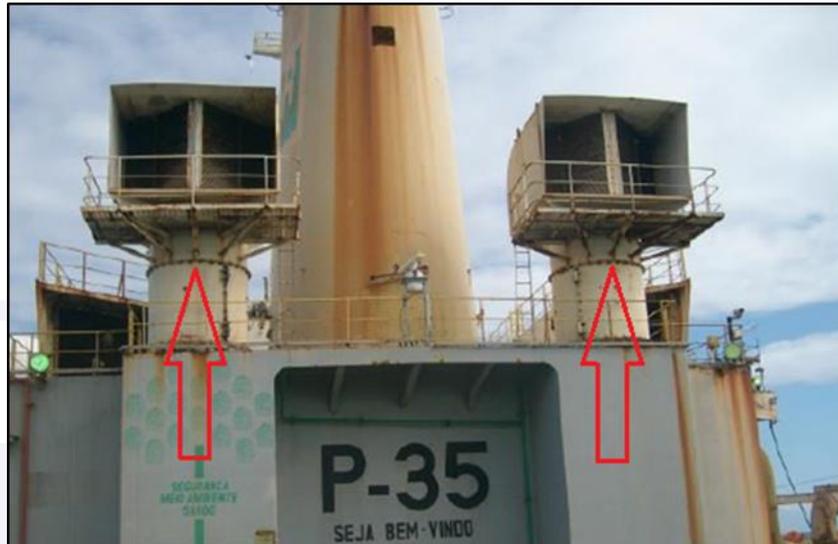
According to information from PETROBRAS, the two chimneys located at the rear of the platform, just above the helideck, were no longer in operation. They served only to circulate air between the deck of the ship (Figure 2).

Figure 2 - View of the two chimneys in the stern of platform P-35.

Once, they served to release gases from the propulsion system. However, this system was removed on the conversion of the ship into a stationary platform.

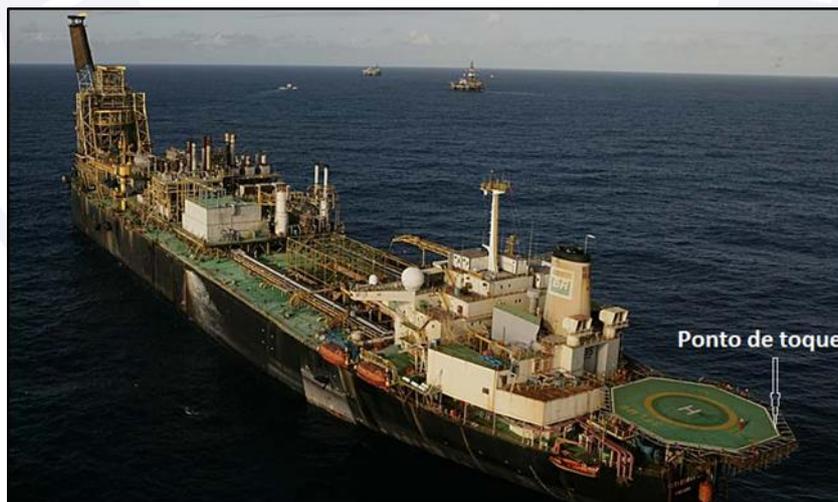
The first touch of the abrupt landing occurred outside the touching area, at the limit of the final approach and takeoff area (AAFD) and very close to the helideck protection net (Figure 3).

Figure 3 - Location of the first touch point.

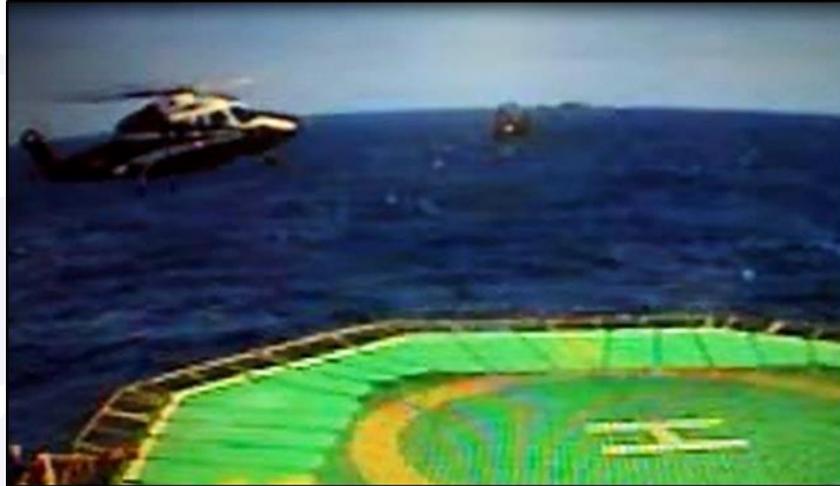
It is highlighted, next, the trajectory covered by the PR-SEC in the short end to the landing in the helideck of the P-35 (Figure 4).

Figure 4 - Short end for landing in the helideck.

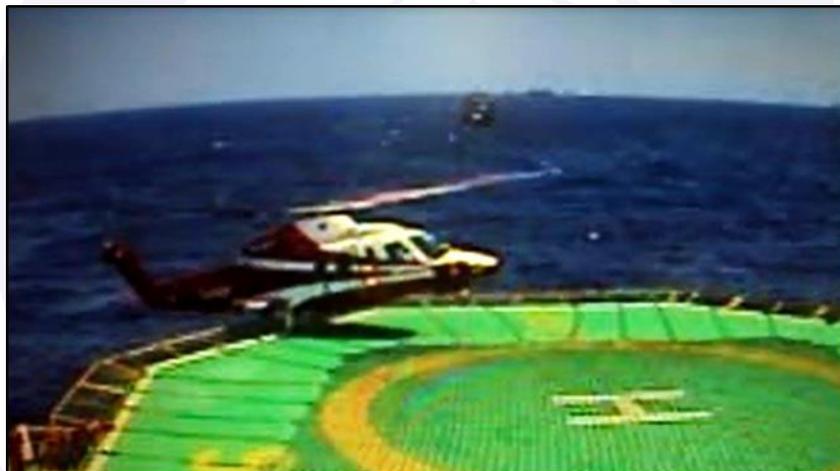
It can be seen that, after the first touch outside the touching area, the aircraft jumped, and stopping at the limit of this area (Figures 5, 6, and 7).

Figure 5 - Moment of the first touch of the abrupt landing outside the touching area.

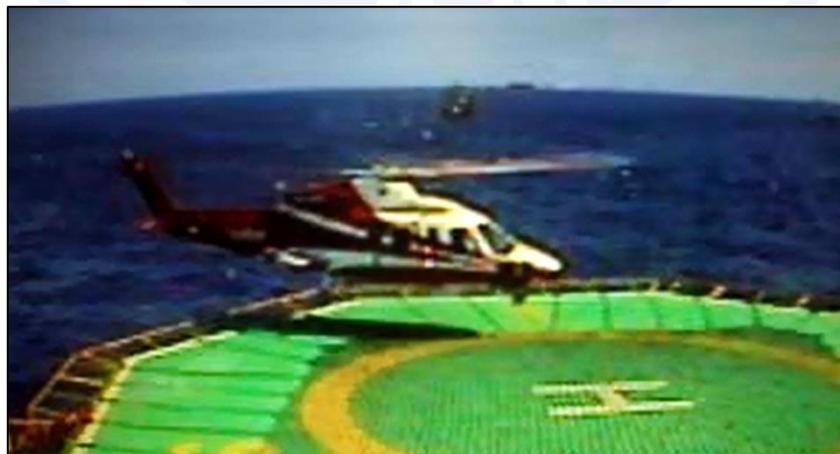
Figure 6 - Detail of the "jump" after the first touch.

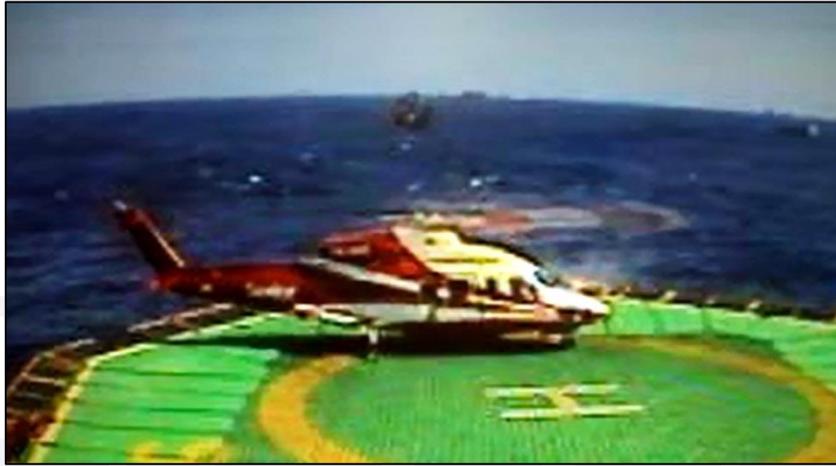
Figure 7 - Breakpoint of the aircraft.

It could also be observed from the recorded images that the bow of the aircraft was out of phase with the longitudinal axis of the ship. The touch of the aircraft in the helideck was performed almost transverse to the axis of the platform (Figure 7).

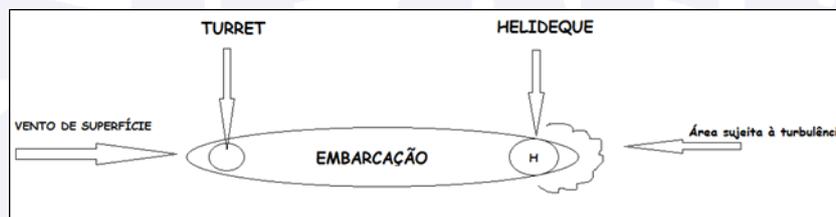
The Turret anchorage allows the ship to move freely around the Turret, a kind of pivot located on the front of the ship, in which the mooring ropes are fixed to the bottom of the sea (Figure 8).

Figure 8 - Turret anchorage.

With this type of anchorage, the ship, in fact, tends to align with the wind, but is also influenced by the direction of the waves' movement and the surface sea current.

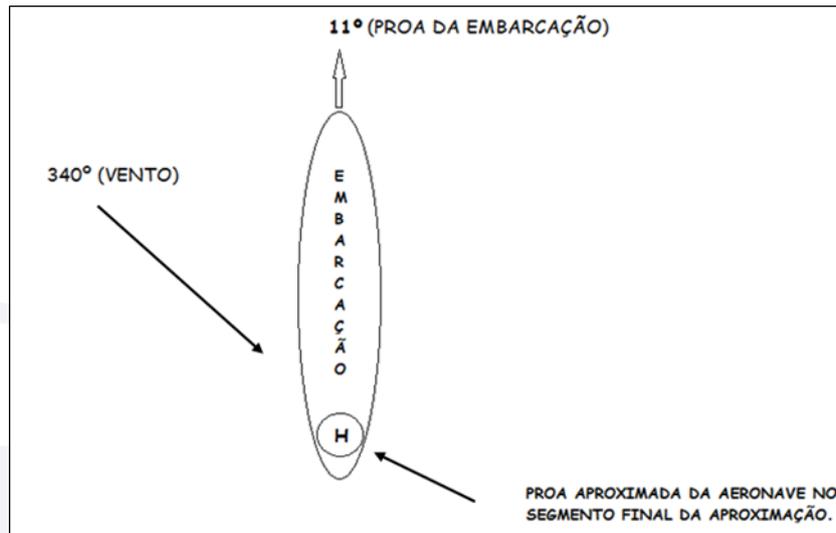
From the images record of the final segment of the approach, it was observed that the approach axis of the aircraft almost coincided with the direction of the wind, between 330° and 340° (Figure 9)

Figure 9 - Sketch of the approach.

The images captured by the helideck cameras showed that the approach was performed with the platform to the right of the axis and with the nose slightly up. In this profile, the occupant of the left chair, the instructor, had his helideck field of vision substantially reduced, especially in the last stretch of the approach.

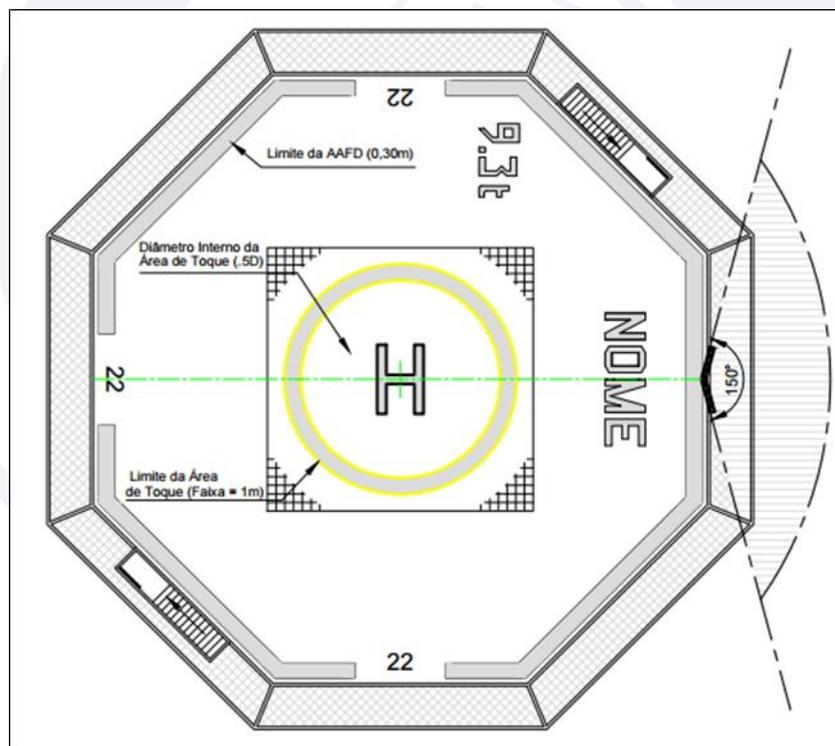
- the touching area should be in the center of the AAFD.

Figure 10 - Limits of the touching area and the AAFD.
