**COMANDO DA AERONÁUTICA**  
**CENTRO DE INVESTIGAÇÃO E PREVENÇÃO DE**  
**ACIDENTES AERONÁUTICOS**

**FINAL REPORT**  
**A - 070/CENIPA/2017**

<b>OCCURRENCE:</b>	<b>ACCIDENT</b>
<b>AIRCRAFT:</b>	<b>PT-CHT</b>
<b>MODEL:</b>	<b>PA-30</b>
<b>DATE:</b>	<b>28APR2017</b>

This is the Final Report of the 28APR2017 accident with the PA-30 aircraft, registration PT-CHT. The accident was classified as “[LOC-I] Loss of Control in Flight”.

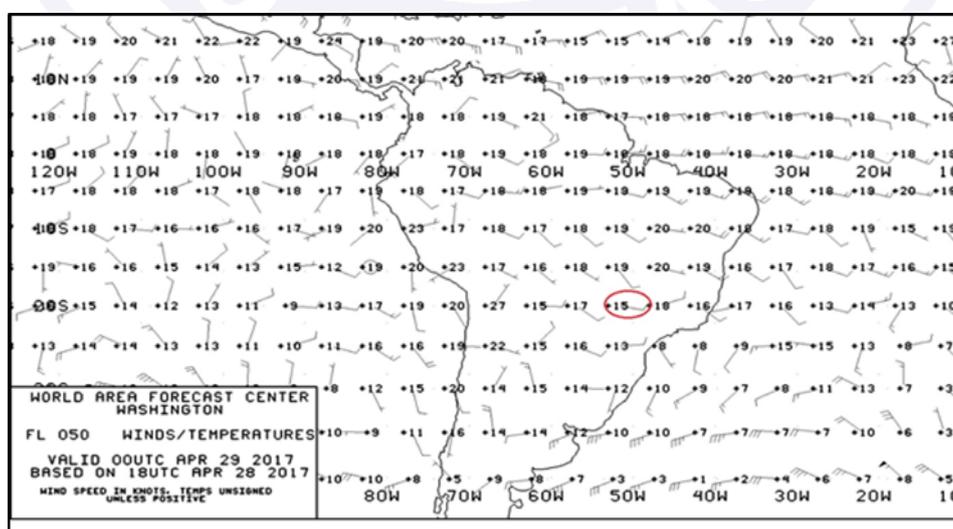
The wind chart (layer wind), generated at 1800 (UTC), valid until 0000 (UTC) of 29APR2017, indicated predominant wind in the region of the accident of east direction and intensity of 15kt, at FL050, flight level close to the one in which happened the flight (Figure 1).

Figure 1 - Wind chart on FL050.

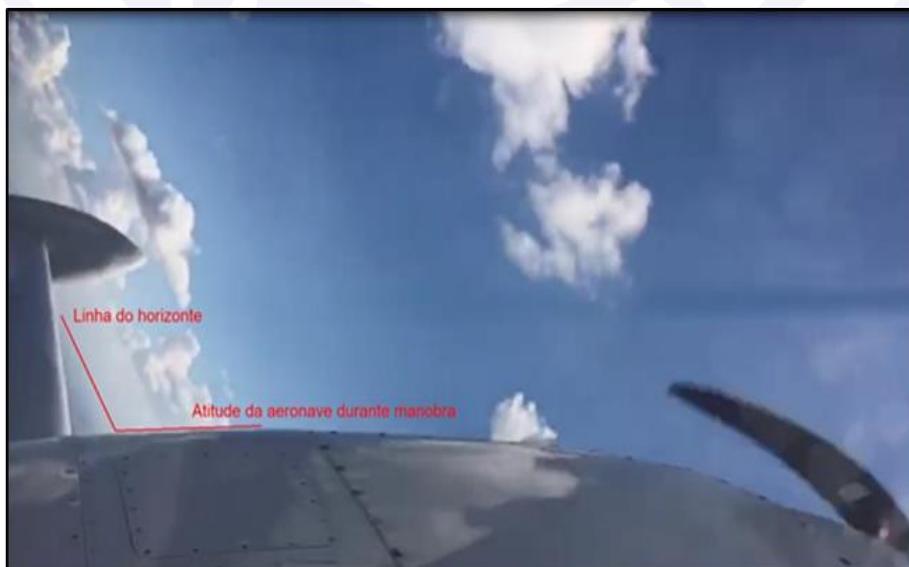
The Investigation Team had access to one of these videos, in which it was possible to see a stall, in the same aircraft of the accident, out of the Aeroclub's established standards, with a rather pitch up attitude to the type of maneuver (Figure 2).

Figure 2 - Stall exercise performed by the instructor of the occurrence, in the same aircraft, in a previous flight.

Just after that, it started to circulate in a broader way, a footage on a flight of the occurrence instructor, on the same crashed aircraft, on a date prior to the accident. In this video, it was observed that a stall exercise was performed, with a rather pitch up attitude. This form of exercising differed greatly from what was stipulated by the Aeroclub.

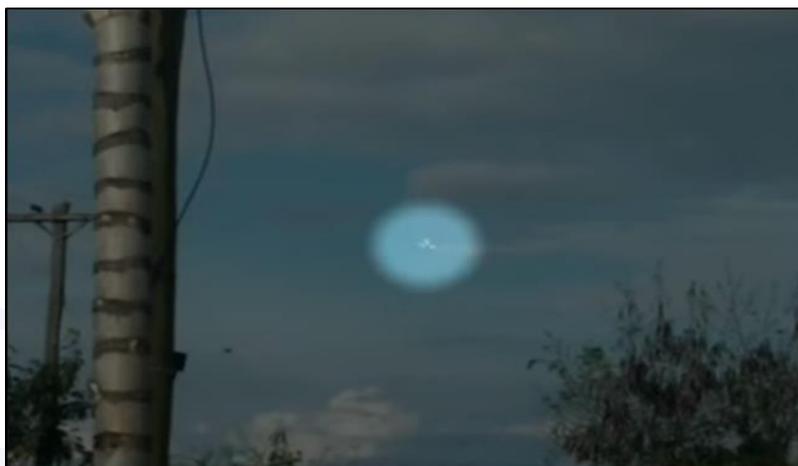
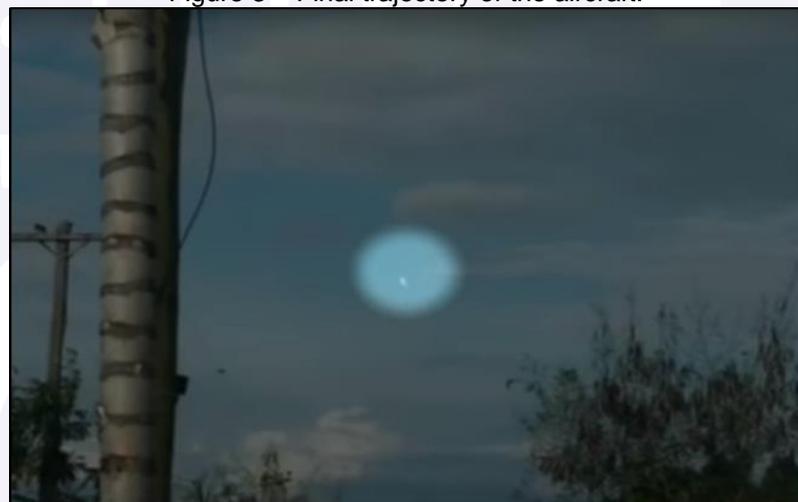
Figure 3 – Final trajectory of the aircraft.

Figure 4 – Final trajectory of the aircraft.

It was possible to see in the filming that the final trajectory of the aircraft happened in spin. The aircraft in question was not approved for the execution of this exercise.

The torsion signals from the fuselage corroborate with the images in which the aircraft descends in a spin way, out of control, until the collision against the ground.
