**COMANDO DA AERONÁUTICA**  
**CENTRO DE INVESTIGAÇÃO E PREVENÇÃO DE**  
**ACIDENTES AERONÁUTICOS**

**FINAL REPORT**  
**A-096/CENIPA/2016**

<b>OCCURRENCE:</b>	<b>ACCIDENT</b>
<b>AIRCRAFT:</b>	<b>PT-DJH</b>
<b>MODEL:</b>	<b>182E</b>
<b>DATE:</b>	<b>02JUL2016</b>

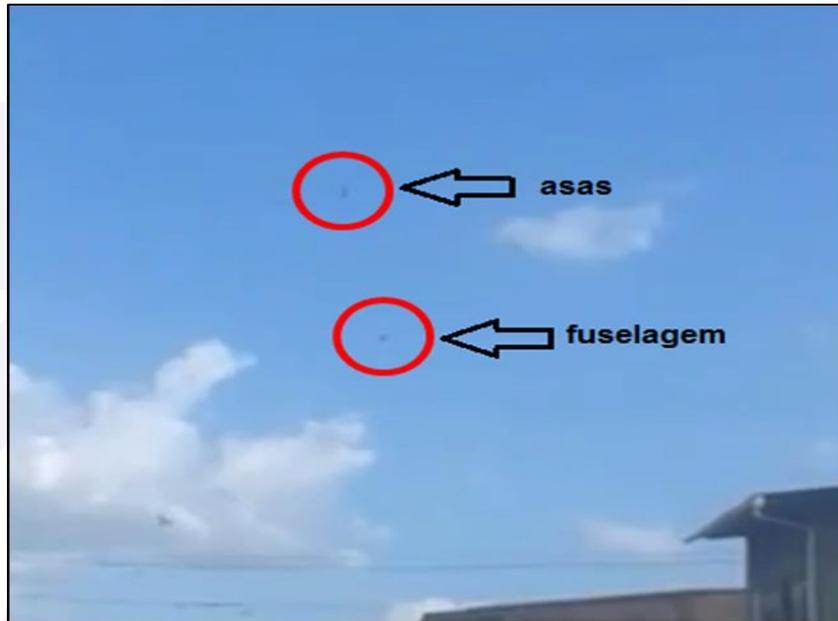
According to observers of the moment of fall, the aircraft was developing a downward trajectory and, during this route, structural parts were detached, being possible to identify that there was a separation between the wings and the fuselage (Figure 1).

Figure 1 - Moment of the aircraft's fall with few clouds in the flight area. Highlight to the wings above and the fuselage below.

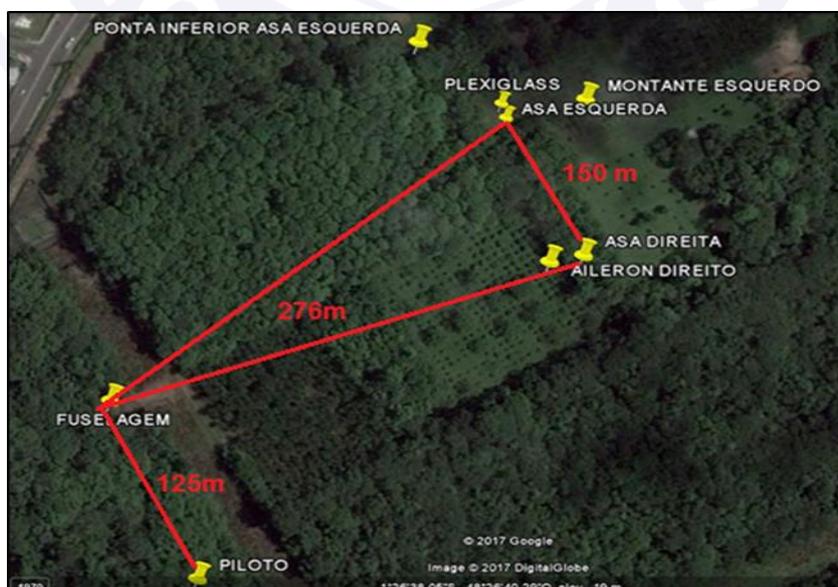
On the ground, the left and right wings were 276 meters from the fuselage and about 150 meters apart.

The pilot was located 125 meters from the fuselage. Observers reported that the pilot was in free fall outside the aircraft.

Figure 2 shows the distribution of the wreckage and the pilot's body. The three parachutists remained inside the aircraft.

Figure 2 - Distribution of the aircraft wreckage at the crash site.

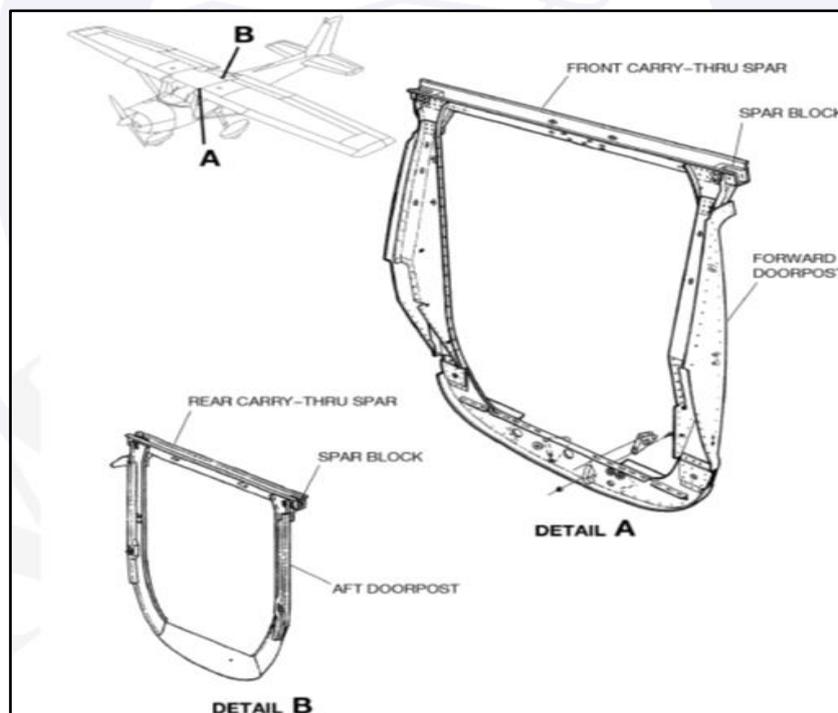
The aircraft was of the high wing type, with those being fixed in the upper part of the fuselage in two points of each side. The wings were joined by two U-shaped rear and front spars (Figure 3), which showed fractures (Figure 4).

Figure 3 - Front Spar in Detail A and Rear Spar in Detail B.

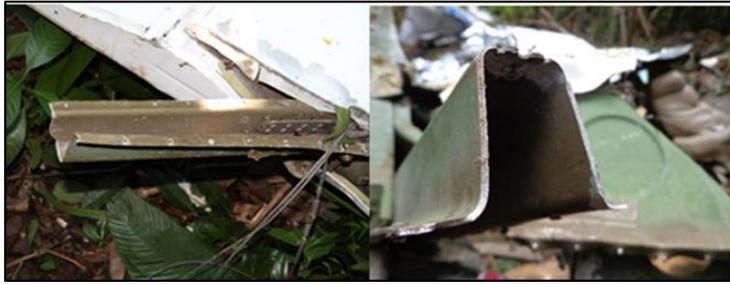
Figure 4 - Fractured spar.

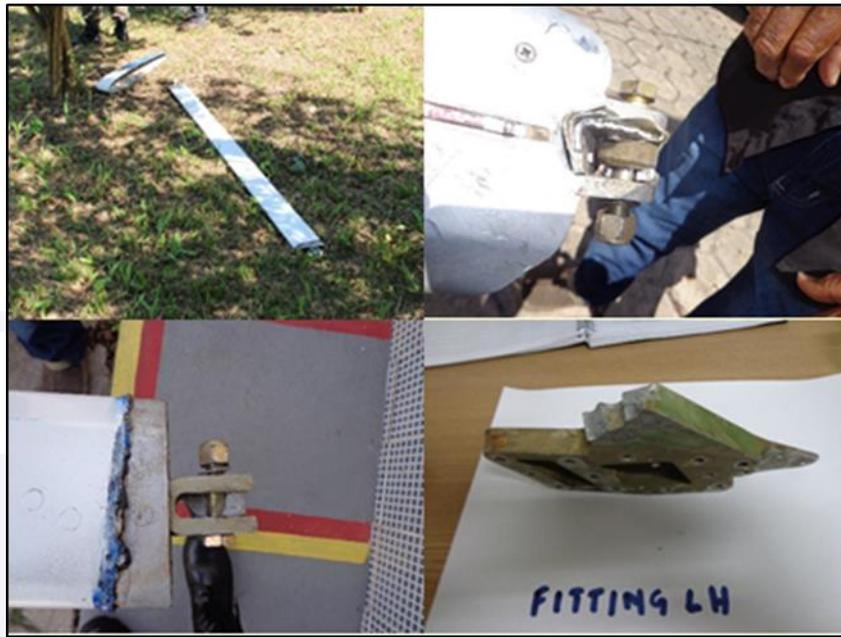
The left wing strut was found near the tip of the left wing with fractured fixation points (Figure 6).

Figure 6 - Left wing strut with fractured fixation points.

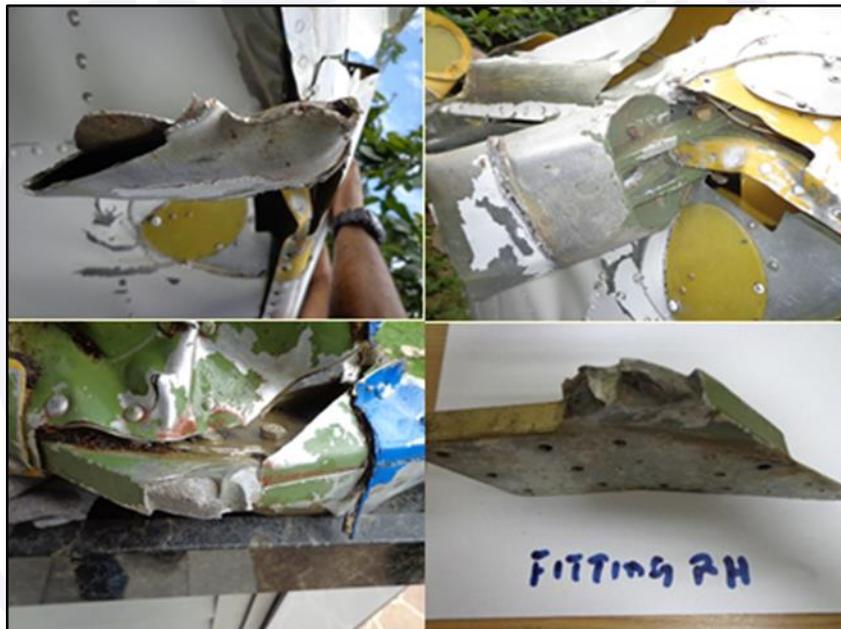
The right wing strut was not found, however the fixation points were identified, which presented fractures (Figure 7).

Figure 7 - Attachment points of the fractured right wing strut.

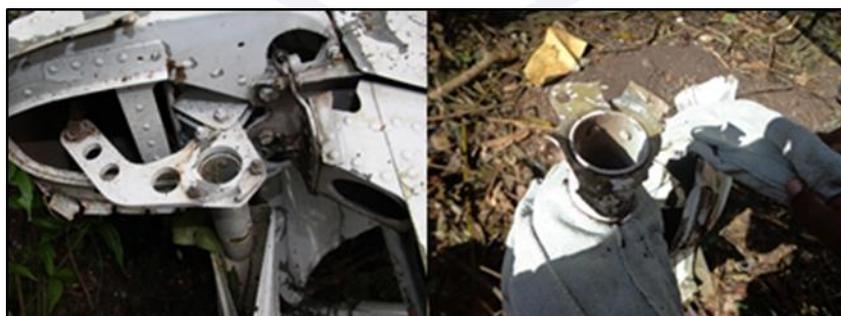
The left elevator was found fractured (Figure 8). The flange riveted to the torque tube had three tie-down eyelets that were fractured. There were no indications of failure of the elevators.

Figure 8 - Left elevator fractured.

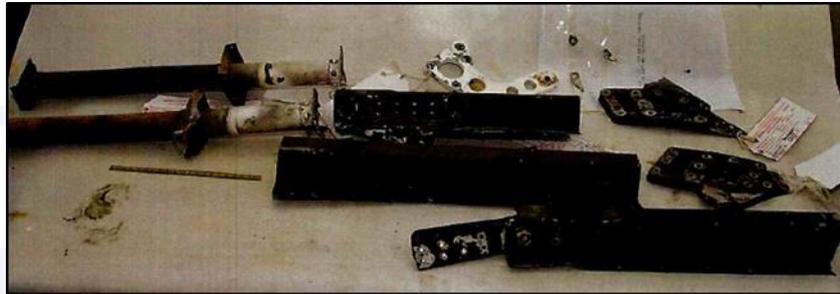
At first, the DCTA's Institute of Aeronautics and Space (IAE) analyzed the fuselage fragments (Spar Assy Rear); (Fitting Bulkhead LH and RH) and Tube Assy Elev (LH) (Figure 9).

Figure 9 - Parts of the aircraft analyzed in the Technical Report.

The analyzed parts were submitted to visual and stereoscopic analysis. The conclusion of this report reported that all surface fractures were caused by overload applied to the material.

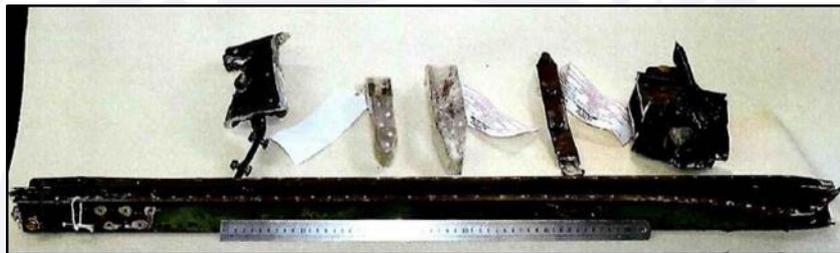
Then, the left wing strut, the central part of the front spar and the fragmented part of the right front spar were also analyzed by the IAE (Figure 10).

Figure 10 - Central part of the front spar and fuselage fragments.

Likewise, the visual analysis and by stereoscopy revealed that all analyzed material had fractures caused by overload applied to the material, and there were no signs of corrosion or fatigue in all the material analyzed.

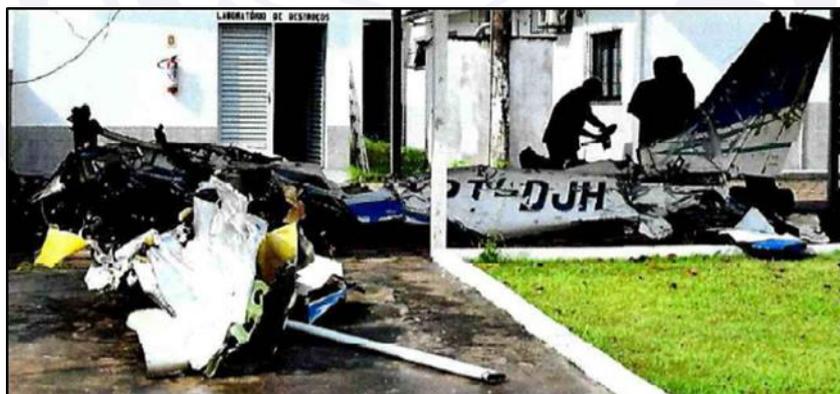
Still in the First Regional Aeronautical Accident Investigation and Prevention Service (SERIPA I), the control cables, surfaces and fractures of the wings, tail cone, engine fixation and the general structure of the crashed aircraft were analyzed (Figure 11).

Figure 11 - Wreckage analyzed at SERIPA I facilities.

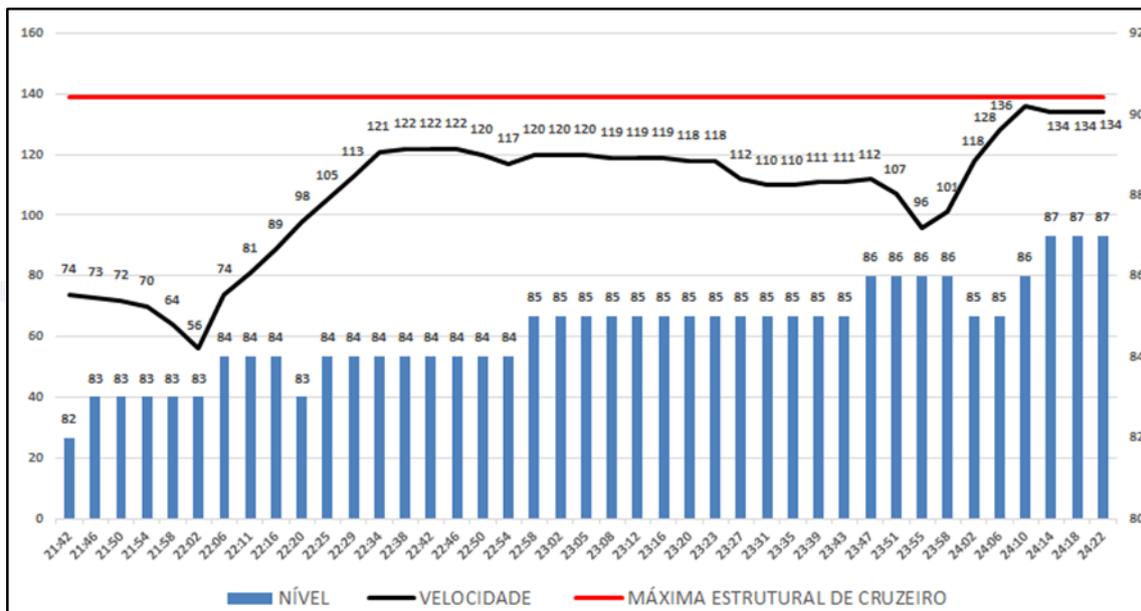
Figure 13 shows a chart with flight level and velocity data, as seen in the radar, in the 2 minutes and 40 seconds preceding the disappearance of the aircraft from the radar.

Figure 13 - Flight level and speed data, according to radar visualization, in the 2 minutes and 40 seconds before the traffic control loses the aircraft location.

Another aspect observed during the flight was the Maximum Maneuvering Speed (VA), whose maximum value was 111kt. From the moment of 24 minutes and 00 seconds, the aircraft began to describe a curve trajectory at a velocity in relation to the ground above 118kt, which assumes that it maneuvered with speeds greater than 111kt.

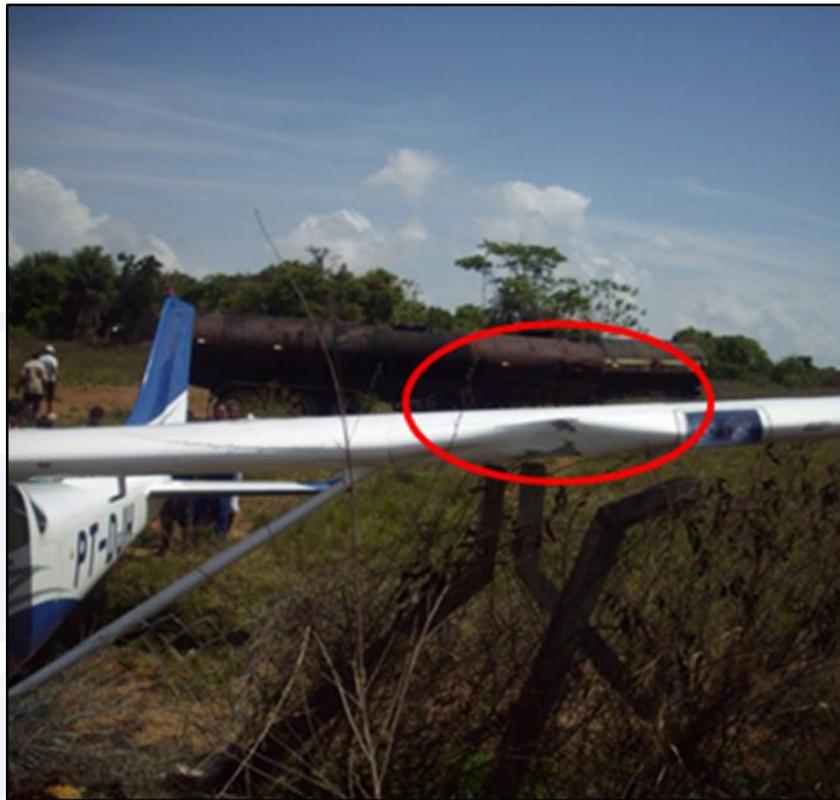
The images of the aircraft attest that it had damage at the leading edge of the left wing, the right wing and the right wing strut (Figures 14 and 15).

Figure 14 - Damage to the leading edge of the left wing (22DEC2012).

The aircraft was involved in an aircraft accident that took place on 22DEC2012, in the locality of Gurupá - PA. In the photographic records in Figures 14 and 15, damage was identified on the leading edge of the left and right wing, and on the right wing attachment strut.

In the Failure Report issued by the company that recovered the aircraft after the accident in 2012, there are no records of repairs to these components, thus suggesting that these services may have been performed by not qualified personnel and without the pertinent verification of the conformity required for structural repair.

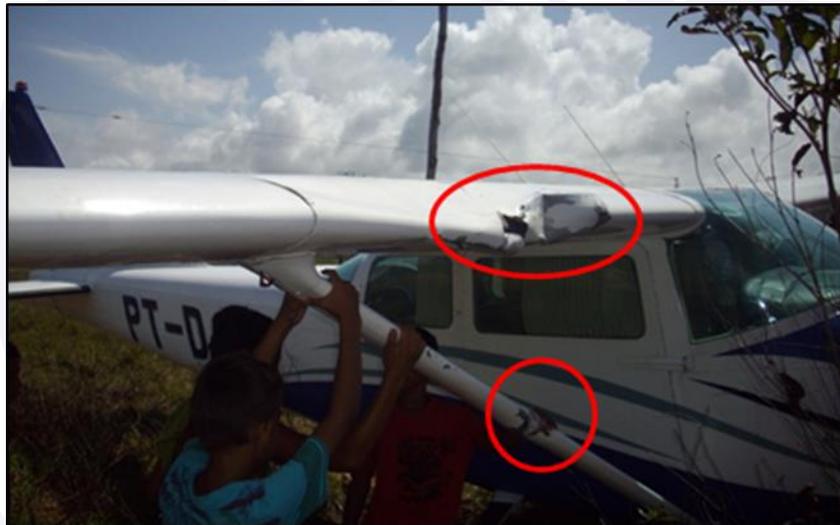
Figure 15 - Damage to the leading edge of the right wing and the strut of the right wing (22DEC2012).
