COMANDO DA AERONÁUTICA
CENTRO DE INVESTIGAÇÃO E PREVENÇÃO DE
ACIDENTES AERONÁUTICOS

FINAL REPORT
A - 209/CENIPA/2014

OCCURRENCE:	ACCIDENT
AIRCRAFT:	PT-HNC
MODEL:	HB-350B
DATE:	27DEC2014

This is the Final Report of the 27DEC2014 accident with the HB-350B aircraft, registration PT-HNC. The accident was classified as “Undetermined”.

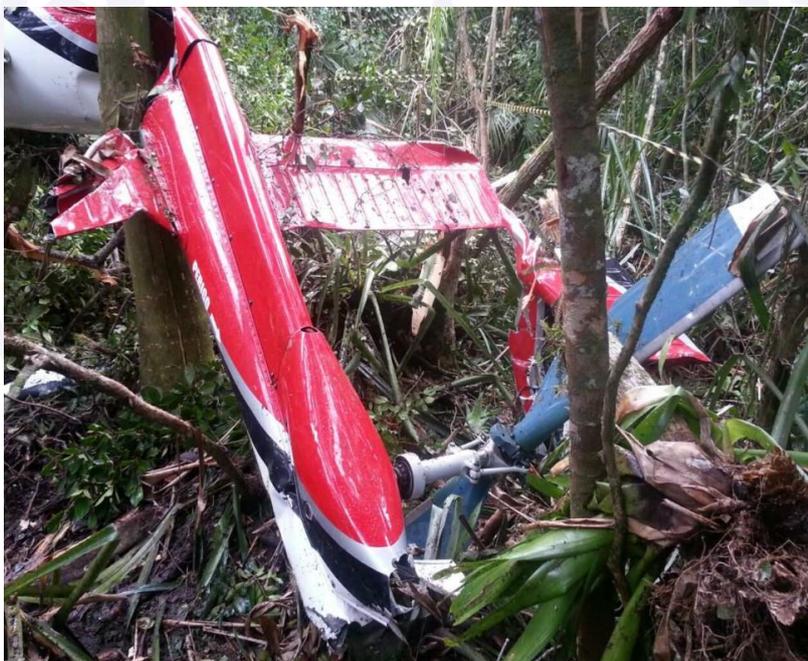
The first impact occurred in a tree at 10m, at an angle of approximately 45°. There was fire after the impact. The entire cabin was consumed by fire. The tail cone, the rear gearbox and tail rotor were not struck by fire and showed no signs of failure. The main rotor blades, although incinerated, and the blades of the tail rotor, indicated low rotation at the final instants of the flight. The absence of torsion in the rear drive shaft corroborates to the low rotation at the moment of impact.

Figure 1 - View of tail cone, rear gearbox and tail rotor, not hit by fire.

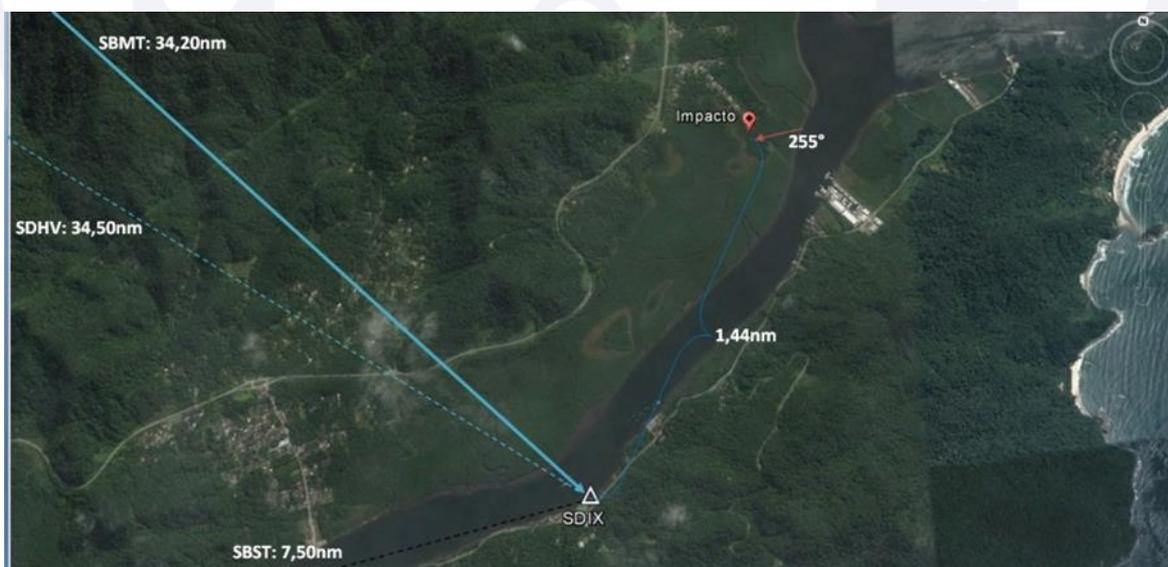
The takeoff had a normal profile, for the type of the helicopter, with northeast direction, offset with the bow of the destination, toward the point of impact. The ground collision occurred at 1.44NM in SDIX. The route taken between takeoff and impact could not be determined.

Figure 2 - Sequence of events and location of the accident.
