**COMANDO DA AERONÁUTICA**  
**CENTRO DE INVESTIGAÇÃO E PREVENÇÃO DE**  
**ACIDENTES AERONÁUTICOS**

**FINAL REPORT**  
**A-587/CENIPA/2016**

<b>OCCURRENCE:</b>	<b>ACCIDENT</b>
<b>AIRCRAFT:</b>	<b>PT-HOL</b>
<b>MODEL:</b>	<b>R22</b>
<b>DATE:</b>	<b>11JUL2012</b>

This is the Final Report of the 11JUL2012 accident with the R22 aircraft, registration PT-HOL. It was classified as “System/Component Failure”.

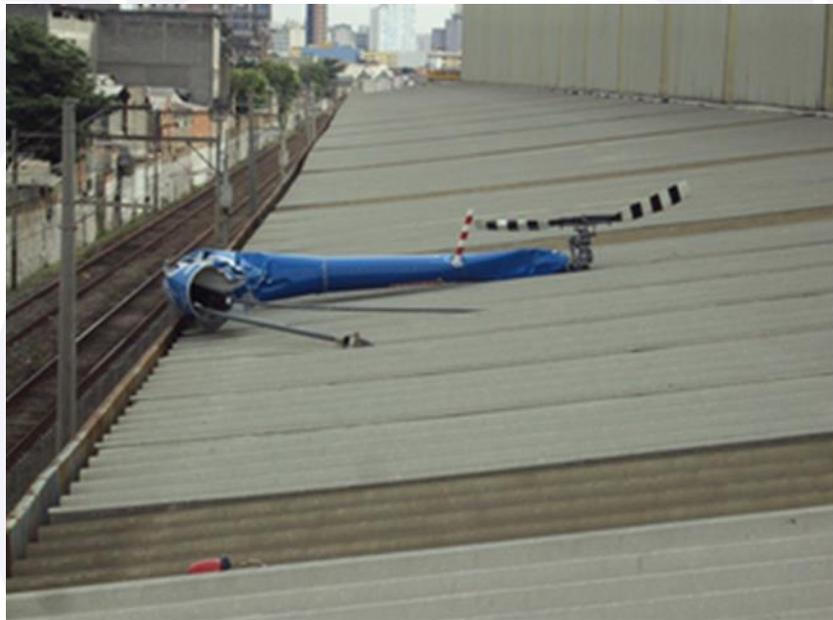
The impact was on the roof of a company's warehouse that stored large rolls of industrial reels. There was tail sectioning and it remained on a lower part of the roof (Figure 1).

Figure 1 - Tail cone on the roof / post-impact position.

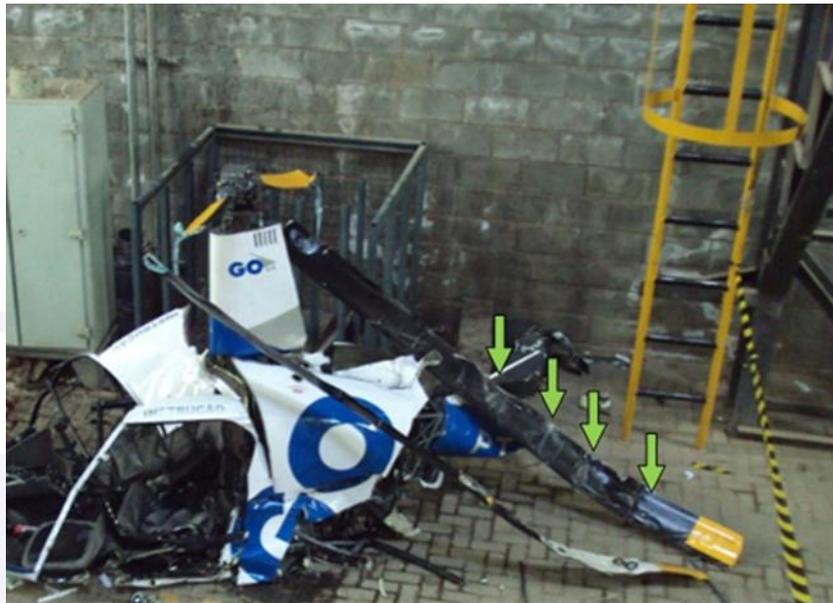
The roof was cracked in a small area. The main rotor blades had characteristic "wrinkle" damages. There were also scratches in the blades, as well as the absence of damage in the leading edges, as well as fracture of the blades near the main rotor head.

The impact of the fuselage against the ground caused structural damage. The main transmission, engine accessories, fuel tanks and the rest of the fuselage were destroyed. There was fuel leakage in the place (Figure 2).

Figure 2 - Aspect of the fuselage, after the victims removal, with detail to the damages in the blades of the main rotor, in the form of "wrinkles".

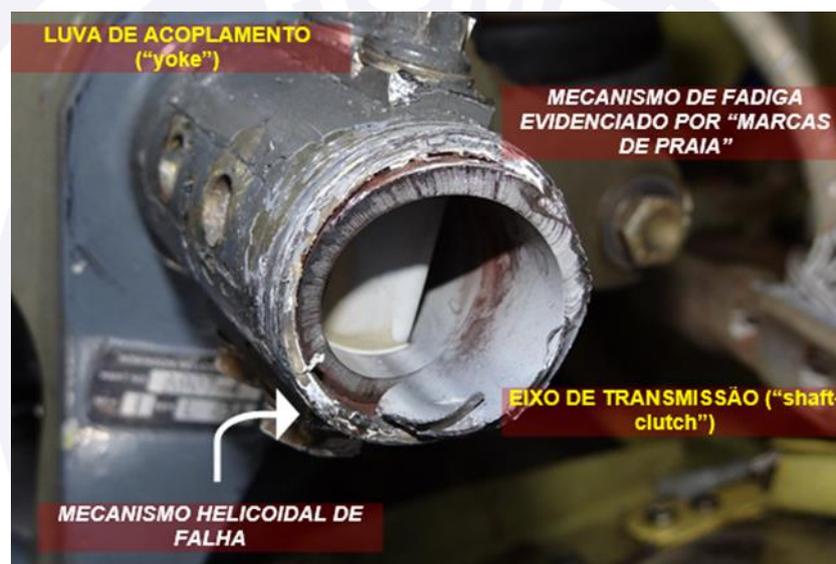
The front axle, located between the upper pulley and the Main Transmission Box (CTP), had a fracture at a 45° angle, close to the yoke and flange connecting the axle to the CTP (Figure 3).

Figure 3 - Detail of the crack formation in the helical direction, in the transmission shaft.

It was observed a break in the power transmission shaft, part number - PN A166-1, due to fatigue mechanism. It started by corrosion in the transmission shaft fixing hole to the yoke, PN A907-4, by the gearbox's side.

The crack progressed helically on the axis, and as it reached the yoke's end, the catastrophic failure of the set occurred. This has caused an interruption in the transmission of power from the engine to the gearbox.

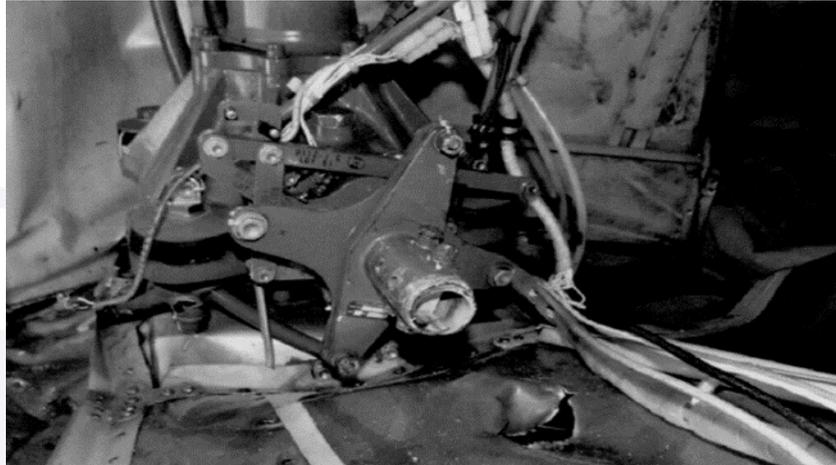
The yoke, Figure 4, apparently had adequate attachment to the shaft, and two screws and one block, accompanied by "lock-nuts", provided the adjustment. Still, in the firewall, below the fractured region of the shaft, there was a dent with a crack. The axis and the other components of the fractured region were also submitted to a technical analysis of the DCTA.

Figure 4 - Overview of the Yoke, still assembled in the gearbox.

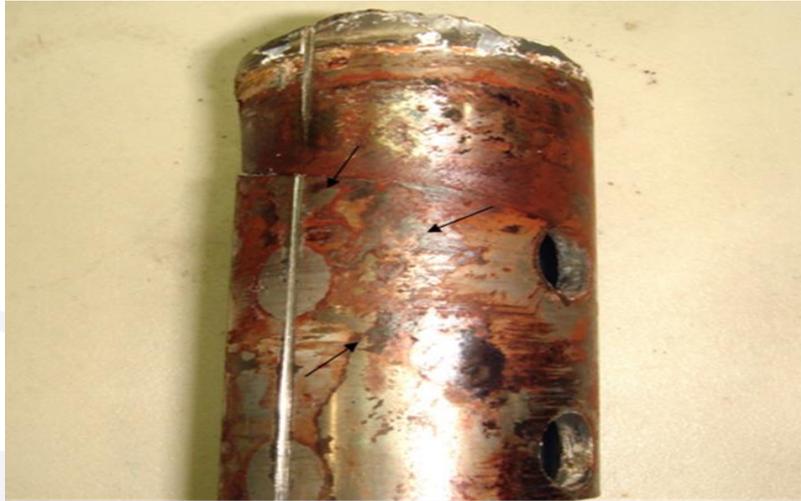
In addition, another DCTA report pointed out this conclusion, also based on the fact that there was no trace of applied product between the shaft and the yoke: (Figure 5)

The performed analyzes indicated that the failure of the power transmission shaft occurred through a fatigue process initiated in one of the shaft fixing holes with the coupling to the CTP. The initiation of the process was facilitated by the occurrence of corrosion. No protection was observed on the contact surfaces between the parts to prevent corrosion.

Figure 5 - Fretting marks on the fractured power transmission shaft, with no trace of product applied for protection.

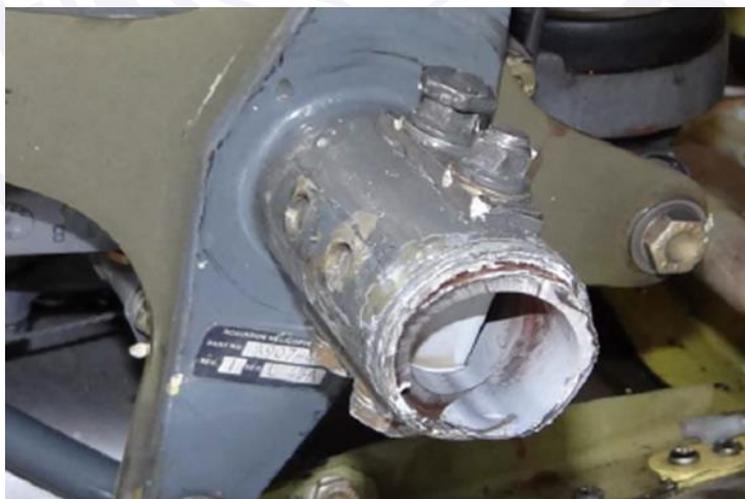
Visual examinations performed on the yoke-shaft power transmission received indicated that the manual procedures were not followed.

Figure 7 shows the set still assembled, after the fracture, indicating that item 5 of the sealing procedure of the assembly was not performed with primer.

Figure 7 - General aspect of the received power transmission yoke-shaft.

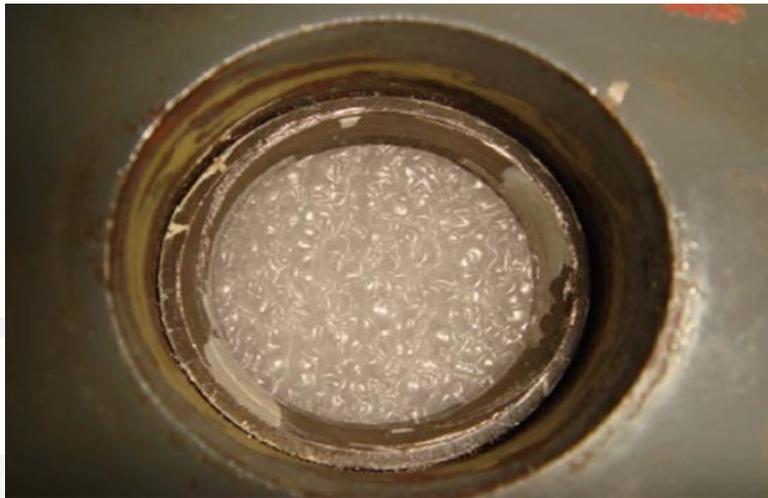
Figure 8 shows the rear view of the set indicating that there was also no sealing of the yoke-shaft with the primer.

Figure 8 - Rear view of the set: yoke - transmission shaft. It is noted that there was no sealing with primer.

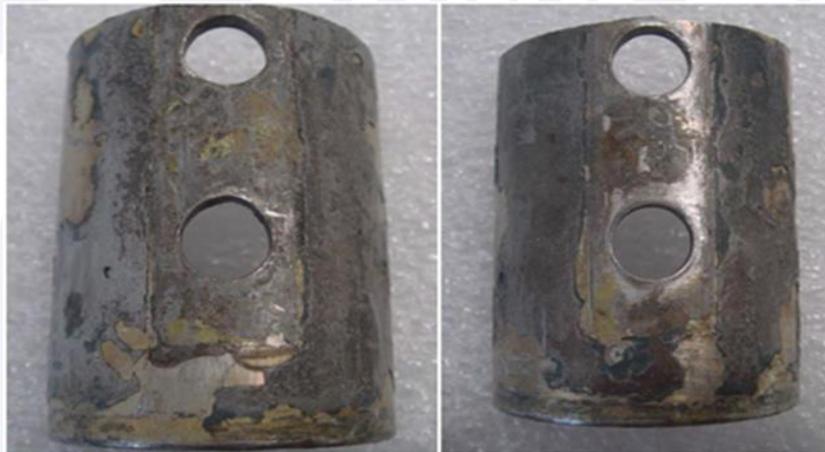
Figure 9 shows the regions of fixation of the support blocks after their removal, indicating that in the region of the interface of the axis with the blocks, there was no removal of the ink from the shaft.

Figure 9 - Aspect of the regions of the axis where the external support blocks are placed. It is noted that the ink was not removed from the settling region of the blocks.

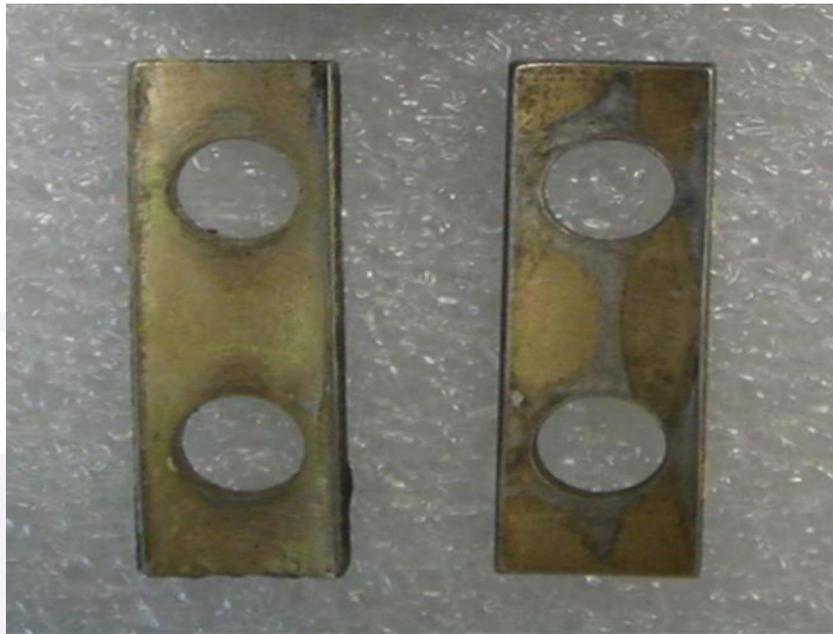
The blocks were screwed on top of the paint and not on the recommended primer. Figure 10 shows that there was no application of the primer on the contact surfaces of the support blocks. Therefore, items 1 and 4 of the installation procedure have not been performed.

Figure 10 - Appearance of the laying regions on the shaft of the outer support blocks. It is noted that there is no presence of primer.

Failure to comply with items 1, 4 and 5 of the maintenance manual installation instructions facilitated the occurrence of fretting and corrosion, which led the shaft to fatigue failure.

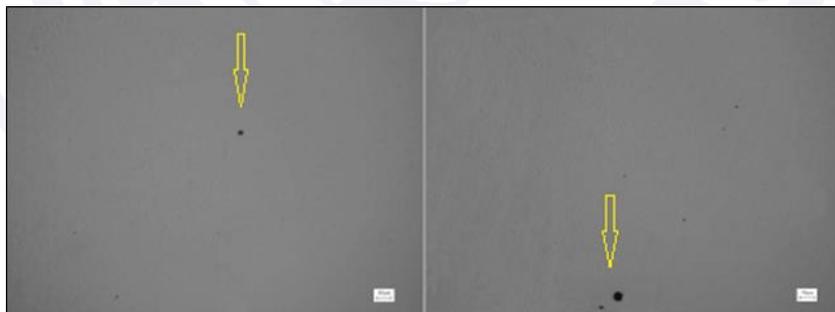
The inclusion level verification was performed by image analysis in an area close to the fracture, and the presence of globular type D inclusions was verified above the maximum width allowed by the ASTM E45 standard, which is  $13\mu\text{m}$ . Twelve inclusions of type D with widths between  $13.68\mu\text{m}$  and  $27.98\mu\text{m}$  were observed, as shown in Figure 11.

Figure 11 - Aspect of two of the observed fields, with globular inclusion with  $13.68\mu\text{m}$  and  $27.98\mu\text{m}$  width.

Also, according to the report, the results obtained in the evaluation of the material of the shaft did not indicate that it influenced the fracture process, despite the presence of some inclusions above the maximum size indicated by the standard.

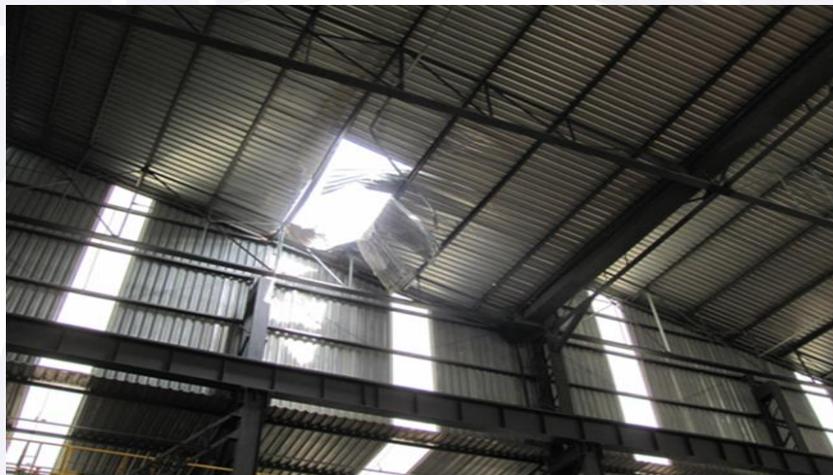
The helicopter collided the tail cone, practically at its root, against the side structure of the roof of a large warehouse of steel reels. The metal structure of the roof in this building did not support the weight of the rest of the device. Considering the direction of approach, there was a yard for car maneuvers after the warehouse, free of obstacles (Figure 18).

Figure 19 - Aspect of the roof of the warehouse, being visible the part without cover, where the fuselage of the PT-HOL entered.

Evidence found in the main rotor and tail rotor as well as the damage suffered by the roof of the shed indicated that the rotors were with low rotation and the aircraft with little displacement ahead, that is, reduced speed.

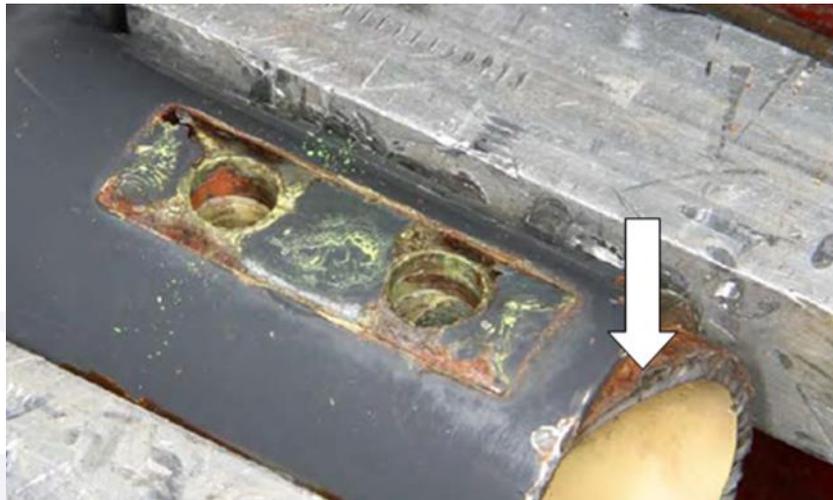
The Commission had access to R-22 accidents reports in Australia, similar to that one with PT-HOL, namely: VH-HFP in 1992, VH-UXF in 2003 and VH-HXU in 2005. In all occurrences, there was failure in the transmission shaft, loss of connection of the "yoke" assembly under study, lack of use of specific product or even the use of non-suitable product in the contact area as a contributing factor, in two of these three occurrences (Figure 20).

Figure 20 - Detail of Yoke and Transmission Shaft PN of R-22 VH-UXF, with helical fracture mechanism, where no predicted product was applied between the items, as well as their assembly with original painting. Source: Report 200304074, Australian Government - Civil Aviation Safety Authority.
