COMANDO DA AERONÁUTICA
CENTRO DE INVESTIGAÇÃO E PREVENÇÃO DE
ACIDENTES AERONÁUTICOS

FINAL REPORT
A - 091/CENIPA/2014

OCCURRENCE:	ACCIDENT
AIRCRAFT:	PT-HTQ
MODEL:	206L-3
DATE:	03MAY2014

This is the Final Report of the 03MAY2014 accident with the 206L-3 aircraft, registration PT-HTQ. The accident was classified as "System/Component Failure".

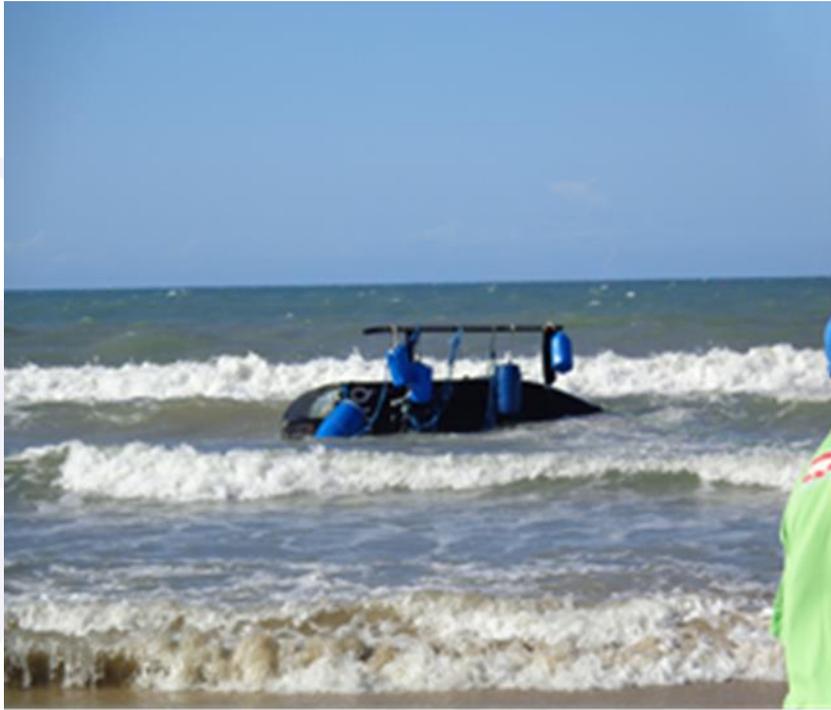
The wreckage of the aircraft remained submerged for approximately 48 hours, being removed from the sea by the team of the Military Fire Brigade of the State of Ceará (Figures 1 and 2).

Figure 1 – Removal of the aircraft's wreckage from the sea.

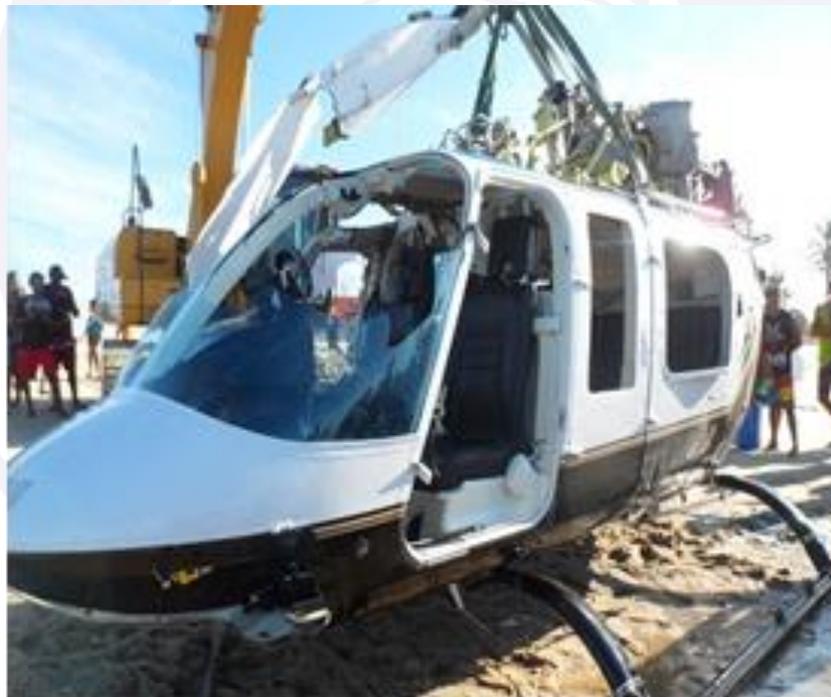
The aircraft suffered substantial damage in the engine, transmission, main rotor, tail rotor, cockpit and also in the rear fuselage.

Figure 2 - Damage to the aircraft.

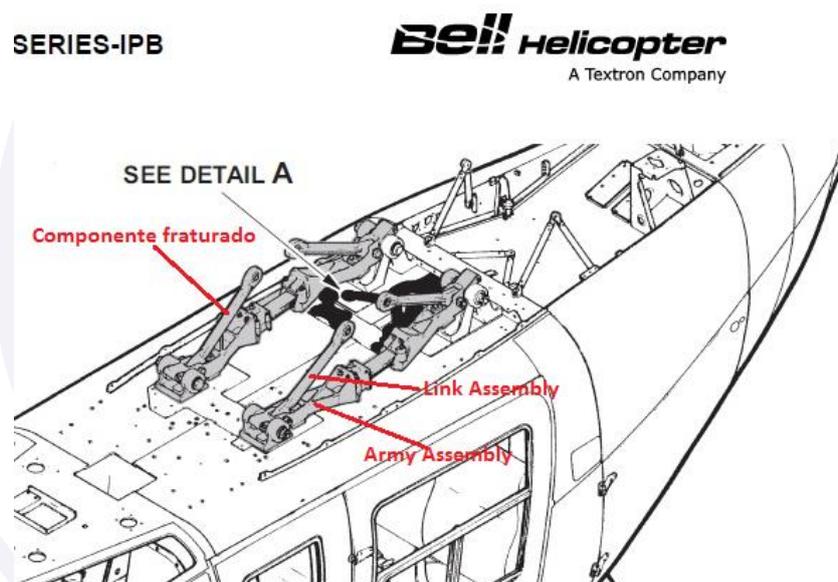
During the analysis of the whole transmission of the helicopter, it was observed that the right front Link Assembly (P / N 206-033-554-101) item was fractured. The component consisted of an aluminum alloy rod, which fixed the aircraft cell to the main rotor transmission through the Arm Assembly (P / N 206-033-505-001) (Figure 3).

Figure 3 - Assembled components on the aircraft.

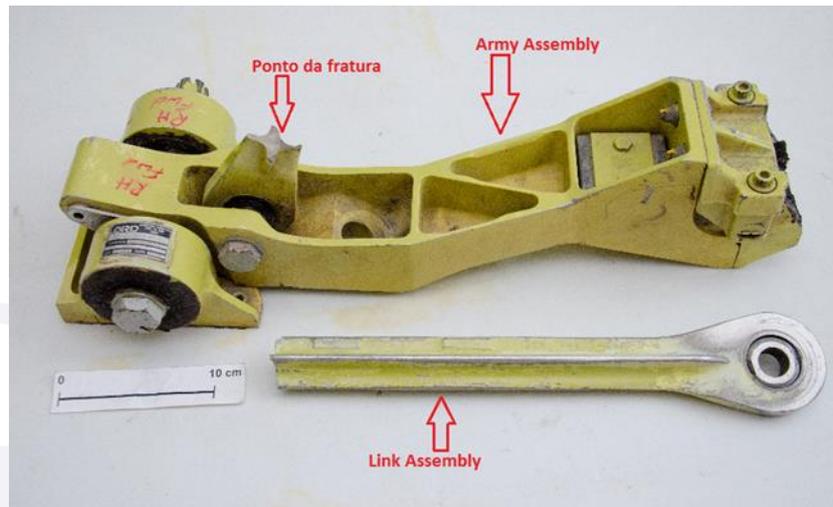
The component was sent to the laboratories of the DCTA, in order to be submitted to component failure analysis (Figure 4).

Figure 4 - Overview of the fractured component sent to the DCTA.

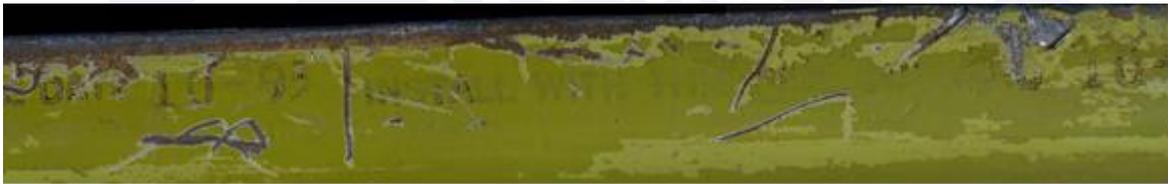
A report of the component failure analysis of the PT-HTQ aircraft's Transmission Box was prepared by the DCTA. The visual analysis of the fractured rod (link assembly) indicated the presence of impact marks, dents and wear on the surface (Figure 5)

Figure 5 - Surface details of one side of the rod with the presence of impact marks, dents and wear.

The failure of the aluminum rod occurred due to fatigue. Impact marks, kneading, and wear have been observed on the rod surface. In the region of the beginning of the fatigue, the presence of a thinning, probably by sanding, was observed.

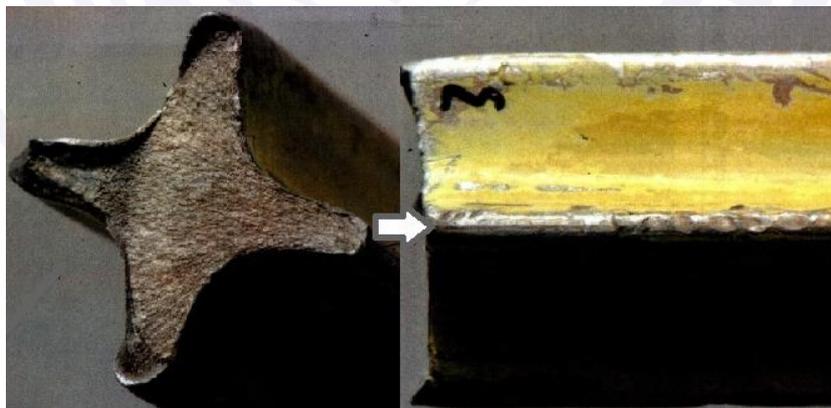
The scanning electron microscopy (MEV) analysis on the surface of the fracture indicated the probable onset of rupture (Figure 6).

It was not possible to detect striations due to the oxidation action on the surface of the fracture. There was evidence of wear, probably due to sanding, in the region of the beginning of the fracture.

Figure 6 - General view of the fractured rod in the region of probable beginning of fatigue with the presence of kneading.

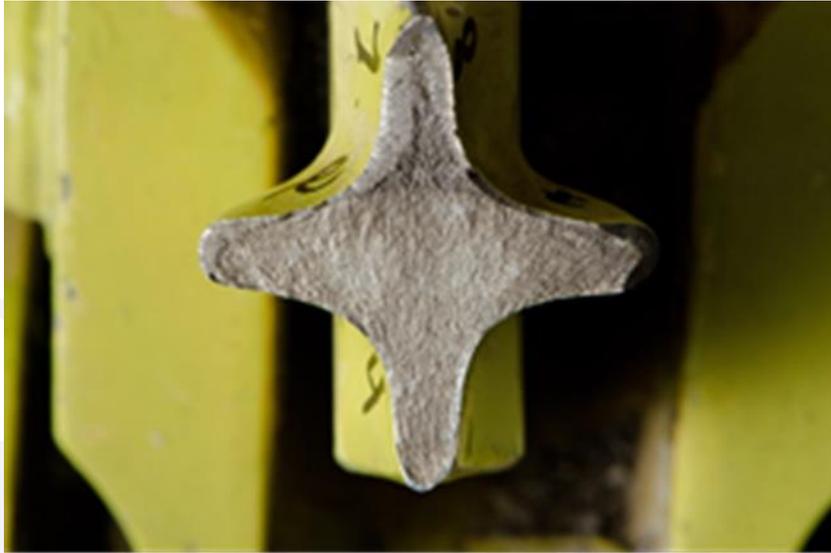
The stereoscopic analysis of the fractured surface showed the presence of "beach marks" indicative of material fatigue (Figure 7).

Figure 7 - Detail of the fracture with the presence of fatigue.

Another result of the laboratory analyzes found that the rupture in the Right Front Link Assembly occurred due to fatigue, and that the fractured region was a point of concentration of tensions. In addition, in the region of the beginning of the fatigue, the presence of a thinning probably caused by sanding was observed.

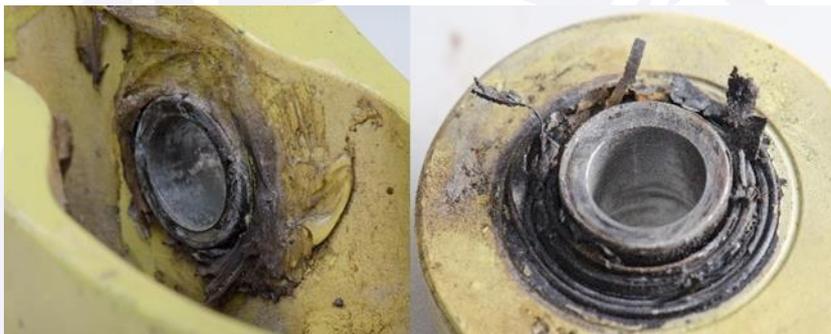
The stereoscopic analysis of the eyebolt region showed wear of the polymer material as well as the eccentric position of the fractured rod. Loss of polymer material, metal component clearance and degradation of the polymeric material can also be observed (Figure 8).

Figure 8 - Wear and degradation of the polymeric material.

The elastomer showed degradation with loss of material, which can cause clearance in the working region, inducing vibrations to the assembly and introducing unplanned efforts in the rod, which associated with the thinning observed in the region of onset, can facilitate the occurrence of the fatigue process. It should further be noted that the region of the fatigue rupture is a region of variation of the component section, in other words, a natural region of stress concentration.

The tests also showed degradation of the polymer material (elastomer), causing metal component clearance in the right front Link Assembly bearings. The degraded state of the elastomers (including loss of material) could have caused clearance in the working region of the component, inducing vibrations to the assembly and introducing unplanned forces into the rod, facilitating the fatigue process and subsequent in-flight rupture.

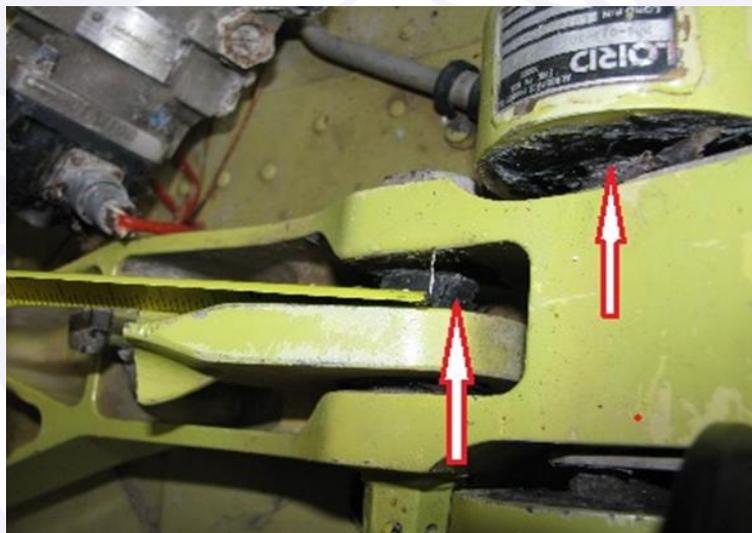
It was observed that a layer of sealant covered the Link Assembly and Arm Assembly elastomers.

Figure 9 - Presence of sealant on the Arm Assembly and Link Assembly elastomers.

It was not possible to identify when the sealant was placed on the elastomers of the Link Assembly and the Arm Assembly of the aircraft. The Aircraft Maintenance Manual did not contain any mention of the use of sealant in the Arm and Link Assemblies. There was no traceability of the Arm Assembly and Link Assembly in the helicopter documentation.

During the investigation of the occurrence, it was observed that the elastomers of the Link and Arm Assemblies were covered by a layer of sealant, a procedure not contemplated by the Maintenance Manual of the aircraft.

The aircraft maintenance program prescribed that the Link Assembly should be inspected every 100 hours for damage and deterioration. Although performed, maintenance interventions were impaired, because the presence of the sealant prevented the visualization and evaluation of the elastomers' state of conservation.

Improper application of sealant to the elastomer of the right front Link Assembly of the aircraft prevented the visualization of the deterioration of the polymer material, with the metallic component having a clearance in the bearings, which associated to the thinning in the part, resulted in the fracture of the item in flight.

Act next to the TC Helicopter Maintenance shop Ltd. (shop that performed the last inspection of the aircraft) to ensure that the maintenance procedures performed on Bell 206L-3 aircraft are in accordance with the manufacturer's manual.

Act with the TC Helicopter Maintenance shop Ltd., in order to improve the supervision mechanisms of the work performed in the aircraft maintenance.

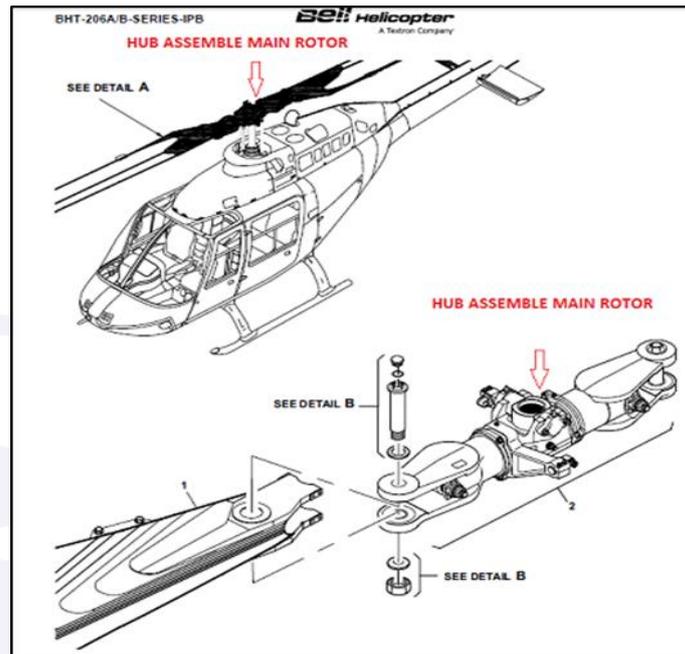
The helicopter bearing control was performed by moving the Hub Assembly Main Rotor, a component located in the transmission assembly that interconnected the main rotor-oscillating disc to the main rotor blades (Figure 10).

Figure 10 - Hub Assemble Main Rotor Bell 206.
