FINAL REPORT
A-173/CENIPA/2015

OCCURRENCE:	ACCIDENT
AIRCRAFT:	PT-HZL
MODEL:	AS 350 B2
DATE:	13DEC2015

This is the Final Report of the 13DEC2015 accident with the AS 350 B2 aircraft, registration PT-HZL. It was classified as (CTOL) "Collision with Obstacle during Take-off and Landing".

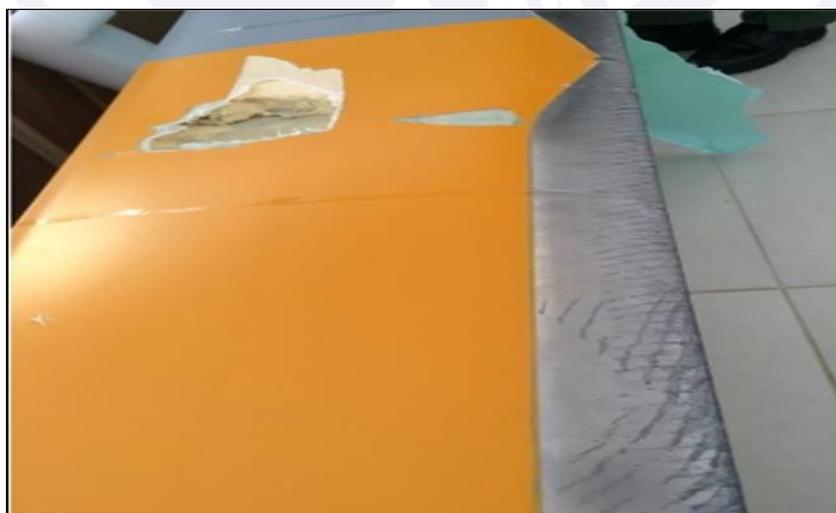
The crew realized the collision and continued on the flight for another 18 minutes until the return to its operational base in Lages (SBLJ). After landing, on post-flight inspection, damage (missing one piece) was found in the median position of the main rotor blade upper camber and a fracture in its lower camber.

Damage to the yellow blade of the main rotor.

Figure 01 - Image of the damage on the upper camber of the yellow blade.

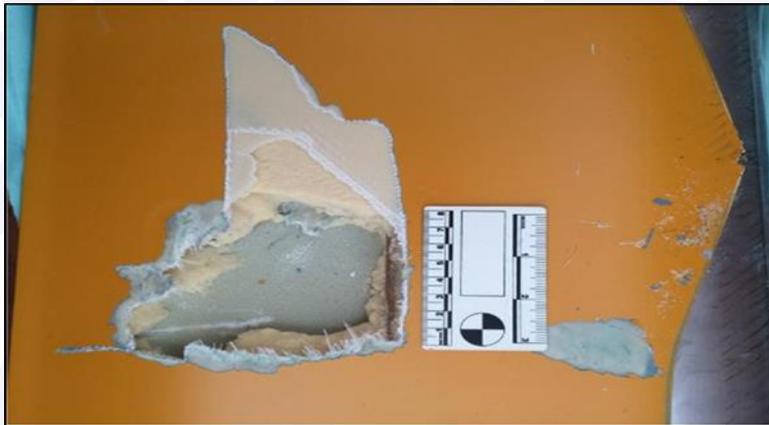
In the exams, the lack of part of the upper camber (8cm x 16cm hole) and a crack of 12cm in the lower camber of the yellow blade of the main rotor were verified (Figures 2 and 3).

Figure 2 - Dimension of damages on the upper camber of the blade.

The damaged blade had total loss, according to the AEROMOT shop. According to this company, there was no damage to the engine or the main gearbox.

The impact caused a hole in the upper camber and a crack in the lower camber of one of the main rotor blades, but the aircraft proceeded back to its operational base.

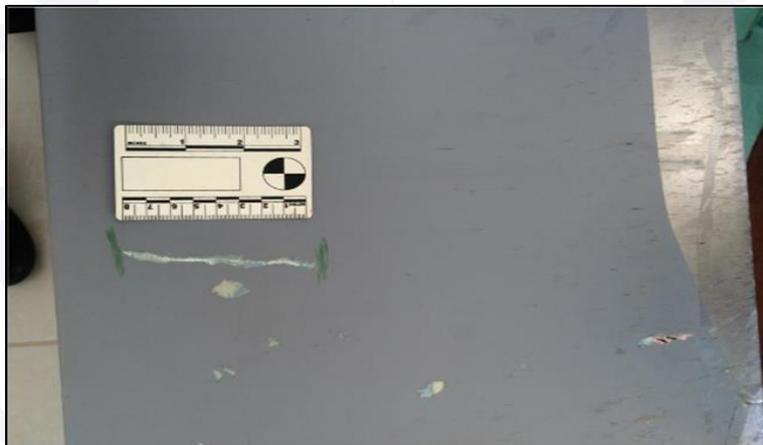
Figure 3 - Dimension of cracks in the lower camber of the blade.
