FINAL REPORT
A-193/CENIPA/2013

OCCURRENCE:	ACCIDENT
AIRCRAFT:	PT-HZQ
MODEL:	AS 350 B2
DATE:	27OCT2013

This is the Final Report of the 27OCT2013 accident with the AS 350 B2 aircraft, registration PT-HZQ. It was classified as “Loss of Control in Flight”.

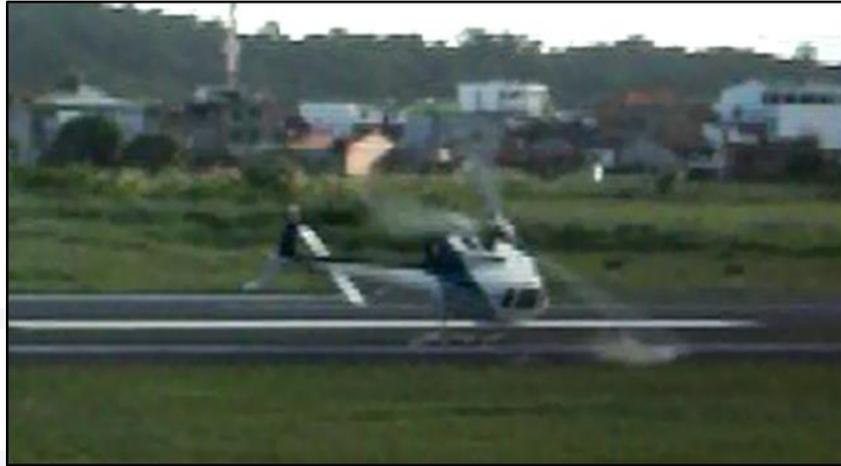
Upon completion of the fifth turn on the landing / take-off runway, the aircraft entered a downward trajectory to the right until the touch of the main rotor blades on the asphalt, followed by the flipping over to the right side (Figure 1).

Figure 1 - Moment of the aircraft's impact.

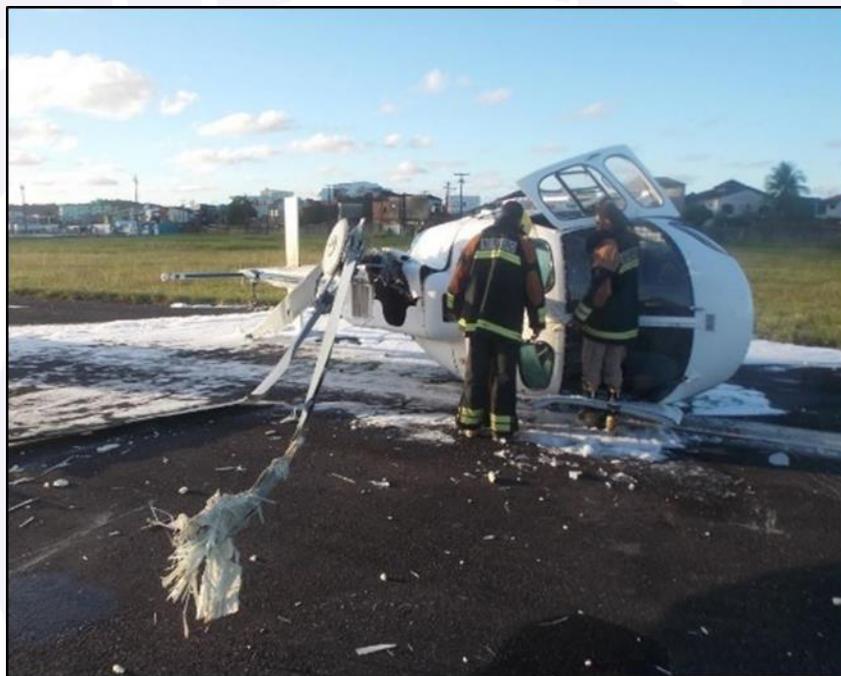
The aircraft had substantial damage throughout the main rotor assembly, gearbox, horizontal stabilizer, right-side ski and fuselage.

The helicopter toppled over the 1000ft mark on the head of runway 29 (Figure 2).

Figure 2 - Aircraft wreckage.

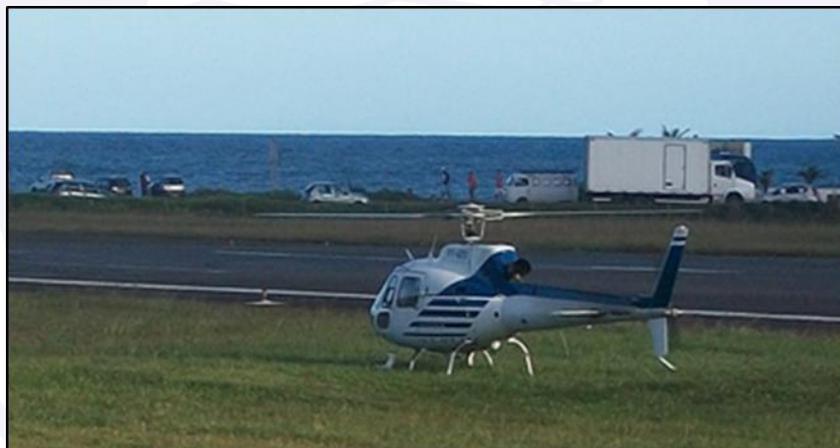
Figure 3 - View of the aircraft in the grassy area.

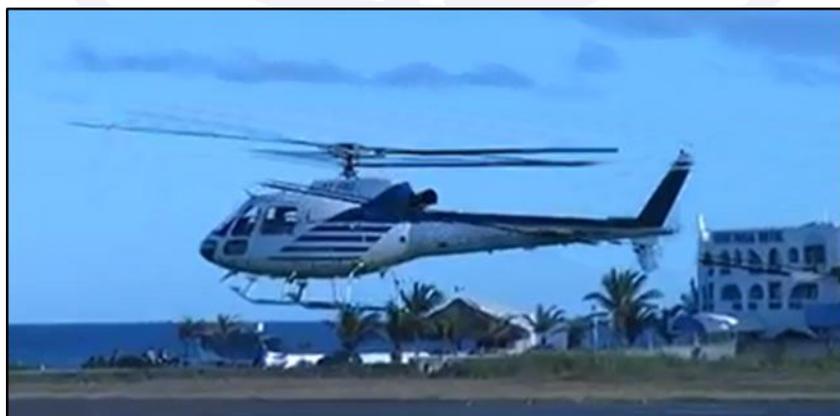
Figure 4 - View of aircraft performing approach maneuver.

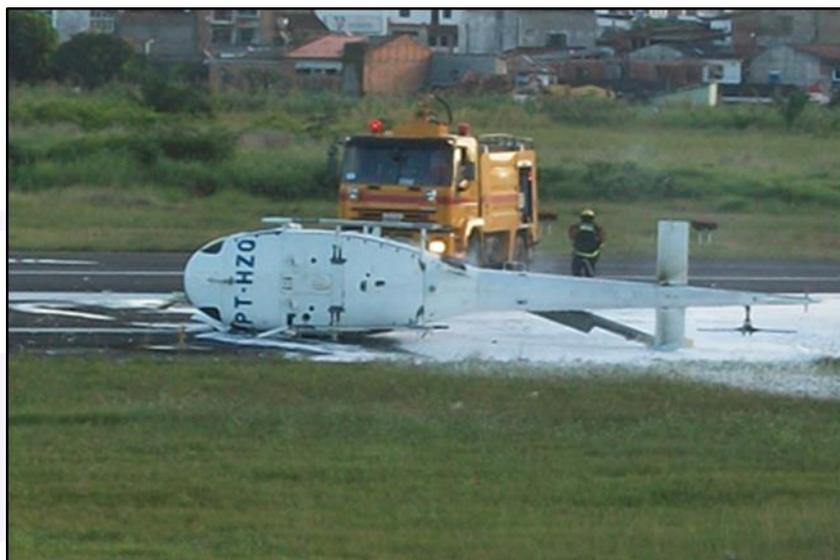
At 19h45min02sec (UTC), there was the last communication between the pilot of the aircraft and the APP-IL, followed by the accident (Figure 5).

Figure 5 - View of the aircraft after the accident.

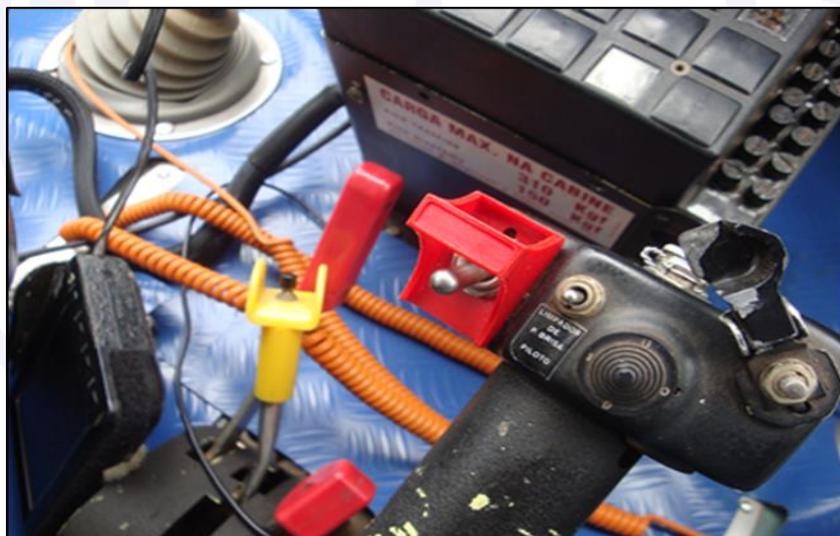
During the first action, it was observed that the cut-off switch of the aircraft's hydraulic system was OFF (Figure 6).

However, due to the actions arising from the removal of the aircraft, such information could not be adequately considered since third parties may have handled this key.

Figure 6 - Hydraulic system cut off switch in OFF.

- the removal of the hydraulic system caused rapid changes in the intensity and direction of the forces exerted to maintain control of the aircraft, causing an overload of work of Commander; and
