FINAL REPORT
A - 005/CENIPA/2015

OCCURRENCE:	ACCIDENT
AIRCRAFT:	PT-NAB
MODEL:	EMB-710C
DATE:	10JAN2015

This is the Final Report of the 10JAN2015 accident with the EMB-710C aircraft, registration PT-NAB. The accident was classified as “Engine Failure in Flight”.

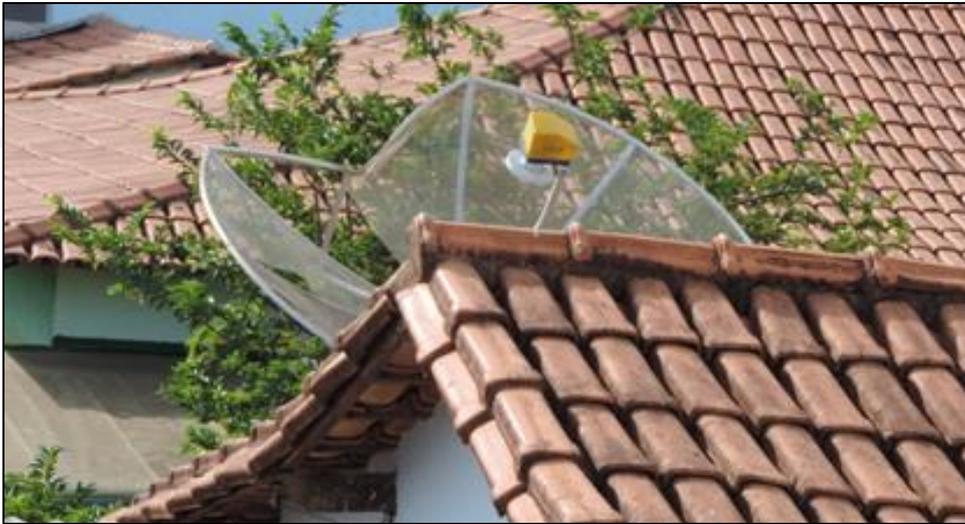
The first impact was against a satellite dish, 26,40 meters away from the site of the wreckage.

Figure 1 - View of the first impact site.

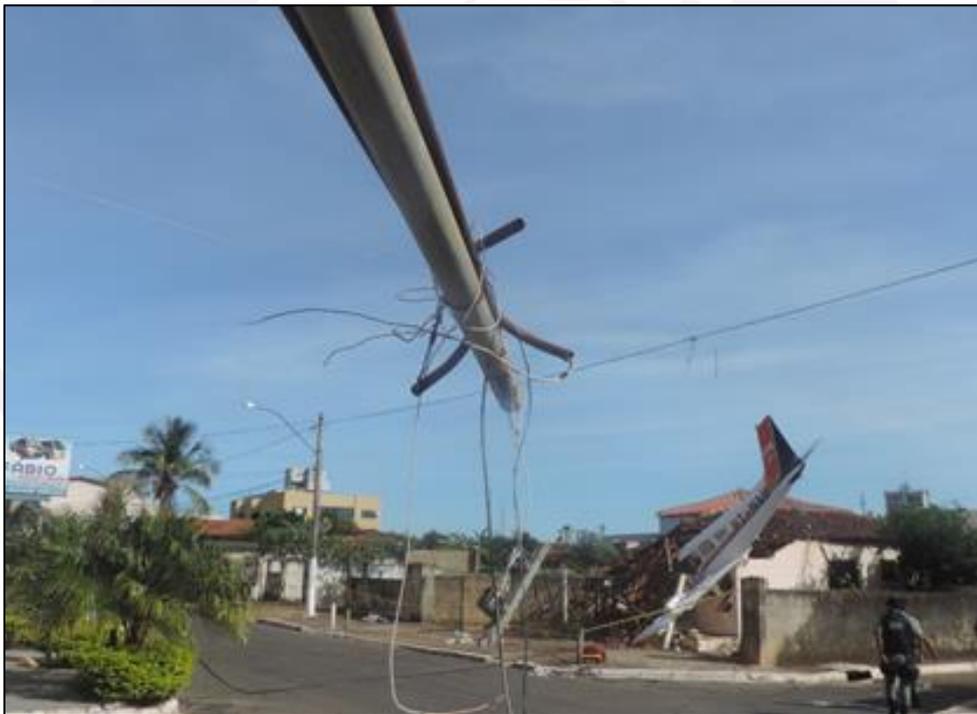
After this first impact, the aircraft crashed into a residential power pole, away from the satellite dish, broke a low voltage wire and crashed into a building at an angle of approximately 14°.

Figure 2 - Residential power pole and the aircraft wreckage.

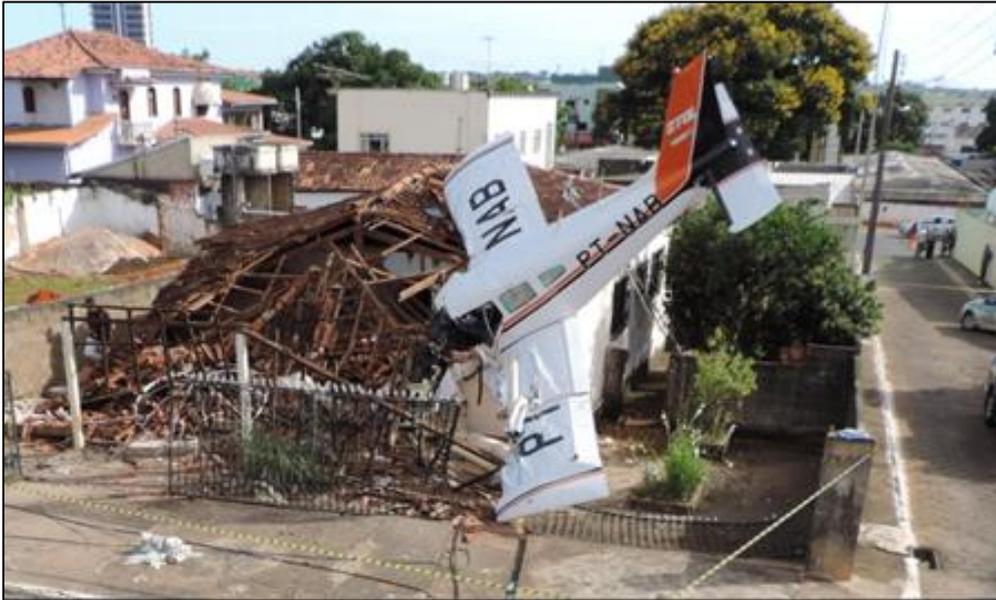
As it collided with this building, the aircraft had a yaw to the left, of about 30°, and stopped in a pitch down attitude of approximately 44°.

Figure 3 - View of the aircraft after the last impact.

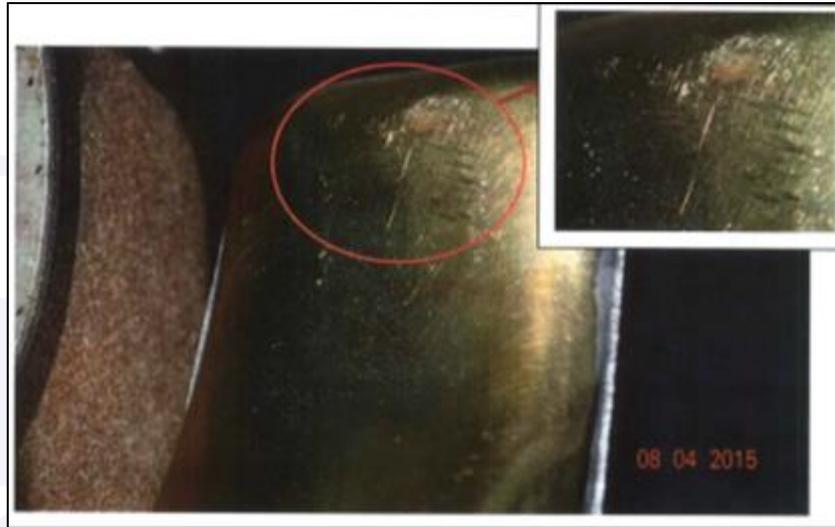
The Marvel-Schebler carburetor, model MA-4-5, PN 10-5054, serial number BZ-12895, installed in the engine, had float metal floats. As shown in Figure 4, they had scratching marks against the walls of the tub.

Figure 4 - Scratch marks observed in the carburetor float.

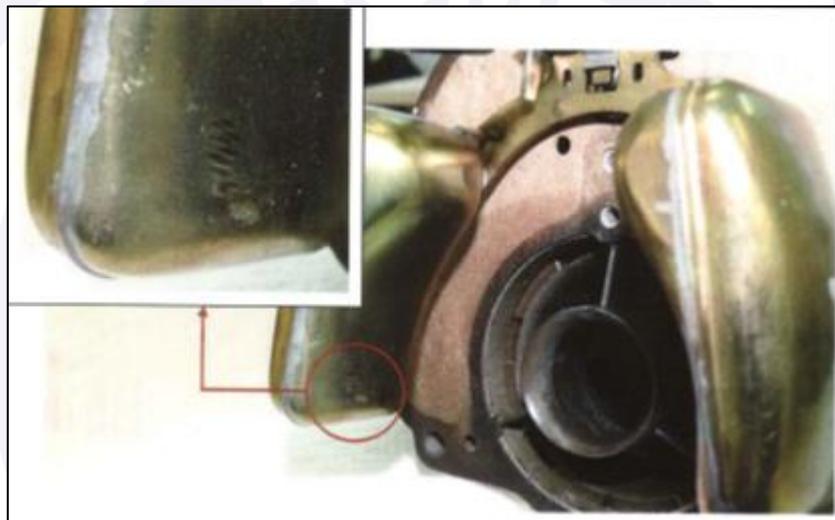
Figure 5 - Detail of the scratch marks observed in the carburetor float.

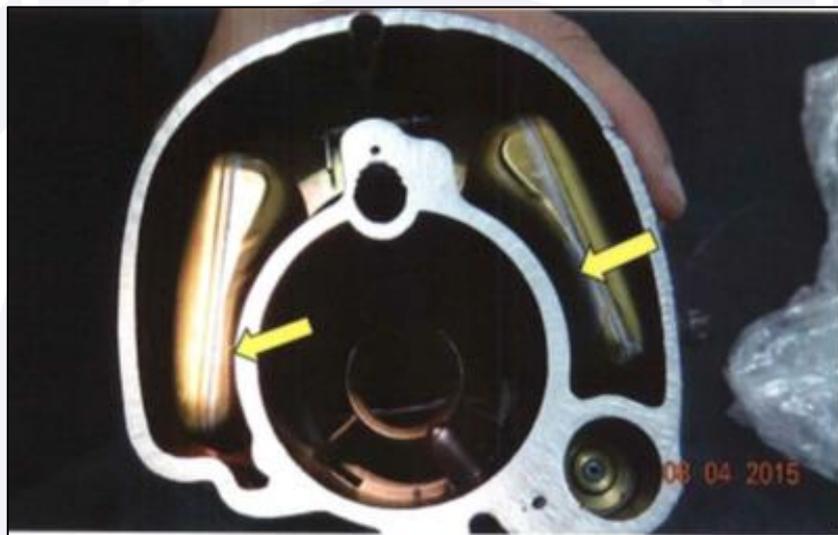
As can be seen in Figure 7, the float buoys were not centered on the carburetor.

Figure 7 - View of the tool assembled on the carburetor cap, according to Installation Instruction E-1002, showing that the float was not centered inside the tank.

Failure to carry out the revision of the Marvel-Schebler carburetor model MA-4-5 and non-compliance with the Service Bulletins SB-2 Rev B of 22JUN2009 and SB-4 Rev B of 02SEPT2009 contributed to the non-identification of the warping of the carburetor rod and the insufficient spacing between the float and the walls of the component tank.

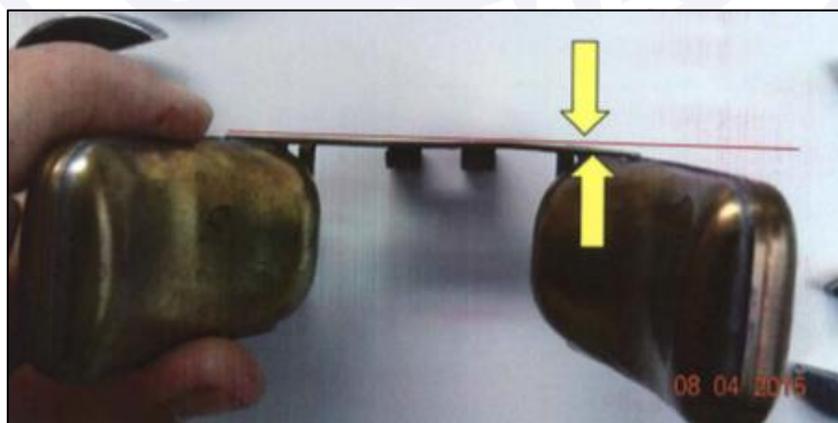
After the disassembly of the buoys, a deformation of its rod was observed, as shown in Figure 8.

Figure 8 - View of the deformation observed on the float rod.

Regarding the warping of the float rod, it was not possible to determine whether it was the cause or effect of the float friction against the walls of the carburetor tub.
