FINAL REPORT
A - 133/CENIPA/2017

OCCURRENCE:	ACCIDENT
AIRCRAFT:	PT-ORU
MODEL:	210N
DATE:	22OCT2017

This is the Final Report of the 22OCT2017 accident with the 210N aircraft, registration PT-ORU. The accident was classified as “[LALT] Low Altitude Operations”.

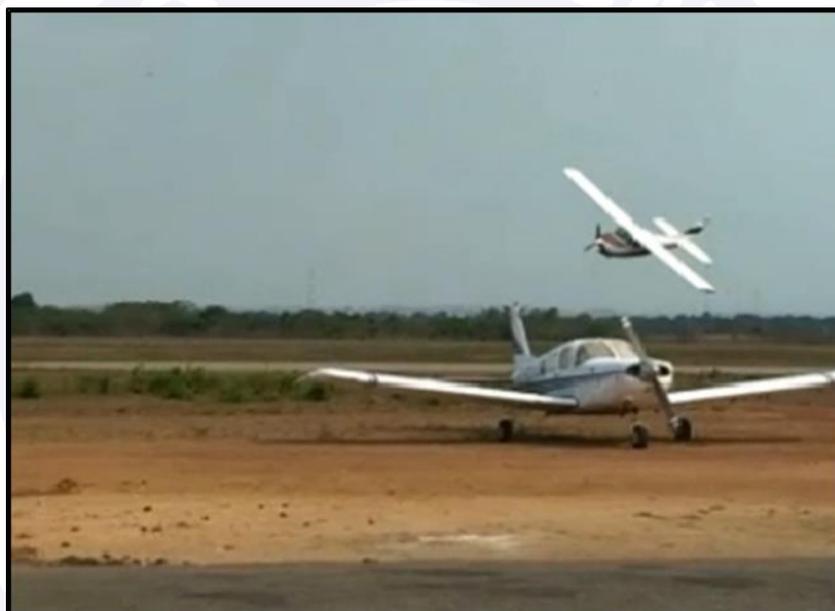
Figure 1 - PT-ORU Low altitude pass on one of the flights preceding the accident.

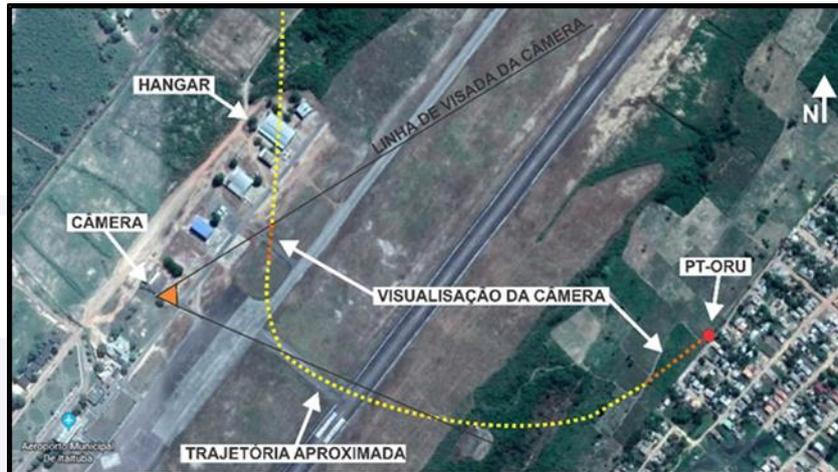
The take-off occurred at 2101 (UTC). However, about 4 minutes after takeoff, another security camera recorded the aircraft making a low altitude pass and performing a

rapid ascent. Soon after the aircraft appeared in recovery and colliding against the ground (Figure 2).

Figure 2 - Sketch of the accident, with the line of sight of the safety camera and approximate trajectory of the aircraft until the impact.

According to information, the aircraft would have performed an acrobatic maneuver (*tonneaux*), but this was not successful.

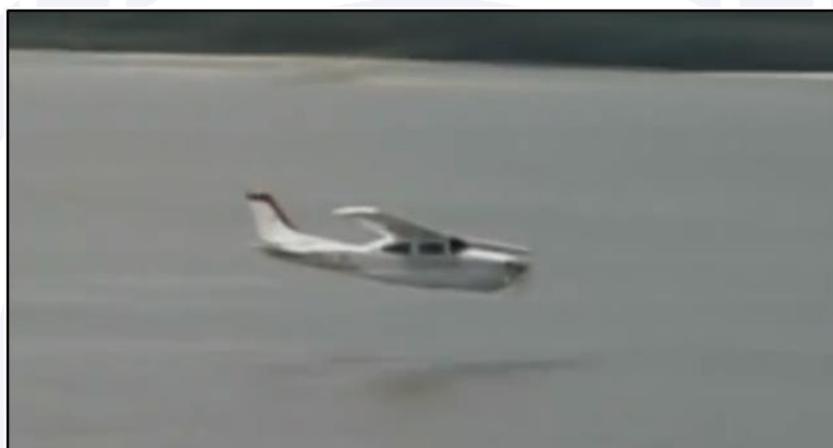
During the investigation, it was verified that it was culture of the regional pilots' group to carry out these types of flight, including several videos and reports in this regard (Figures 3 and 4).

Figure 3 - Image of the Tapajoara TV with an aircraft passing about 10ft over the Tapajós River, in Itaituba - PA, on the Aviator's Day.

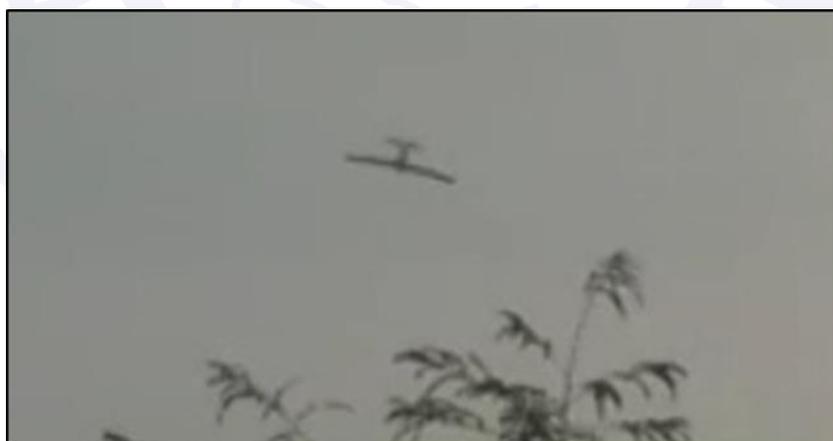
Figure 4 - Image of social medias in which an aircraft performs acrobatic maneuver in Itaituba - PA.
