**FINAL REPORT**  
**IG - 099/CENIPA/2014**

<b>OCCURRENCE:</b>	<b>SERIOUS INCIDENT</b>
<b>AIRCRAFT:</b>	<b>PT-WHT</b>
<b>MODEL:</b>	<b>210N</b>
<b>DATE:</b>	<b>13MAY2014</b>

This is the Final Report of the 13MAY2014 serious incident with the 210N aircraft, registration PT-WHT. The serious incident was classified as "With Landing Gear".

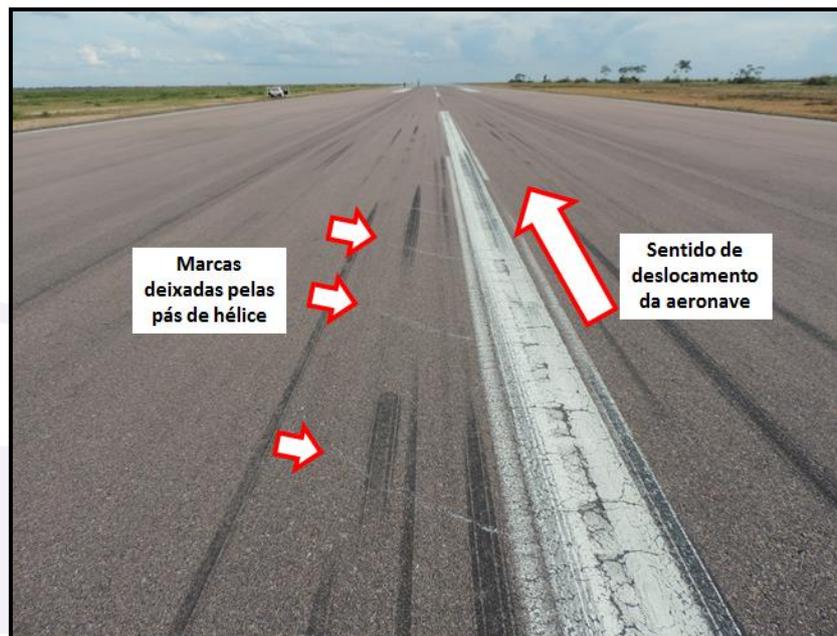
During the run, after landing on runway 21 of SWSI, just after the tire of the nose landing gear wheel touched the runway, there was the touch of the propeller blades on the ground. Then, the lower part of the fuselage, in the nose region of the aircraft, also touched the ground, dragging itself until full stop (Figures 1 and 2)

Figure 1 - Indicative arrows of the marks left by the propeller blades on the runway.

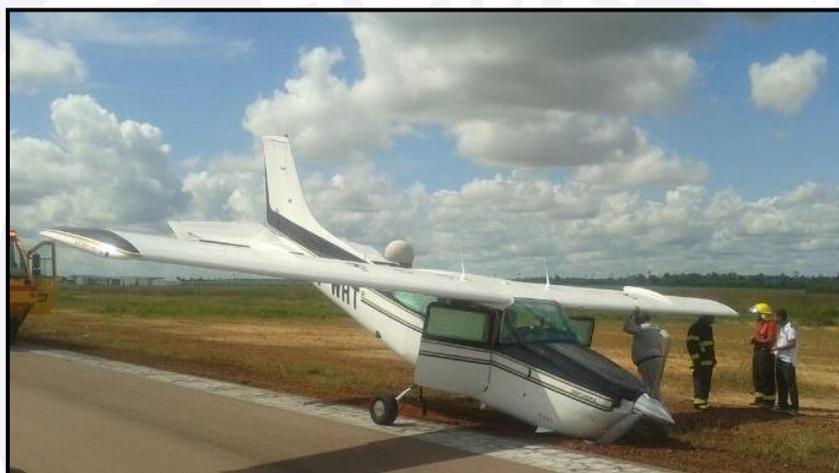
Figure 2 - Aircraft after full stop.

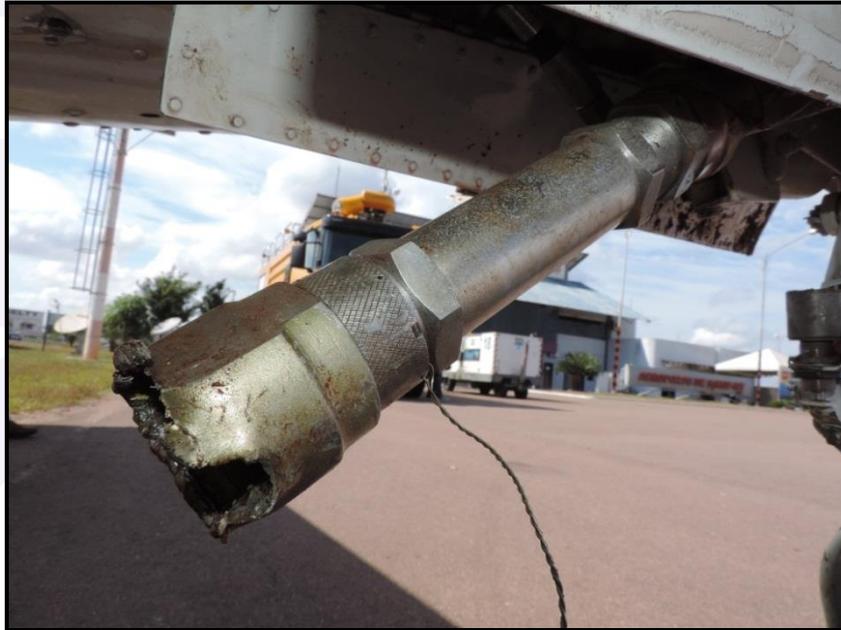
During the Initial Action, the investigation team found that the nose landing gear actuator was damaged (Figures 3, 4 and 5).

Figure 3 - Damaged nose landing gear actuator (PN 9882020-1).

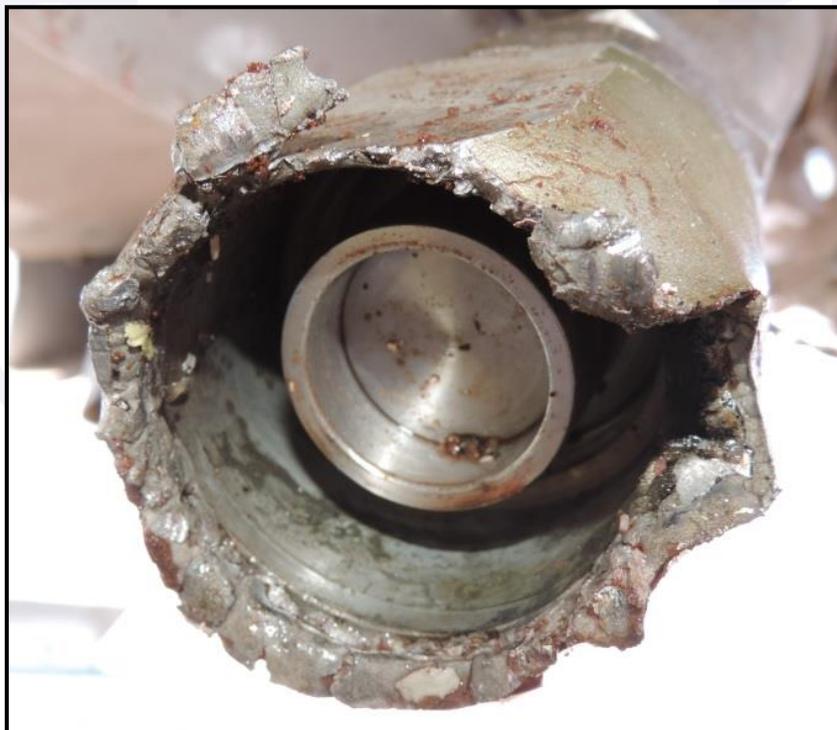
Figure 4 - Damaged nose landing gear actuator (PN 9882020-1).

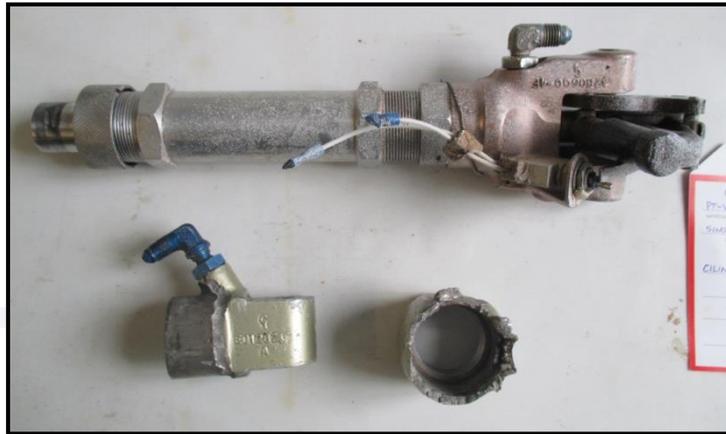
Figure 5 - Damaged nose landing gear actuator (PN 9882020-1).

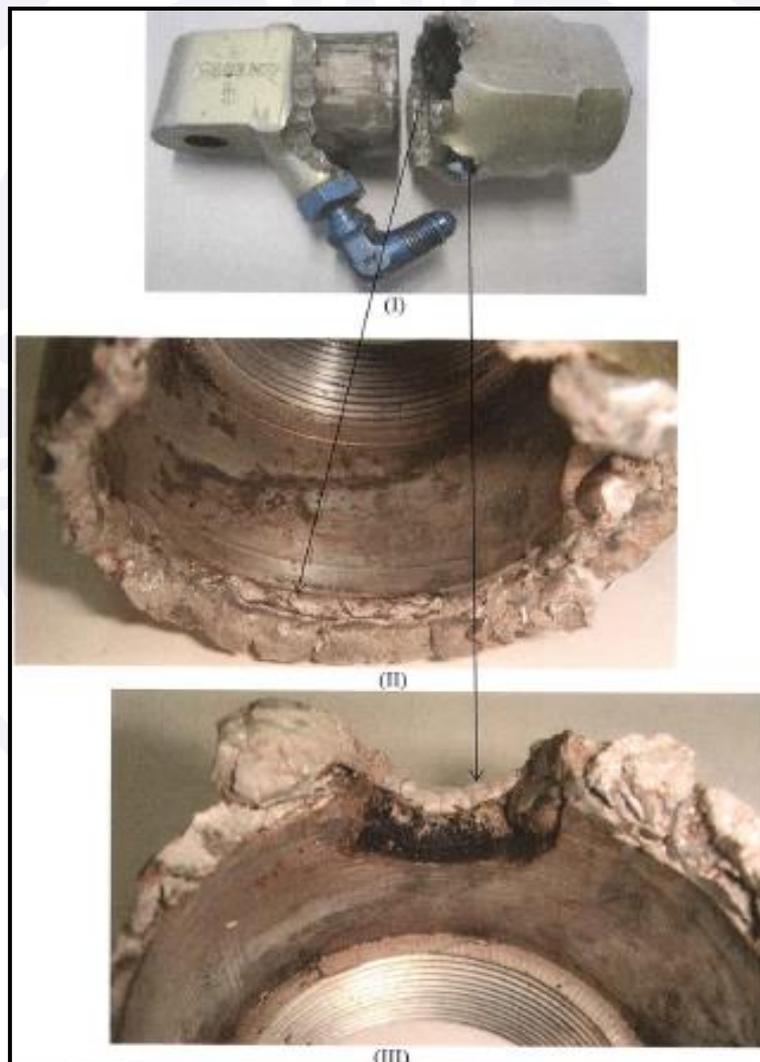
The visual analysis showed a region with typical welded joint fracture aspect, as can be observed in Figure 6 (I).

In the stereoscopic analysis, typical characteristics of a welded joint fracture were observed, as can be seen in Figure 6 (II) and (III).

Figure 6 - In (I) the fractured component can be observed; and in (II) and (III) the details of the weld region.

The fracture in the actuator of the nose landing gear (PN 9882020-1) originated in the region of weld, probably by overload. This non-designed maintenance had welding voids and also cracks advancing on the base metal.

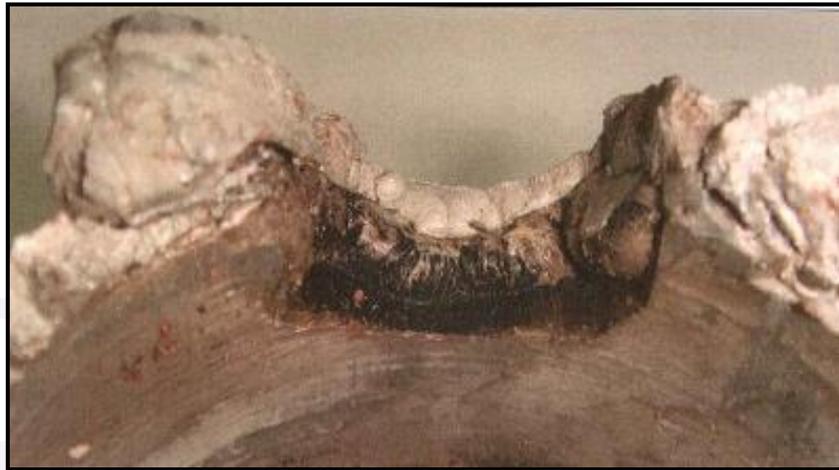
A carving with horizontal and vertical scratches produced by sanding (Figures 7 and 8) was also observed in the region of the weld.

Figure 7 – Carving region.

The inefficient welding process was responsible for the fracture of the component. Changes were observed in the geometry of the component, possibly to facilitate the welding performed.

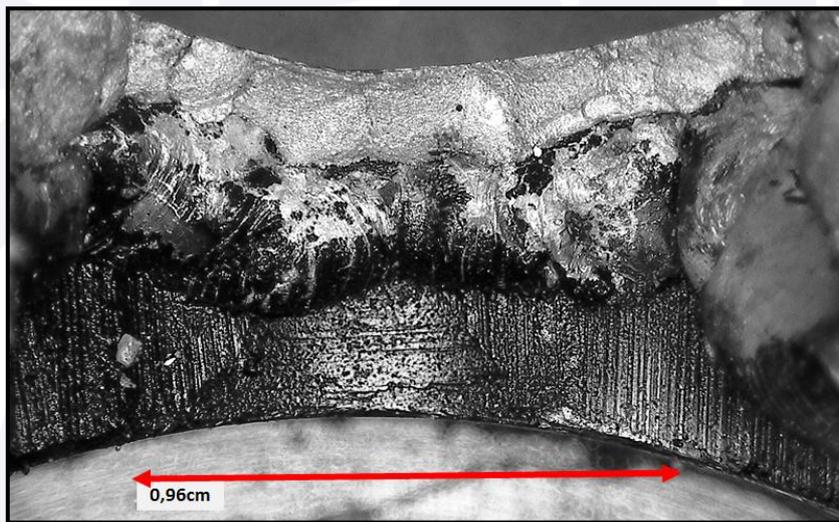
Figure 8 - Detail of the carving region showing weld bead.

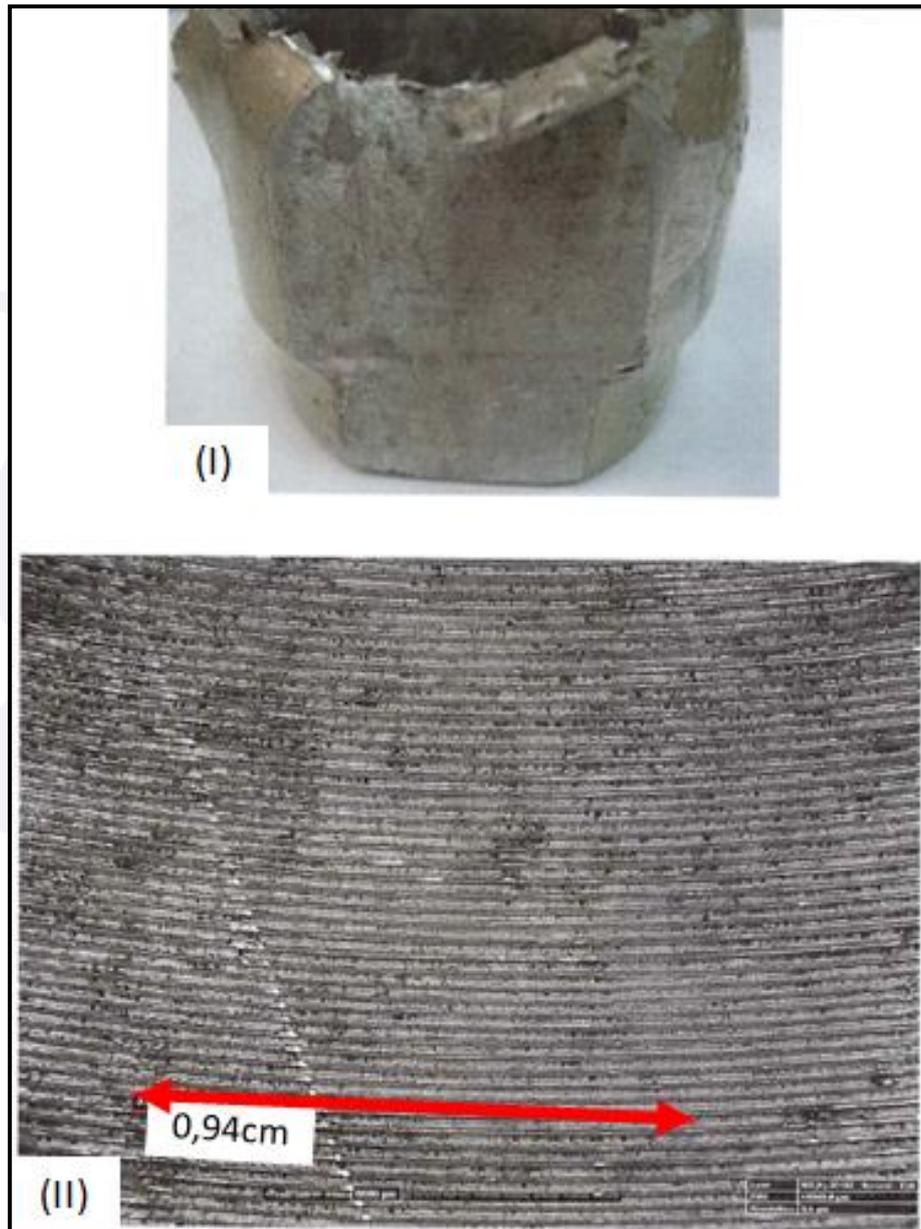
Another observed aspect was a region on the lateral surface of the component that presented work marks, probably milling, with the presence of generalized corrosion due to the absence of surface protection (Figure 9).

Figure 9 - In (I) the side of the component can be observed with the presence of coarse work on the surface (possibly milling); in (II) detail of the surface worked with the presence of generalized corrosion due to lack of surface protection.

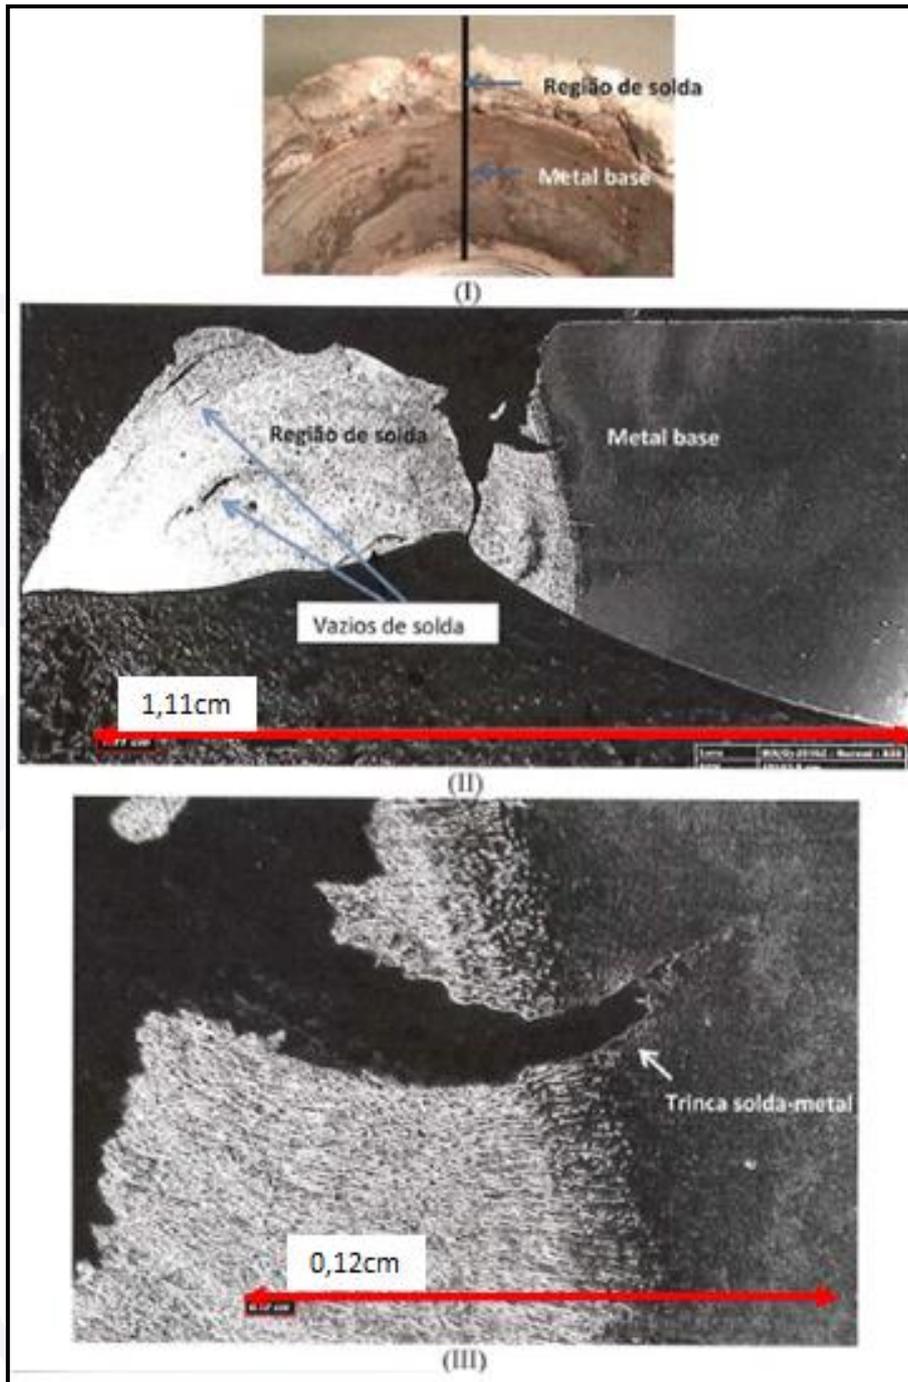
The metallographic tests carried out in a perpendicular section to the surface of the fracture showed the presence of two distinct regions corresponding respectively to the base metal and the weld material. In Figure 10, the voids can also be observed due to the inefficient welding process, as well as the cracking originated in the weld region and with advance in the base metal.

Figure 10 - In (I), a detail of the weld region and base metal. In (II), it can be observed the metallographic section of the weld and the base metal. The welding region is void due to the inefficient welding process. In (III), it is possible to observe a crack originated in the region of weld and with advance in the base metal.

Disseminate the lessons learned in this report in order to raise the situational awareness of operators and owners, especially with regard to inadequate maintenance services or in disagreement with maintenance manuals.
