FINAL REPORT
A - 183/CENIPA/2013

OCCURRENCE:	ACCIDENT
AIRCRAFT:	PT-YSS
MODEL:	AS-350B2
DATE:	12OCT2013

This is the Final Report of the 12OCT2013 accident with the AS-350B2 aircraft, registration PT-YSS. The accident was classified as "Engine Failure In-Flight".

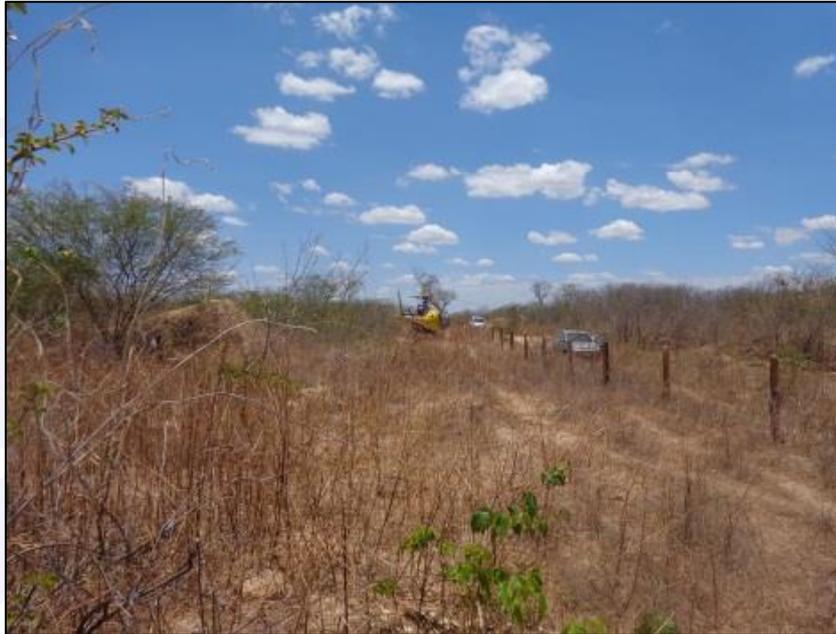
During the autorotation procedure, on the imminence of the landing, the pilot encountered an obstacle (termite nest), forcing him to change the approach ramp. Changing the approach ramp from the initially chosen place led the helicopter to touch the ground 29 meters ahead (Figure 1).

Figure 1 - View of the obstacle in relation to the landing place of the aircraft.

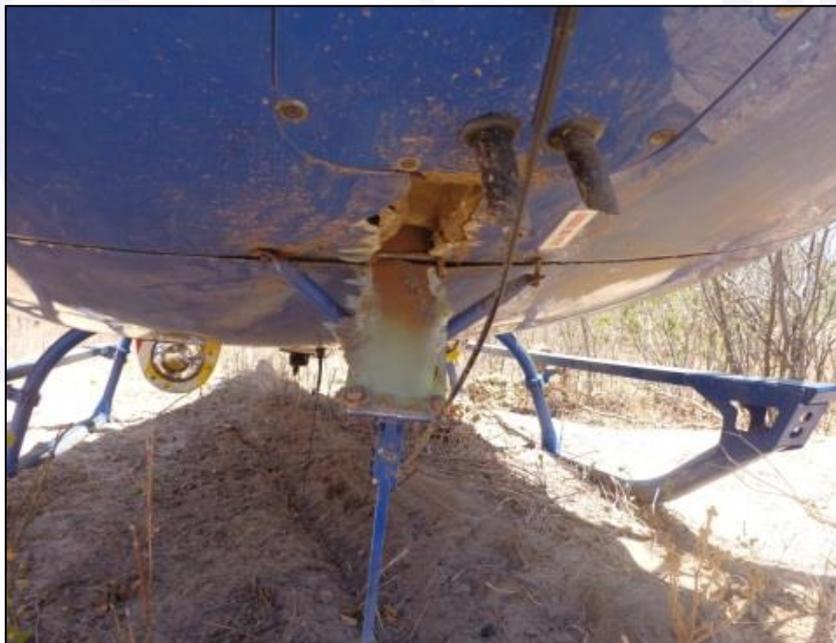
In the last meters of the ground run, the aircraft presented a strong tendency to flip upside down, to the point of damaging the "cutter" located in the lower front part of the aircraft (Figure 2)

Figure 2 - Damage to the lower cutter of the aircraft.

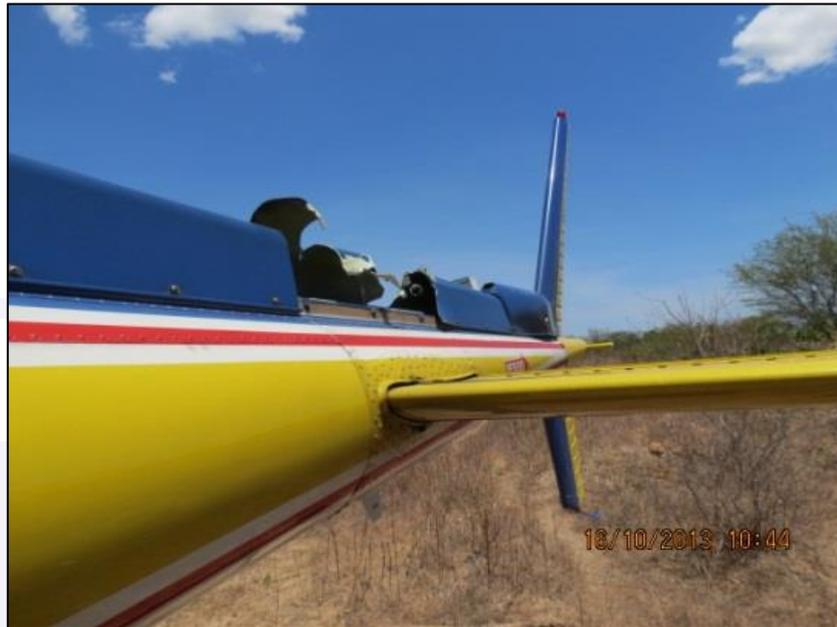
This dynamics was counteracted by the pilot's performance through the cyclic command. Thereafter, there was the touch of the main rotor blades in the tail cone, causing the sectioning of the transmission shaft (Figure 3).

Figure 3 - View of damage in the tail boom of the aircraft.

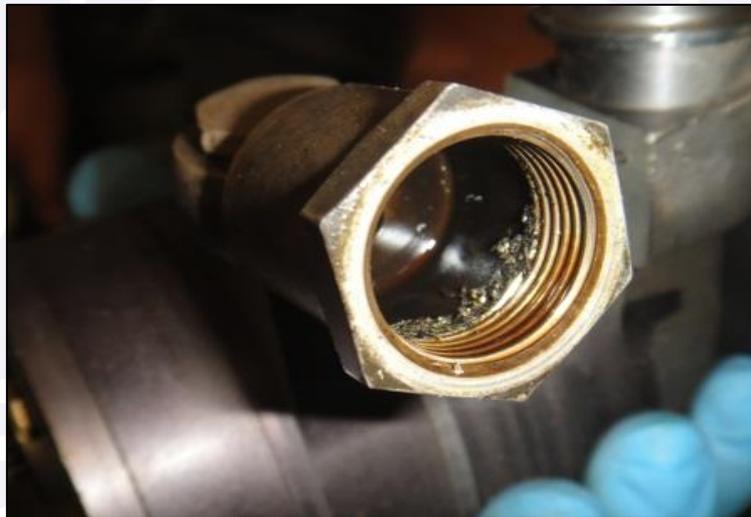
- a) The rotating assemblies of modules 2 and 3 were locked, there being a large amount of particles at the outlet of the oil pump (Figure 4) and in the filter elements of the engine lubrication system.

Figure 4 - Appearance of the engine oil pump outlet.

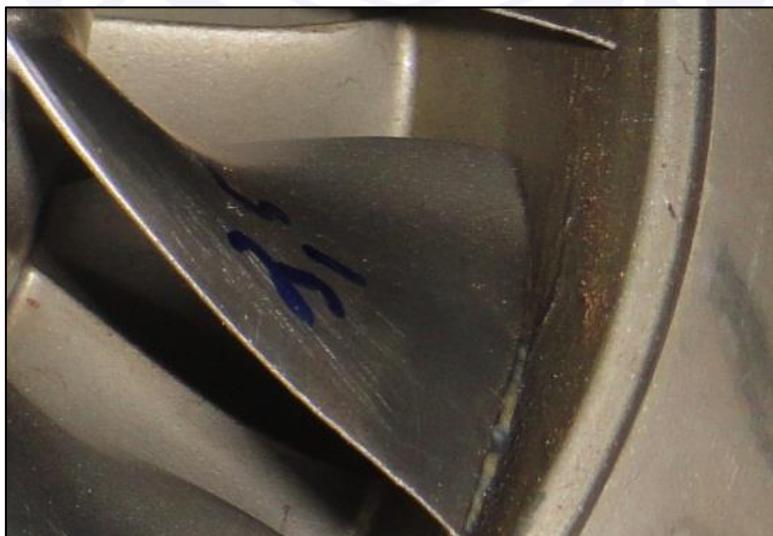
- b) There were marks of intense friction between the axial compression stage and its casing (Figure 5).

Figure 5 - Friction marks between the blades and the axial compressor casing.

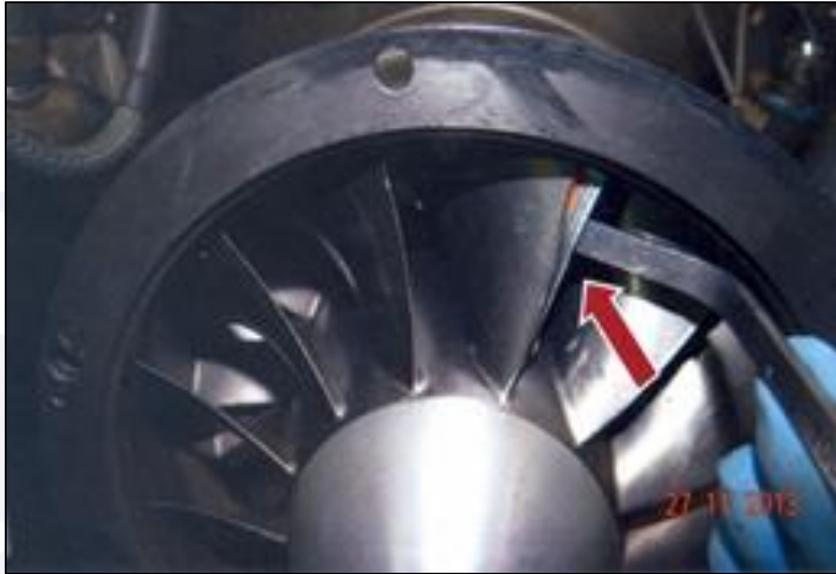
- c) Seven out of thirteen axial compressor blades presented wear from 3.5 mm to 4 mm at the leading edges (Figure 6).

Figure 6 - Wear on the leading edges of the axial compressor blades.

As for the analysis performed on the aircraft engine, a wear of 3.5 mm to 4 mm at the leading edge was evident in seven of the thirteen blades of the axial compression stage, thus, above the limit (3 mm) established by the engine manufacturer.

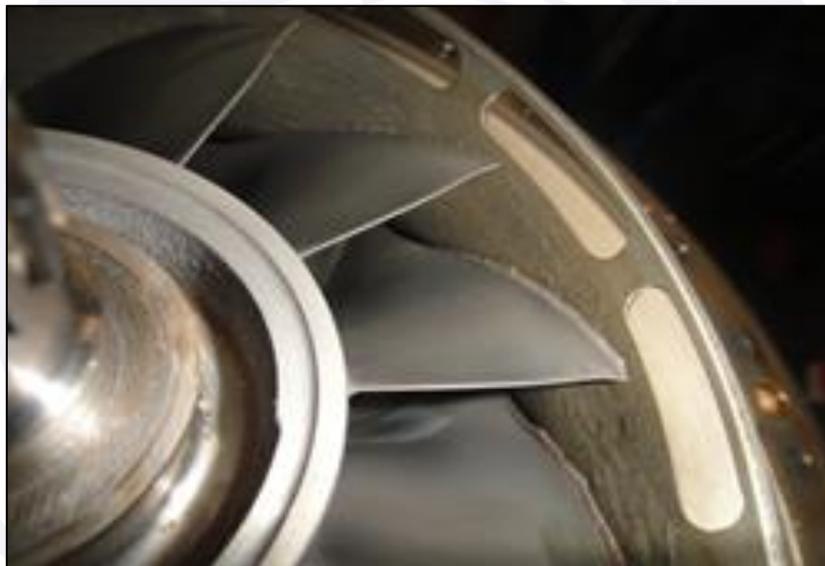
- d) The centrifugal compression stage exhibited damage due to the intense friction between the blades and the impeller casing (Figure 7).

Figure 7 - Damage to the impeller of the centrifugal compressor.

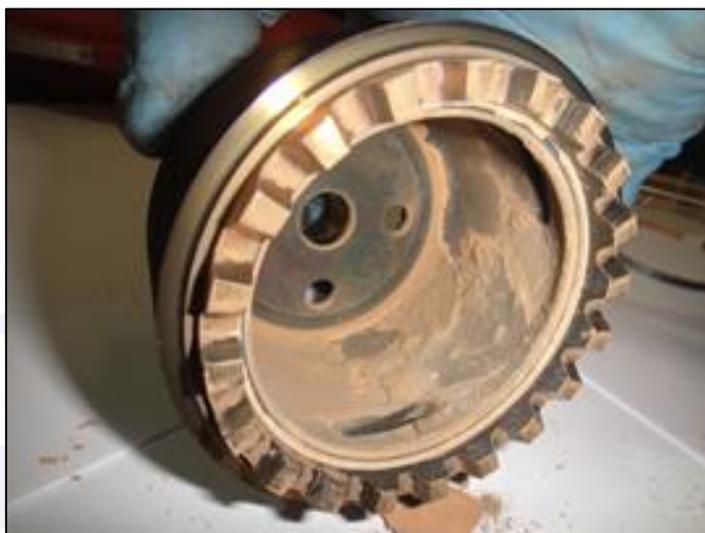
- e) There was a large amount of *laterite* (residual deposits hardened from the decomposition of rocks and surface soil materials) adhered to the inner wall of the hollow shaft of module 3. Only the *laterite* detached from the component accumulated a mass of 8.42 grams (Figure 8).

Figure 8 - *Laterite* detached from the inner wall of the hollow shaft of module 3.

The operation in this environment provided the formation of *laterite* inside the hollow shaft of the engine. The probable detachment of part of this *laterite* from the hollow shaft wall may have caused the unbalance of the rotating assembly of module 3, which damaged the gas generator rear bearing of the engine, causing the engine flameout during the flight on 12OCT2013.

The above-described scenario shows that the detachment of part of the *laterite* that was adhered to the inner wall of the hollow shaft caused the unbalance of the rotating assembly of module 3. The resulting vibration of this module caused damage to the gas generator rear bearing and, consequently, the engine flameout.

Act with Henrimar Air Taxi shop, in order to ensure and, for the purpose of executing the engines maintenance program for the *Arriel 1* and series, to comply with the procedures established by SB A292 72 0230, version C, from 29FEB2012, regarding the monitoring of the wear of the axial compressor blades and the presence of *laterite* deposited on the hollow shaft of the gas generator rear bearing.

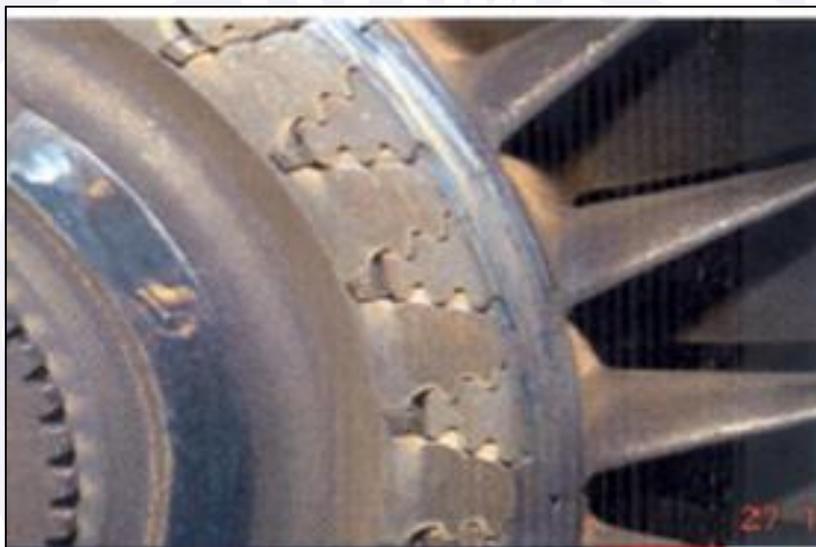
- f) There were friction marks between the first and second stages of the compressor and the second stage stator (Figure 9).

Figure 9 - Friction marks in the turbine rotor.

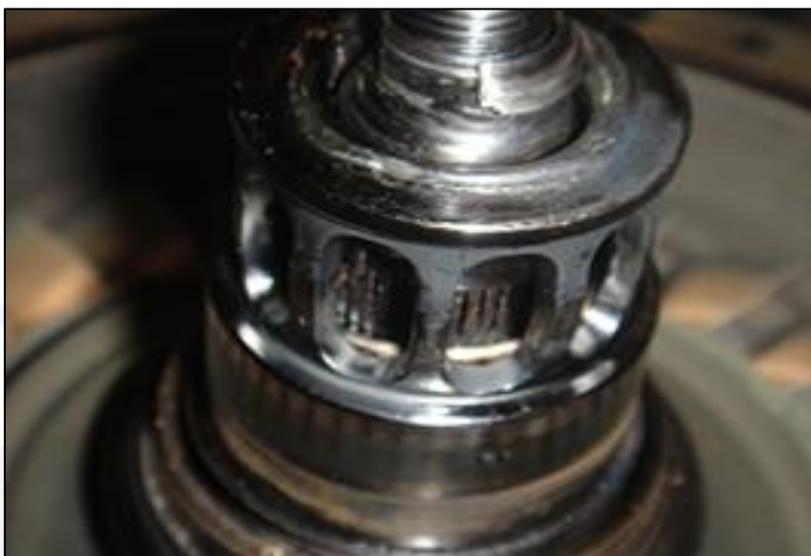
- g) The housing region of the gas generator rear bearing was bluish in color, indicating signs of overheating (Figure 10).

Figure 10 - Indication of overheating in the gas generator rear bearing.

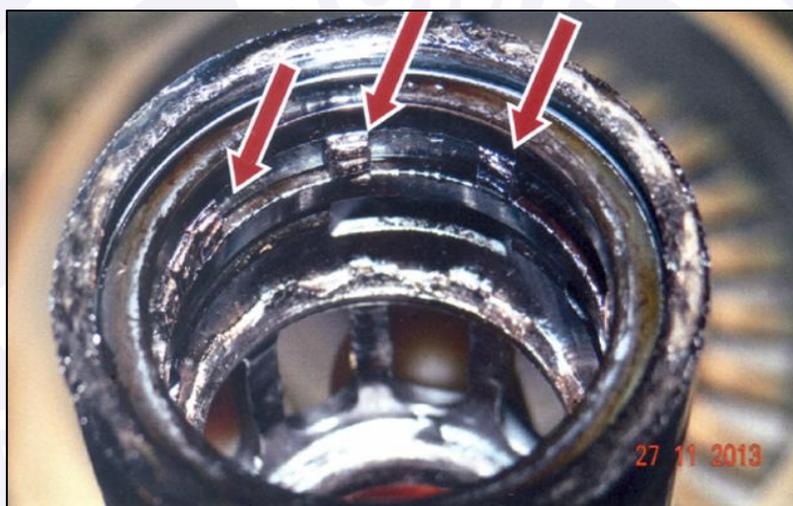
- h) The rollers of the gas generator rear bearing were fused in the outer bearing track (Figure 11).

Figure 11 - Fused roller in the gas generator rear-bearing track.

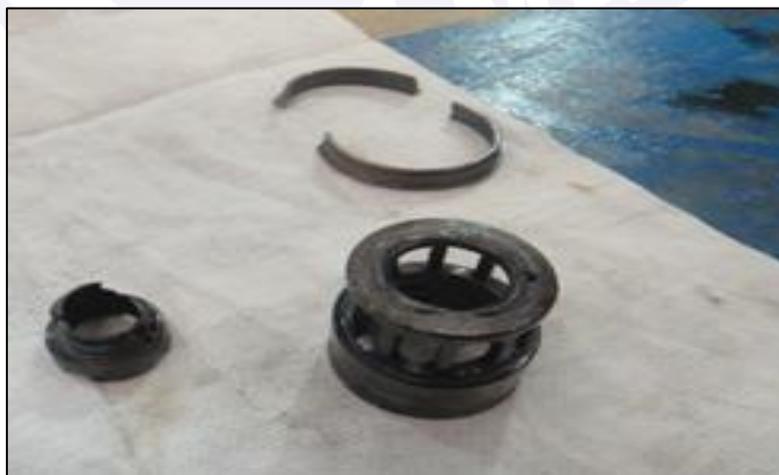
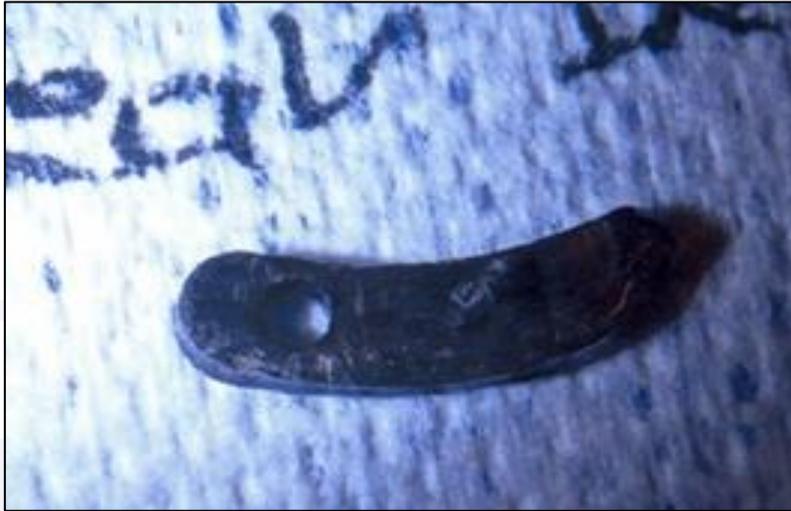
- i) There was the rupture of the locking ring of the gas generator rear bearing, whose fragments were found in the engine lubrication system (Figures 12 and 13).

Figure 12 - Broken locking ring.

Figure 13 - Fragment of the locking ring found in the engine lubrication system.

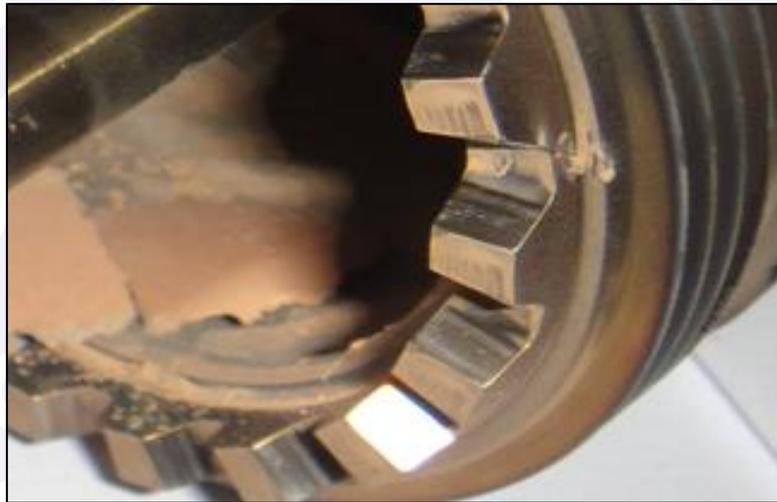
- j) The teeth of the curved coupling of module 3 had vibration marks (Figure 14).

Figure 14 - Evidence of the occurrence of vibration in the teeth of the curved coupling of the hollow shaft of module 3.
