COMANDO DA AERONÁUTICA
CENTRO DE INVESTIGAÇÃO E PREVENÇÃO DE
ACIDENTES AERONÁUTICOS

FINAL REPORT
A-515/CENIPA/2016

OCCURRENCE:	ACCIDENT
AIRCRAFT:	PT-WVM
MODEL:	BONANZA A36
DATE:	10NOV2014

This is the Final Report of the 10 November 2014 accident with the Bonanza A-36 aircraft, registration PT-WVM. The accident was classified as “loss of control in flight”.

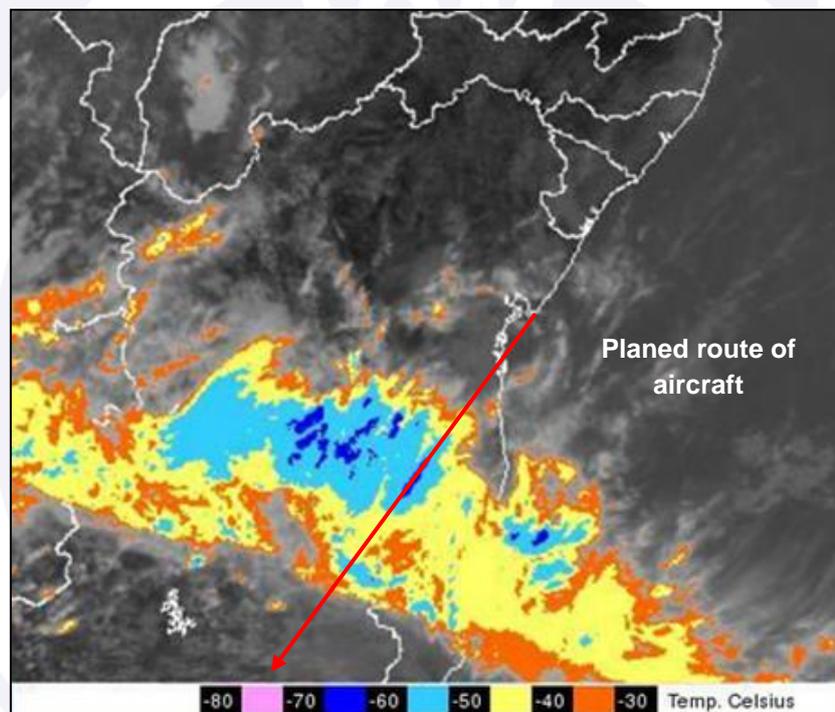
The weather conditions were not favorable for air operations in the region analyzed, since the instability and the line of CBs in the area could generate meteorological phenomena (such as icing and severe turbulence) capable of jeopardizing aircraft safety.

Figure 1 – Satellite image on the day of the accident (15:00 UTC).

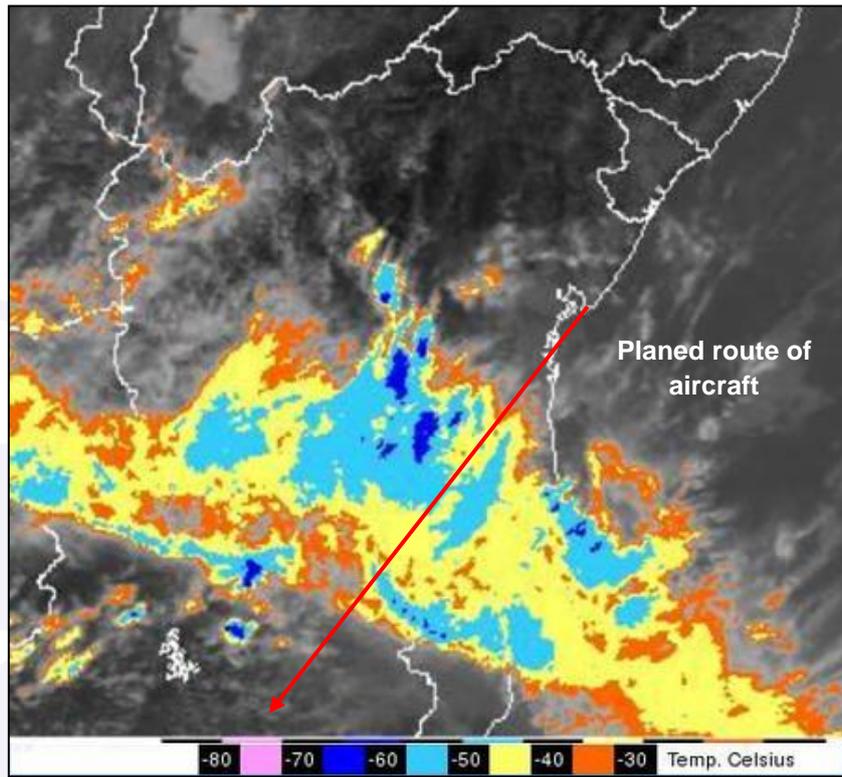
Figure 2 – Satellite image on the day of the accident (16:00 UTC).

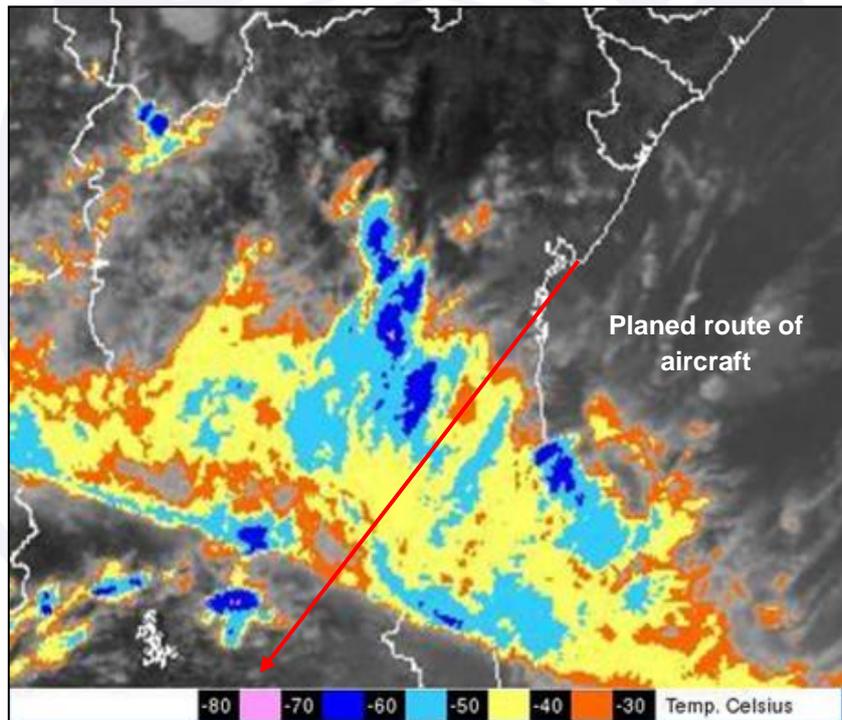
Figura 3 – Satellite image on the day of the accident (16:30 UTC).

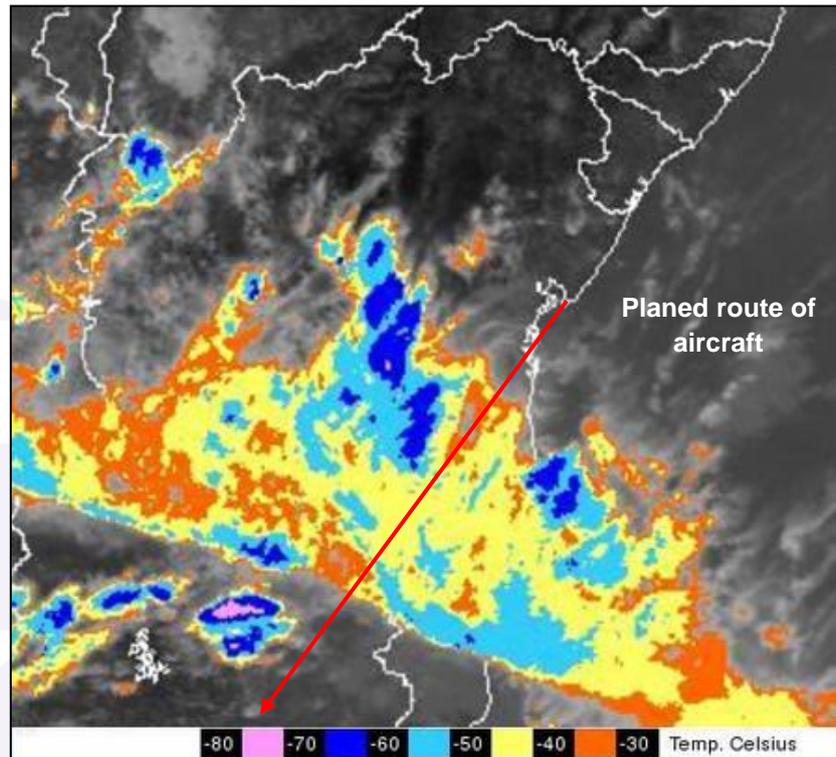
Figure 4 – Satellite image on the day of the accident (17:00 UTC).

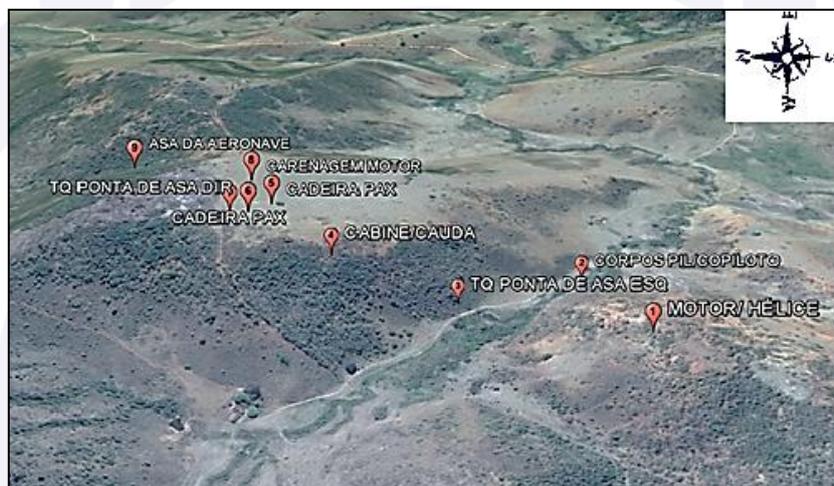
Figure 5 - Croquis of the crash-site.

The aircraft wreckage was found at approximately 6 km to the left of the planned route in the locality known as *Mata do Passarinho* in the municipality of *Maracani*, State of *Bahia*. The aircraft components were distributed in a linear fashion (Figure 5) in an area of about 930m x 200m, without indication of an earlier collision with any obstacles.

The bodies of the pilot and of the passenger who had been occupying the right front seat of the aircraft were located near each other, at a distance of approximately 530 meters from the aircraft wreckage. The body of the passenger who had been seating in the back seat of the aircraft was found in a place that was distant from the one where the other two occupants were found.

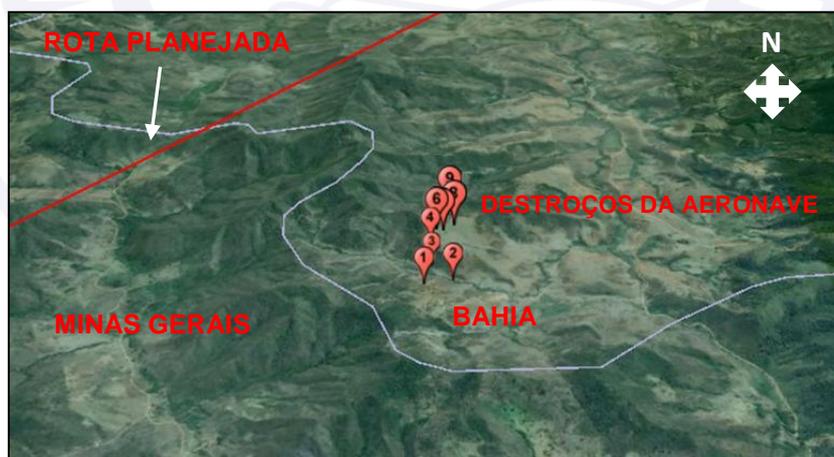
Figure 6 – Position of the crash-site in relation to the planned route of the aircraft.

The wreckage was found in the locality of *Mata do Passarinho*, at a distance of approximately six kilometers to the left of the planned route, without indication of a prior collision with any obstacles.

The location where the aircraft wreckage was found is consistent with the deviations that had been requested by the pilot in view of the bad weather conditions prevailing in the region.

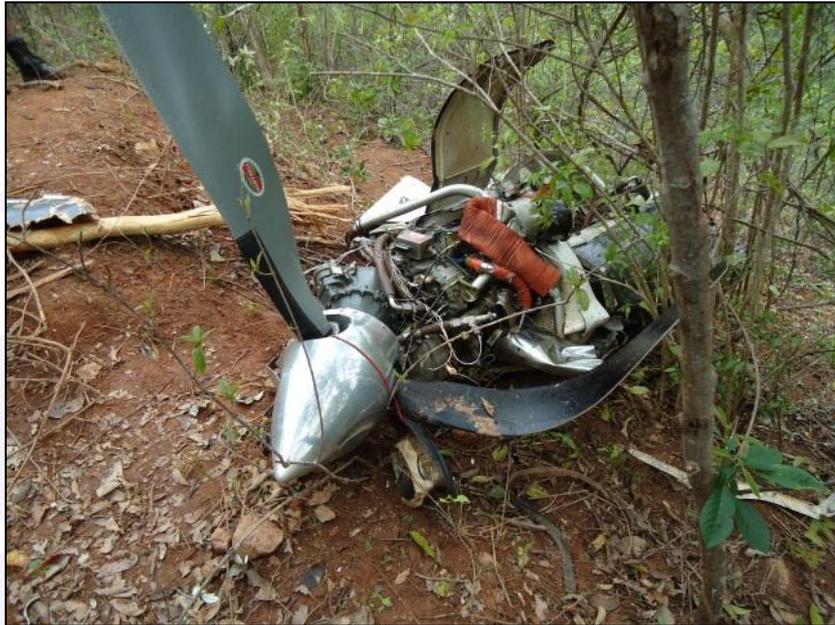
The three-blade propeller assembly had one of the blades broken and detached from the engine. The two other blades remained attached to the hub, being one bent backwards

and the other with minor damage. There was evidence that at the moment of the impact with the ground the aircraft engine was not developing power.

Figure 7 – Aircraft engine/propeller assembly.

Similarly, the observed pieces of evidence showed that at the moment of impact with the ground, the engine of the aircraft was not generating power, probably on account of the inflight separation of the aircraft components which interrupted the flow of fuel.

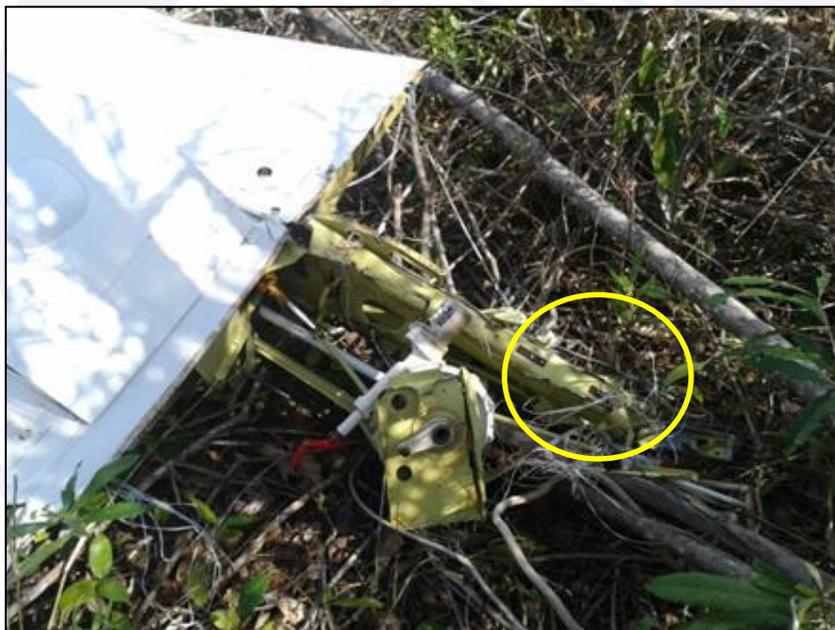
A *Wing Forward Spar Carry* (the one connecting the wings) had been severed. (Figure 8)

Figure 8 – Point of rupture of the Wing Forward Spar Carry (left wing).

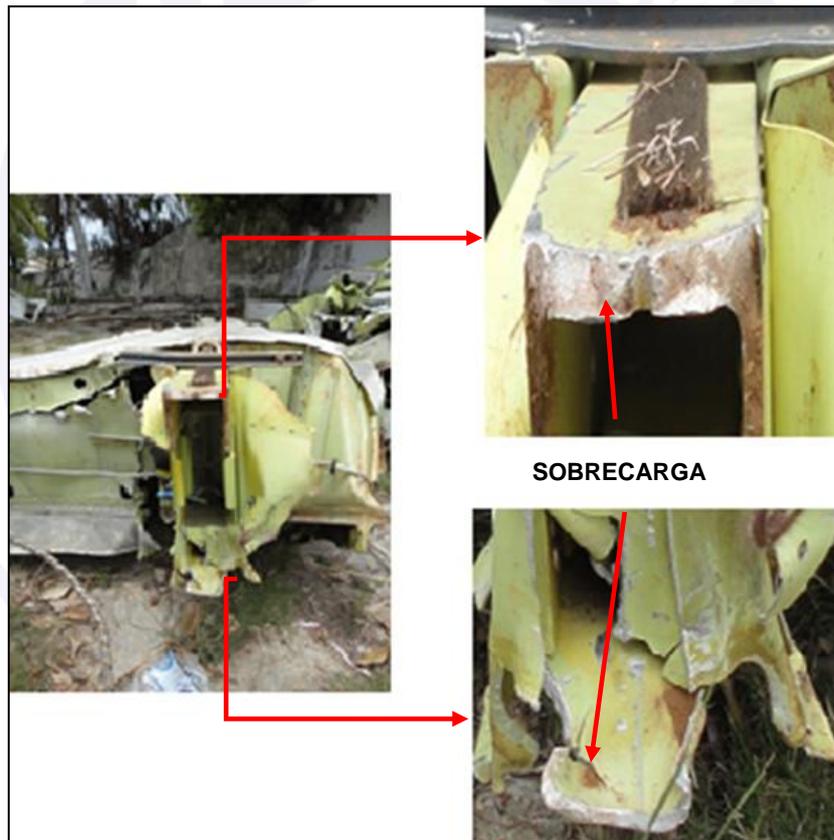
A visual analysis showed the presence of fracture due to overload applied to the material of the left wing, as can be seen in Figure 10.

Figure 10 – Left wing structure (*Wing Forward Spar Carry*), with fracture characteristics typical of overload applied to the material.

Technical analyses of the wreckage showed that the Wing Forward Spar Carry (see Figure 10) sustained rupture on account of overload, and, also, that there were no signs of corrosion or fatigue in the referred component.

The separation of aircraft parts in flight, as observed in the Wing Forward Spar Carry, indicated that the aerodynamic load applied to the airplane had exceeded its structural limit.

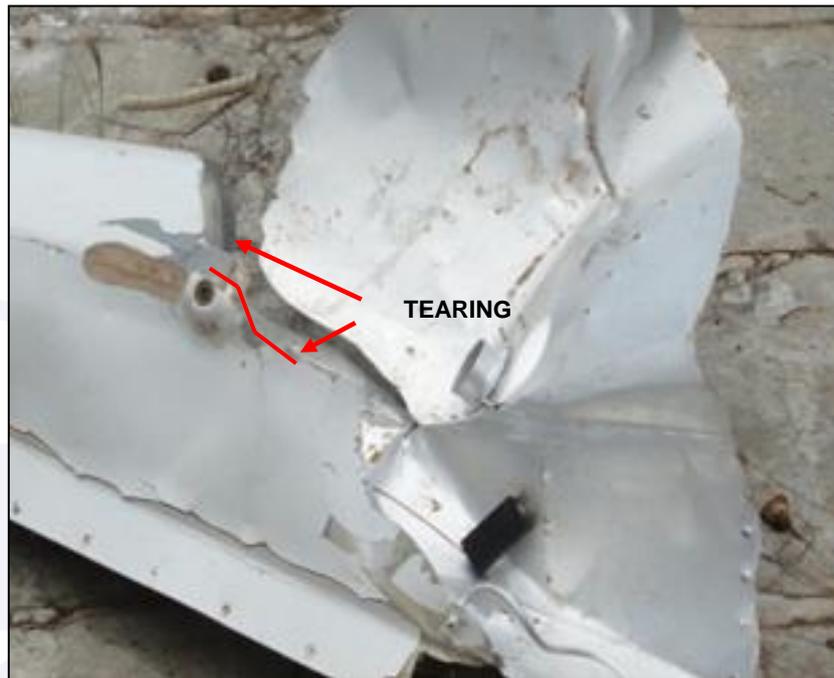
There was also overload on the aircraft surface metal covering, as can be seen in detail in Figure 11.

Figure 11 – Aircraft coating surface showing characteristics of fracture due to tearing with the presence of angles (shown by the red arrows).

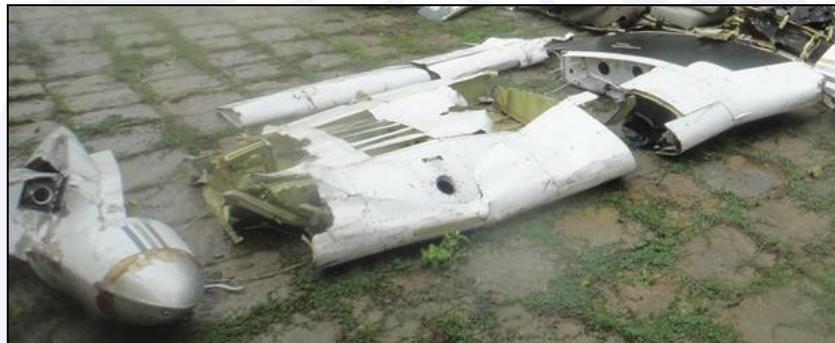
Figure 12 shows the right wing with its tip-tank broken on account of overload.

Figure 12 – Right wing and tip-tank.

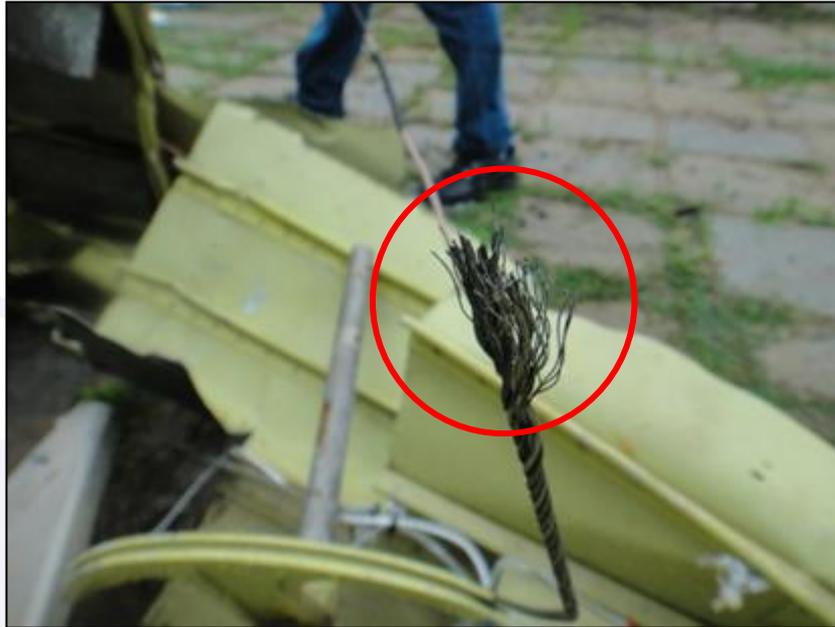
The analysis of the control cables by means of stereoscopy revealed the presence of fractures on account of overload (Figure 13).

Figure 13 – Aspect of the control cable with fracture resulting from overload.

Thus, the result of the analysis was that the structural elements, the metal coating, and the control cables presented failures typical of overload applied to the material, without evidence of failure caused by fatigue or corrosion.
