COMANDO DA AERONÁUTICA
CENTRO DE INVESTIGAÇÃO E PREVENÇÃO DE
ACIDENTES AERONÁUTICOS

FINAL REPORT
A-050/CENIPA/2015

OCCURRENCE:	ACCIDENT
AIRCRAFT:	PP-LLS
MODEL:	EC155B1
DATE:	02APR2015

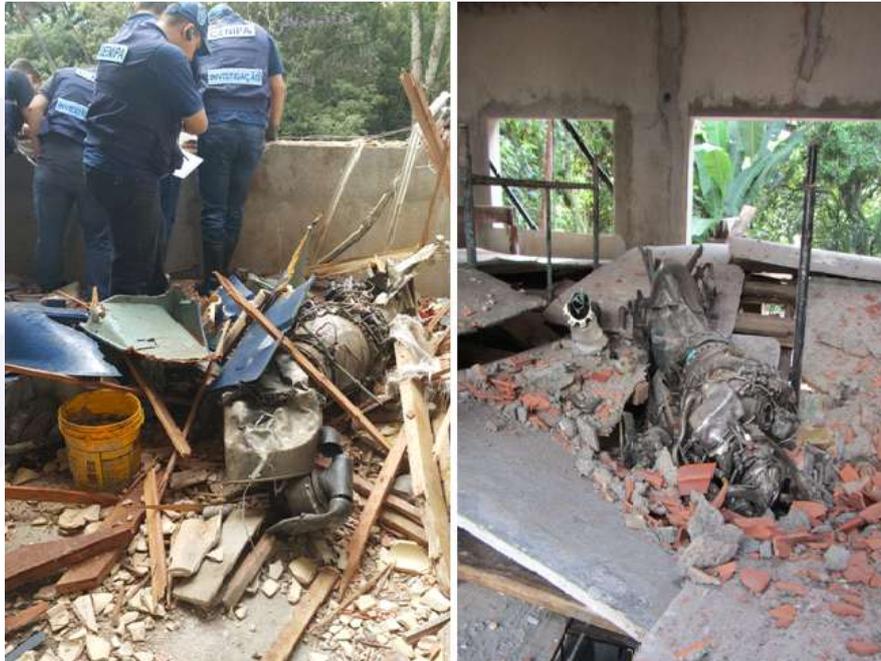
Figure 22 - Location of the engines after the impact.

In the field investigation during the initial action following the accident, the engines were found separated from the fuselage in different rooms of a house (Figure 22).

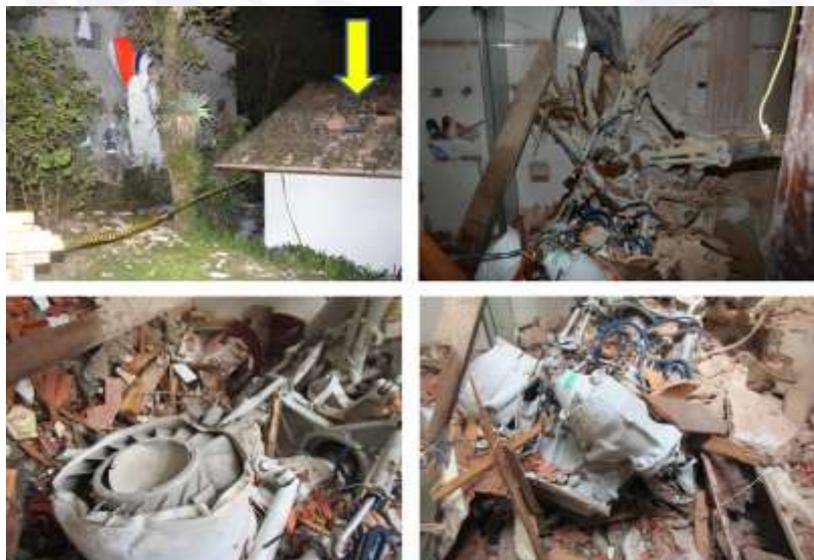
Figure 27 - View of the MGB impact on the roof and inside the room.

In the initial action after the accident, the MGB was found separated from the fuselage, in a room of one of the houses hit by the aircraft (Figure 27).

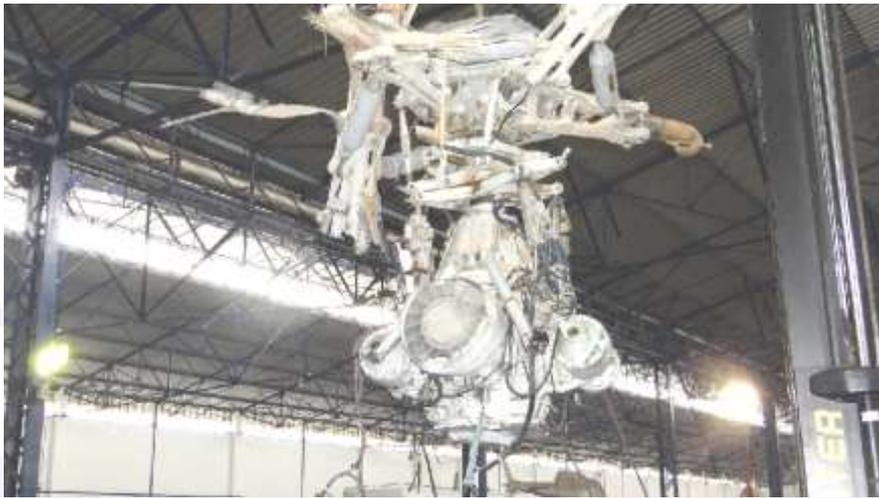
Figure 28 - View of the Main Gear Box (MGB).

The MGB of the aircraft was also disassembled for being inspected (Fig. 28).

When examined, all planetary gears, together with the solar gear, presented characteristics of normal operation. No filings were found in the oil-return screens. The bearings were rotated manually, and responded accordingly. No anomalies were found either in the lubrication pre-obstruction indicator, or in the detector of fillings.

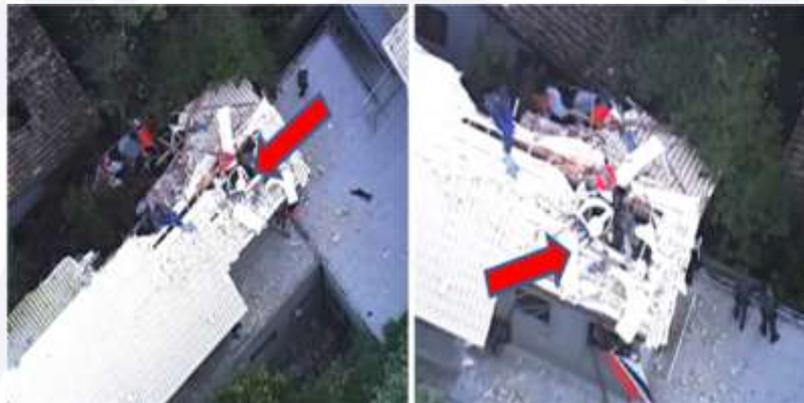
Figure 36 - Spot where the tail rotor was found.

The tail rotor was found on the roof of one the houses hit by the aircraft (Figure 36).

In the interior of the Fenestron cowl, there were marks of rubbing and perforations with small cutting size made by the blades of the component. Friction-generated wear was also observed on the tips of some of the tail rotor blades which did not break.

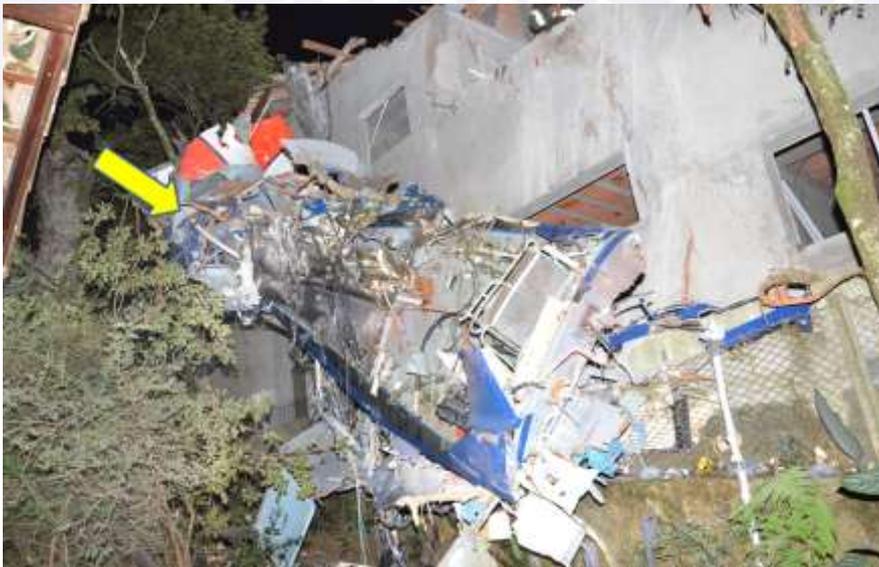
Figure 41 - Detail of the tail rotor driveshaft attached to the fuselage.

In the field investigation at the initial action, the tail rotor driveshaft was found attached to the fuselage in its original position (Figure 41).

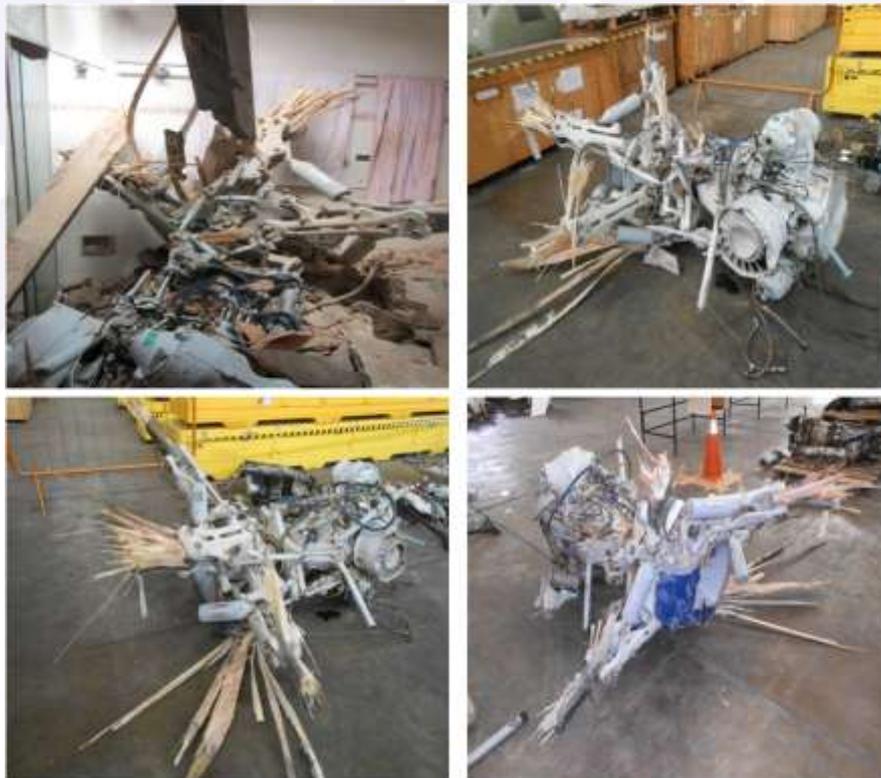
Figure 44 - View of the main rotor assembly, first in the crash site and later in the hangar (from different perspectives).

The roots of the five blades were found connected to their respective blade grips, close to the head of the main rotor and MGB. The white blade was the only one found connected to the main rotor head (Figure 44 A).

The white blade was the only almost complete blade recovered attached to the main rotor head (Figure 44 A).

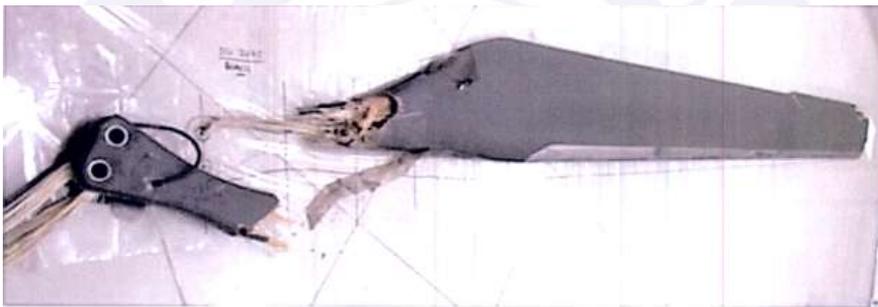
Figure 47 - View of the black blade.

Damage was observed to the blade trailing edge, but there was no significant loss of internal material in the area of the damage, and it was possible to perceive the peaks and valleys of the failure. There was evidence that the damage to the trailing edge had occurred when the blade got fractured and separated.

It was not possible to identify whether any damage or defects were present in the black blade prior to the accident.

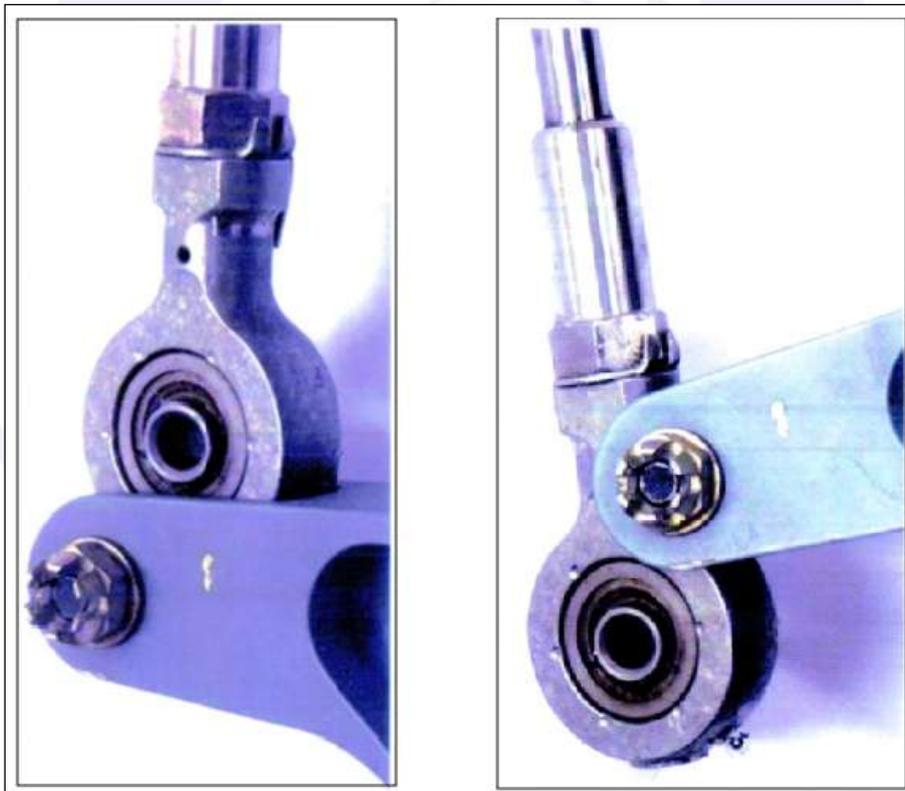
Figure 57 - Positions of the RH roll ball-type flexible control and RH roll bellcrank in the tests.

The tests were conducted in two distinct positions: with the RH roll ball-type flexible control on top the RH roll bellcrank, and with the RH roll ball-type flexible control under the RH roll bellcrank.

For the first position (end of the RH roll ball-type control placed on top of the bolt), the tests showed that the flexible control would not follow the movement of the respective bellcrank.

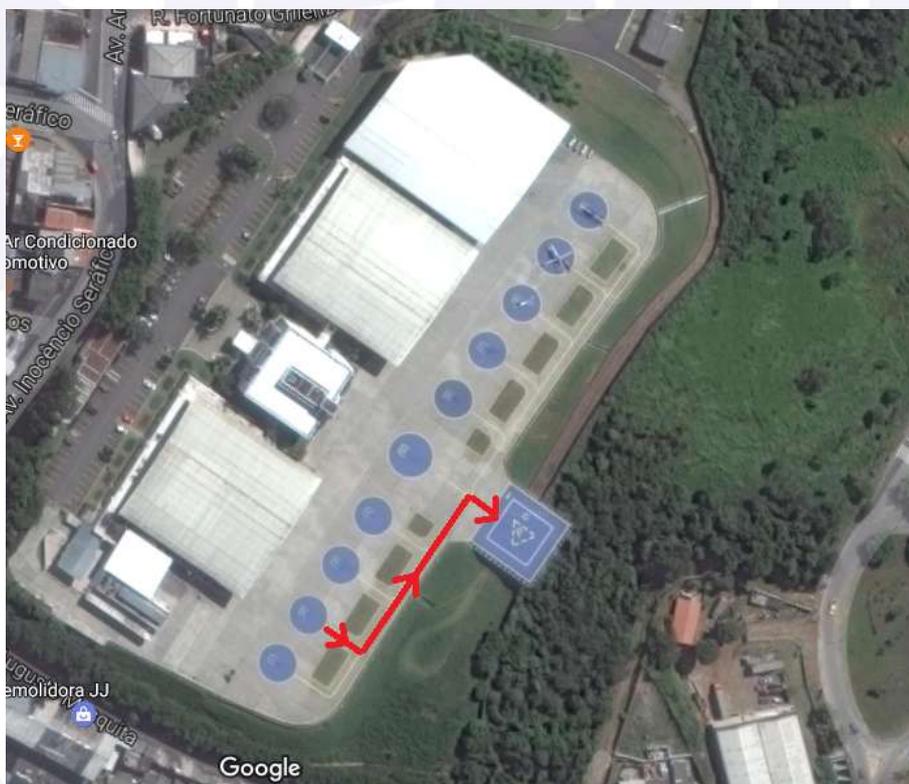
Figure 59 - Planned movement from the number-2 parking spot to the helipad.

In such context, the hover flights of aircraft the size of the PP-LLS had to be conducted over the helipad and not over the parking spots. Thus, for doing the balancing of the main rotor, the pilot would have to move the PP-LLS, and taxi it from the number-2 parking spot to the helipad (Figure 59).

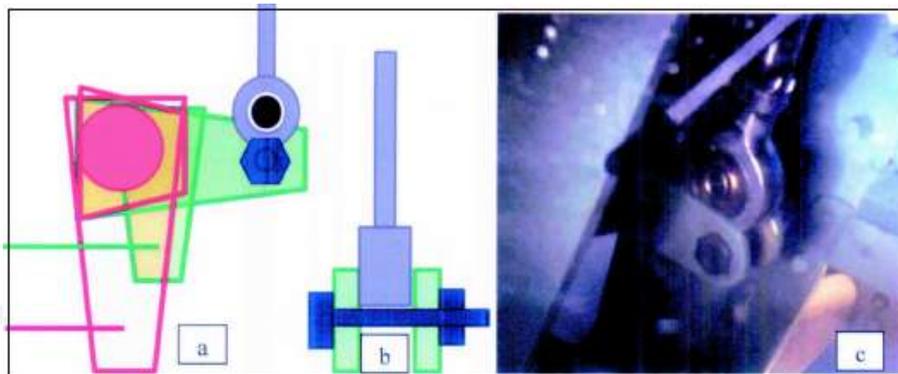
Figure 60 - Simulation of the RH roll ball-type flexible control positioned on top the bolt. a) schematic lateral view; b) schematic frontal view; c) in-perspective view of the components.

In the first hypothesis, one considered that the lower part of the RH roll ball-type flexible control end was on top of the bolt for attachment to the RH roll bellcrank. Figure 60 is an illustration of this hypothesis.

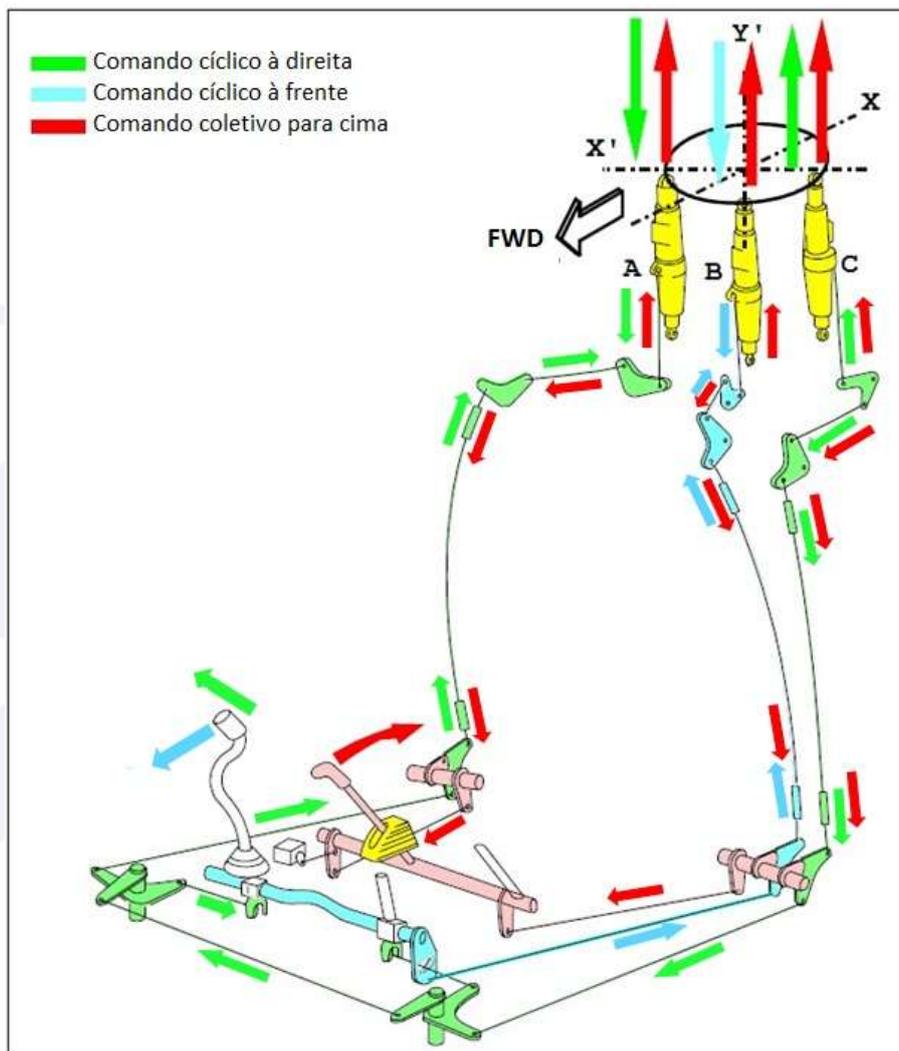
Figure 62 – Schematic representation of the cyclic and collective controls (adapted from the Eurocopter (Airbus Helicopters) THM).

After separate analysis of the behavior of the RH roll bellcrank and of the RH roll ball-type flexible control, which compose the control mechanism of the Right Hand servocontrol, it is possible to observe the following behavior in relation to the cyclic and collective controls (Figure 62):

- When the cyclic control is moved to the right, the RH roll bellcrank moves in a way that displaces the RH roll ball-type flexible control upward, resulting in a retraction of the respective servocontrol, making it move downward. Such movement diminishes the pitch angle of all the blades in that sector of the rotating disk, and the helicopter rolls to the right.

- When the cyclic control is moved to the left, the RH roll bellcrank moves in a way that displaces the RH roll ball-type flexible control in a downward direction, resulting in an extension of the respective servocontrol, making it move upward. Such movement augments the pitch angle of the blades in that sector of the rotor disk, and the helicopter inclines to the left.

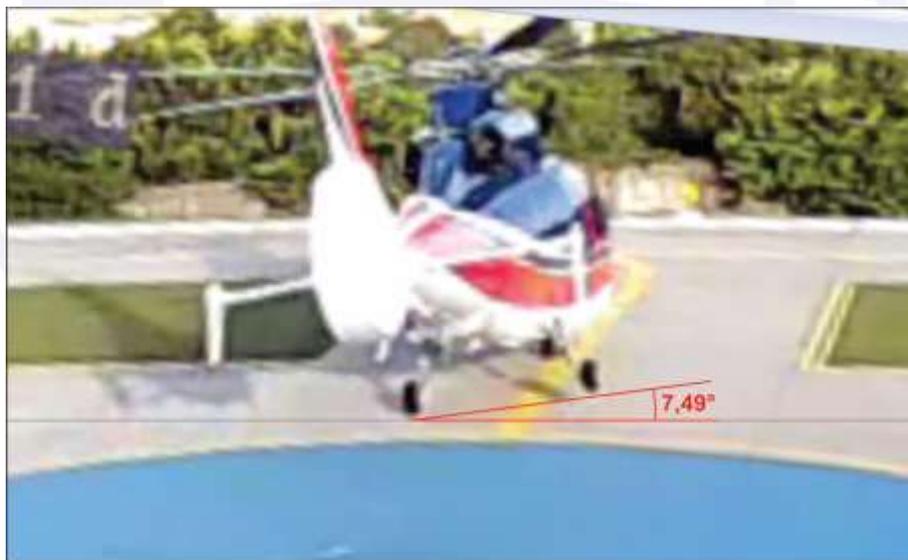
Figure 63 - Helicopter banked to the left at the initiation of the taxi on the ground, with estimated bank angle.

In such condition, when the collective was pulled, the forward and backward servocontrols would actuate symmetrically, while the RH servocontrol would be actuate in an out-of-phase manner. The RH flexible control would move to a position different from the position of the Forward and Backward servocontrols, and the pitch angle of the blades would be larger in the right-hand sector of the rotor disk. In view of such asymmetry, the expected response of the aircraft would be to incline to the left.

The videos showing the aircraft as it began to taxi, also showed that the helicopter inclined to the left, confirming the expected behavior resulting from the discrepancy of the position of the RH servocontrol in relation to the two other ones. Figure 63 shows the moment at which the helicopter inclined to the left as it started taxiing.
