**COMANDO DA AERONÁUTICA**  
**CENTRO DE INVESTIGAÇÃO E PREVENÇÃO DE**  
**ACIDENTES AERONÁUTICOS**

**FINAL REPORT**  
**IG-105/CENIPA/2017**

<b>OCCURRENCE:</b>	<b>SERIOUS INCIDENT</b>
<b>AIRCRAFT:</b>	<b>PR-AVC</b>
<b>MODEL:</b>	<b>A319-115</b>
<b>DATE:</b>	<b>19JUL2017</b>

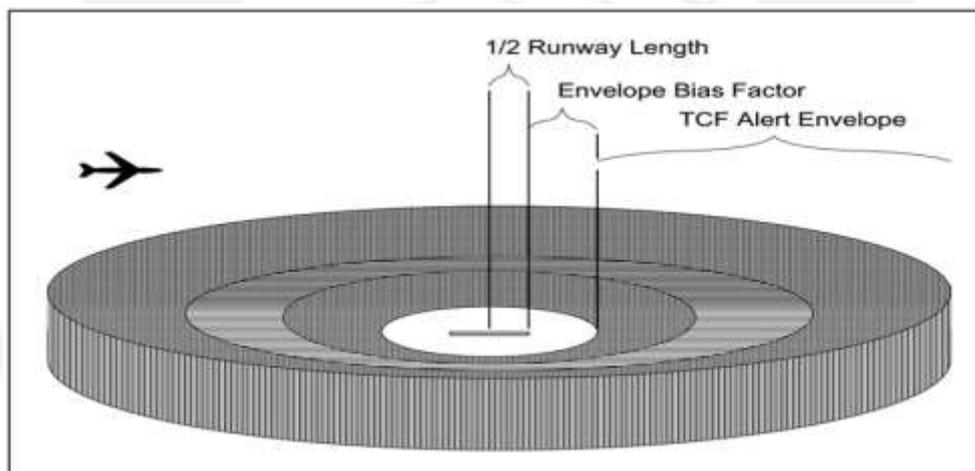
Figure 4 - Terrain Clearance Floor protection area, taken from DWG manual No. 965-0976-603.

The envelope of the Terrain Clearance Floor Mode (gray area of Figure 4) was calculated from the center of the runway at the destination Aerodrome and as a function of the Envelope Bias Factor ( $k$ ) parameter. This parameter considered precision errors in the position of the aircraft obtained through GPS data. Typical values of the Envelope Bias Factor ( $k$ ) parameter ranged from 0.25 to 1.0 nautical miles (NM).

Within the Bias Factor Envelope area (white area of Figure 4), the audible warning would not be issued.

The Terrain Clearance Floor mode was intended to increase the envelope of the basic EGPWS modes near airports. The envelope in this way (gray area of Figure 4) was calculated from the center of the runway of the destination Aerodrome and the function of the parameter Envelope Bias Factor (k).

Within the Envelope Bias Factor area (white area of Figure 4), the audible warning would no longer be issued, since in this area, the aircraft would be close to landing and EGPWS warnings could deviate pilot’s attention from the landing procedures.

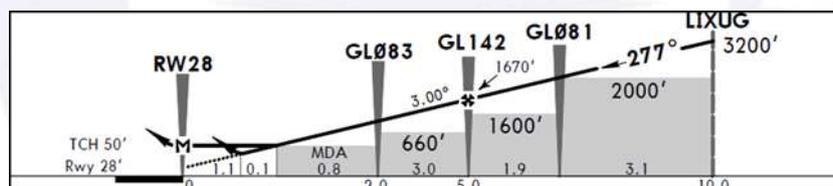
Figure 16 - Profile view of the SBP Jeppesen RNAV Y RWY 28 chart, containing the Minor Segment Altitudes (Stepdown Fixes).

The profile of the procedure used by the crew established some Stepdown Fixes, marked by positions GL081 (2,000ft), GL142 (1,600ft), GL083 (660ft) and MDA itself (470ft), as shown in Figure 16:

When selecting the Vertical Speed (V/S) mode, after passing the FAF, the crew assumed the responsibility of meeting the GL083 and the MDA altitude restrictions.

As seen in Figure 16, in the profile view of the Jeppesen chart, each altitude limiting point in the final approach was referenced by a fix, namely: GL081, restricting descent to 2,000ft; GL142 (FAF), restricting up to 1,600ft; and GL083 restricting to 660ft.
