**COMANDO DA AERONÁUTICA**  
**CENTRO DE INVESTIGAÇÃO E PREVENÇÃO DE**  
**ACIDENTES AERONÁUTICOS**

**FINAL REPORT**  
**A-096/CENIPA/2016**

<b>OCCURRENCE:</b>	<b>ACCIDENT</b>
<b>AIRCRAFT:</b>	<b>PT-DJH</b>
<b>MODEL:</b>	<b>182E</b>
<b>DATE:</b>	<b>02JUL2016</b>

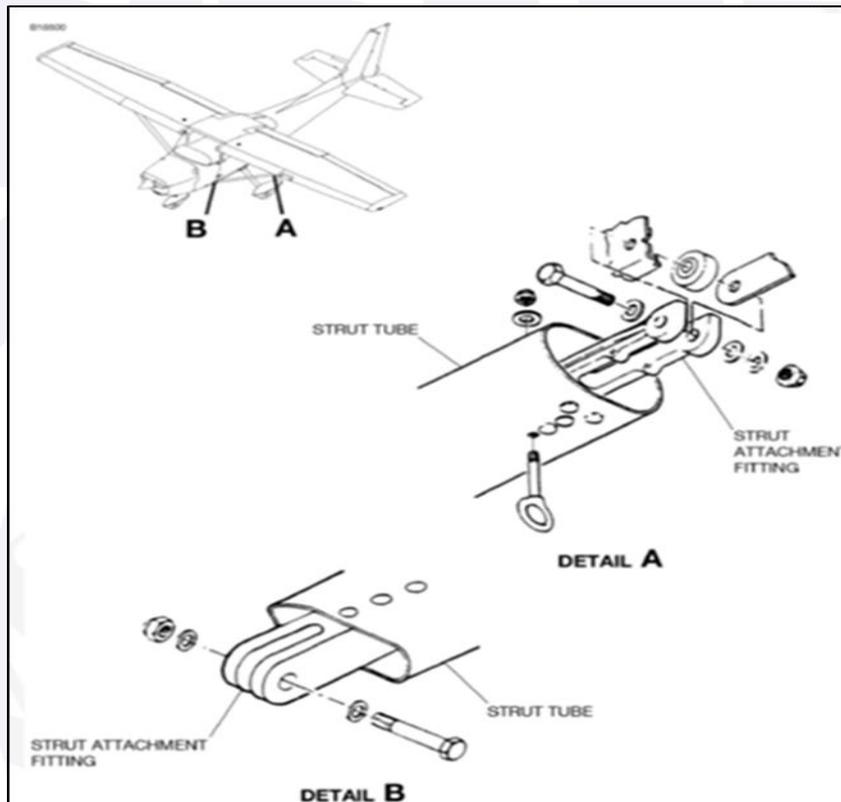
Figure 5 - Fixation points of the wing struts.

A third wing attachment point was fixed in a wing strut in the central region of each wing near the leading edge (Figure 5).
