**COMANDO DA AERONÁUTICA**  
**CENTRO DE INVESTIGAÇÃO E PREVENÇÃO DE**  
**ACIDENTES AERONÁUTICOS**

**FINAL REPORT**  
**A-587/CENIPA/2016**

<b>OCCURRENCE:</b>	<b>ACCIDENT</b>
<b>AIRCRAFT:</b>	<b>PT-HOL</b>
<b>MODEL:</b>	<b>R22</b>
<b>DATE:</b>	<b>11JUL2012</b>

This is the Final Report of the 11JUL2012 accident with the R22 aircraft, registration PT-HOL. It was classified as “System/Component Failure”.

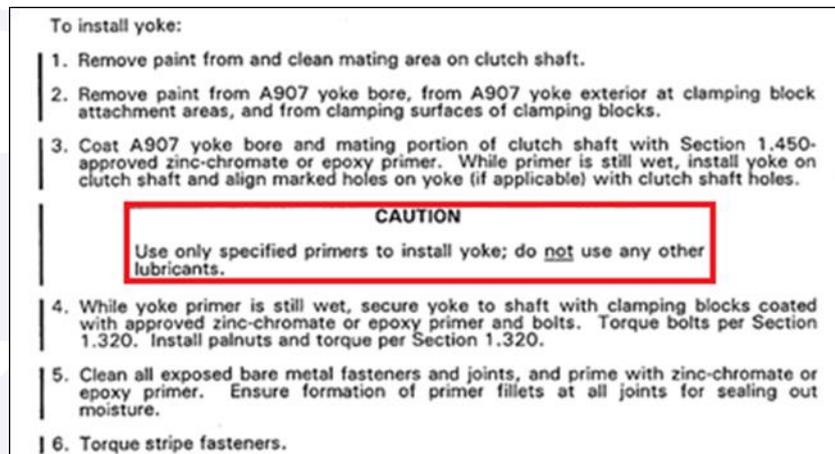
The section 7.260 A907 Yoke Removal and Installation of the RHC R-22 Maintenance Manual, Change 22MAR2004, warned to use only primers specified when installing the yoke, prohibiting the use of other lubricants. These products adhere to the contact surfaces, without allowing air or water to be present (Figure 12).

Figure 12 - Section 7.260 A907 Yoke Removal and Installation of RHC R-22 Maintenance Manual, Change 22MAR2004.

The same section also prevised the removal of the paint, installation of the set and the subsequent coverage with a coated product, which was not correctly observed in the assembly of the set, performed in the event of a post-accident maintenance suffered in 2010.

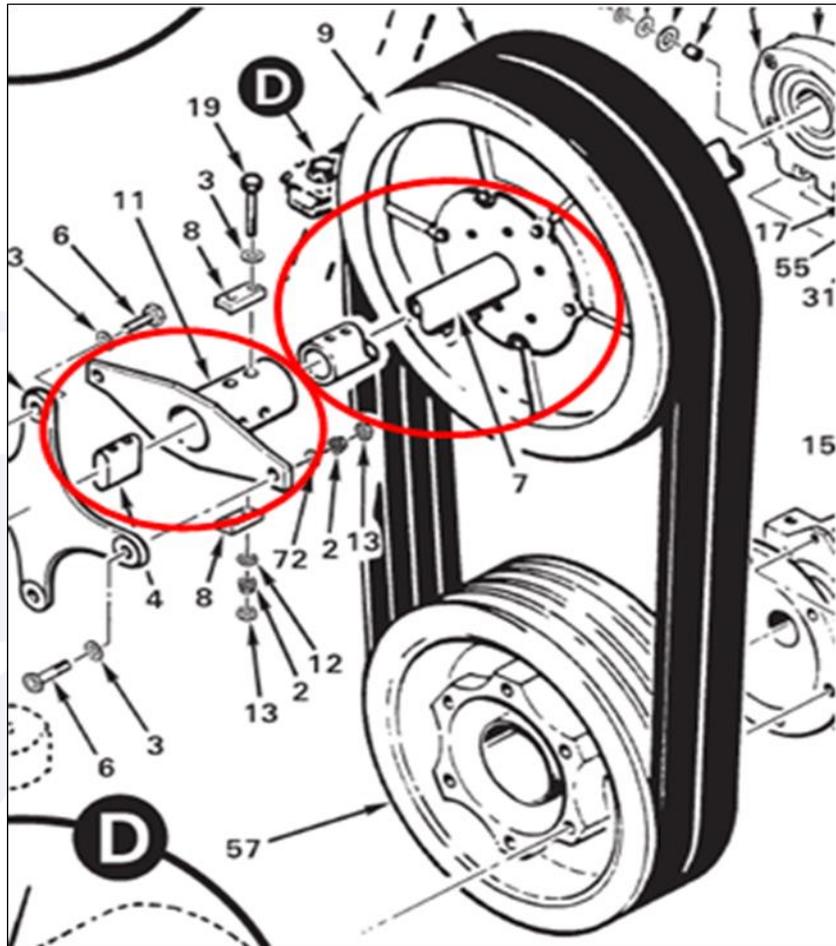
Due to the stresses imposed by the belts to the pulleys, the fractured end of this shaft, in this new condition, would be displaced downwards. This would explain the dent with a crack, seen in the engine's firewall.

With the shaft moved down, the upper pulley would move out of the alignment of the belts, causing them to loosen (especially the front belt). So, it was unlikely that the belts would remain in the tracks (grooves) of the pulleys. With the belts loose and out of the grooves of the pulleys, the rear shaft would no longer be connected, that is, it would not continue to mechanically receive the load of the engine. Thus, the drag produced by the tail rotor blades would also help to decelerate the rear shaft (Figure 14)

Figure 14 - Details of the Yoke (11) and Shaft-Transmission (7), in the R-22 Drive train.

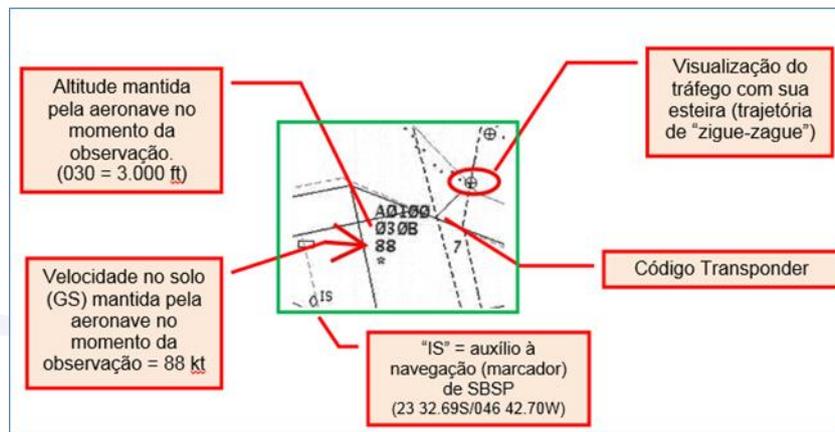
This way, it was observed that the aircraft, when returning from the exercise area and approaching SBMT, at 13:15:56 (UTC), remained in the bow 085 °, at 3,000ft altitude (about 500ft AGL), with speed average of 84kt. The approximate bow of PT-HOL corresponded to the stretch of the visual corridor "ROTA MARTE", on the beginning of Rodovia dos Bandeirantes (Figure 15).

Figure 15 - Frame of 13h16min56s (UTC).

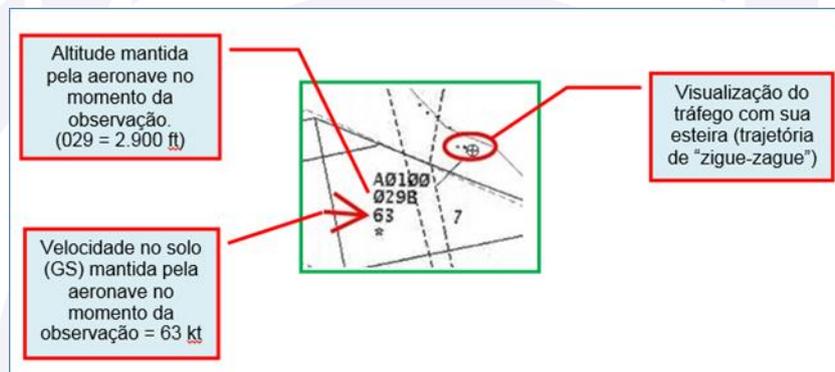
From 13h16min56s (UTC), a change in trajectory (bow variation for both sides) was observed, associated to the significant drop in speed, as indicated in the radar-revision charts. Such changes of flight parameters lasted 25 seconds until the loss of the return-radar. (Figures 16 and 17).

Figure 17 - Frame of 13h17min16s (UTC).

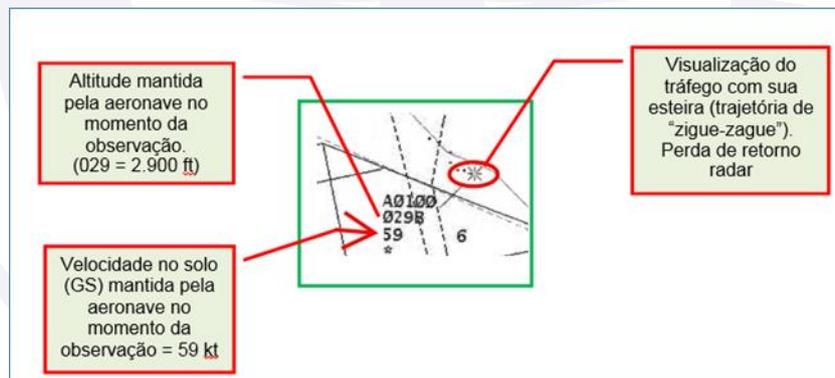
Figure 17 - Frame of 13h17min21s (UTC). Note the loss of radar "plot" (asterisk), indicating altitude loss with practically no horizontal displacement in relation to the previous frame.

These changes in the bow and speed are evidence that the aircraft has been subjected to a sudden loss of power due to failure in the drive system, since the engine was functioning correctly, as it can be inferred from observing the Emergency Procedures of the R -22:

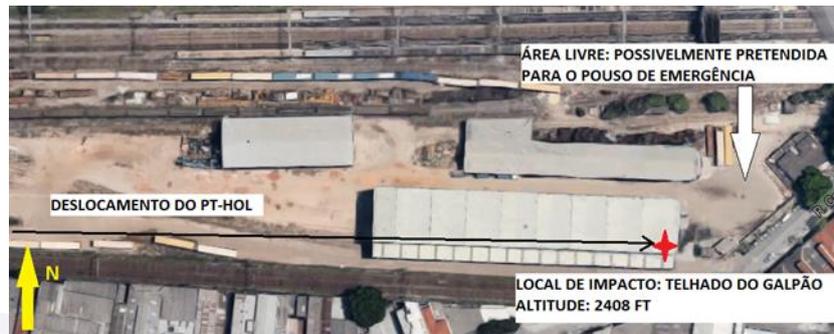
Figure 18 - Sketch of the approximate trajectory of the aircraft.

The helicopter collided the tail cone, practically at its root, against the side structure of the roof of a large warehouse of steel reels. The metal structure of the roof in this building did not support the weight of the rest of the device. Considering the direction of approach, there was a yard for car maneuvers after the warehouse, free of obstacles (Figure 18).
