FINAL REPORT
A - 005/CENIPA/2015

OCCURRENCE:	ACCIDENT
AIRCRAFT:	PT-NAB
MODEL:	EMB-710C
DATE:	10JAN2015

This is the Final Report of the 10JAN2015 accident with the EMB-710C aircraft, registration PT-NAB. The accident was classified as “Engine Failure in Flight”.

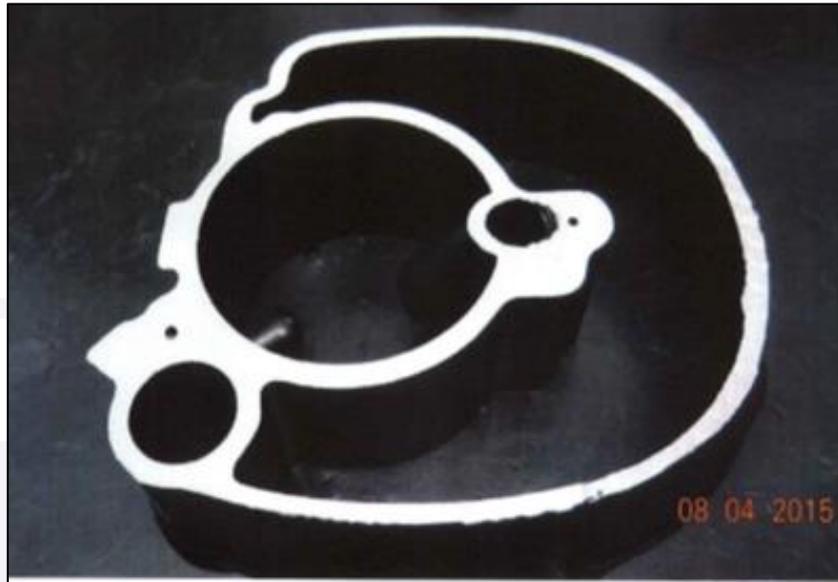
Figure 6 - View of the special mounting tool described in Installation Instruction E-1002.

A special tool, called M-509 (Figure 6), was used to check the spacing between the flotation buoys and the walls of the carburetor tank. This calibration was performed according to the instructions in the Installation Instruction E-1002 manual, 03JAN2011, for the carburetor model.

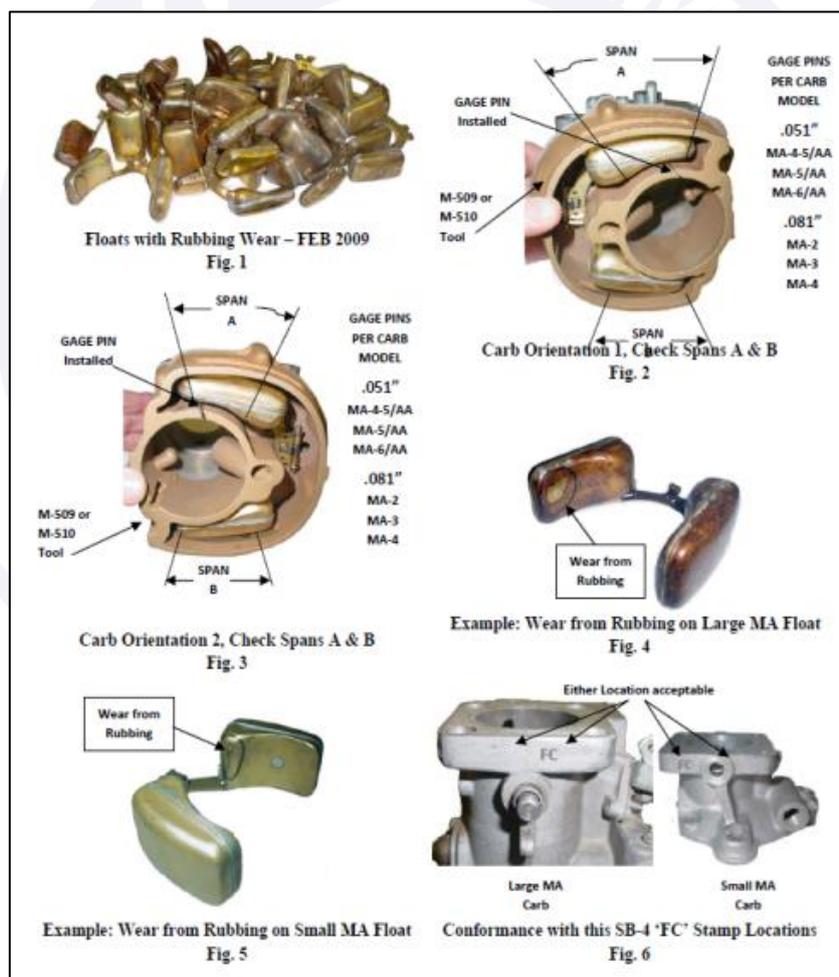
Figure 18 - Page 4 of 4 of the Service Bulletin SB-4 Rev B.

No records of compliance with this SB were found in the aircraft documentation.
