COMANDO DA AERONÁUTICA
CENTRO DE INVESTIGAÇÃO E PREVENÇÃO DE
ACIDENTES AERONÁUTICOS

FINAL REPORT
A-515/CENIPA/2016

OCCURRENCE:	ACCIDENT
AIRCRAFT:	PT-WVM
MODEL:	BONANZA A36
DATE:	10NOV2014

This is the Final Report of the 10 November 2014 accident with the Bonanza A-36 aircraft, registration PT-WVM. The accident was classified as “loss of control in flight”.

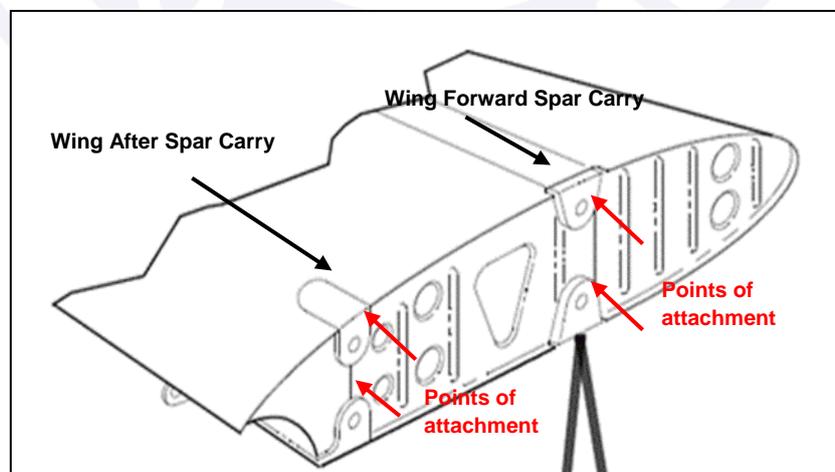
Figure 14 – Forward and rear points of attachment of the left wing.

The wings of the aircraft were attached to the fuselage by means of the main forward spar and the rear one. When assembled, such spars formed a structure connecting each wing to the main spar - *Wing Forward Spar Carry* (Figures 14 and 15).

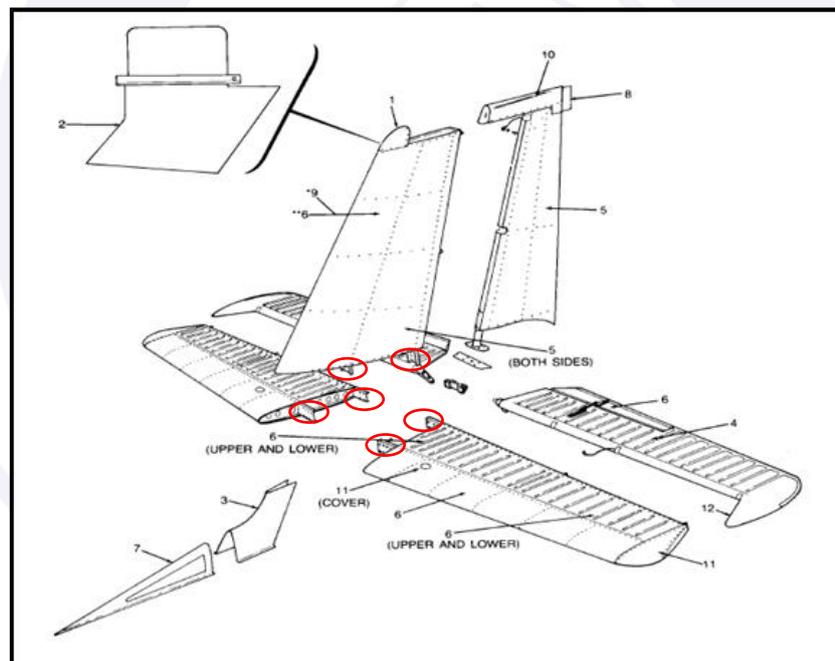
Figure 16 - Points of attachment of the stabilizers to the fuselage.

Each one of the surfaces was attached to the fuselage by means of forward and rear spars (Figure 16).
